TO: Mercedes-Benz Dealer Principals, General Managers, Sales Managers, Service Managers, Parts Managers	FROM: Gregory Gunther, Senior Manager, Vehicle Compliance and Analysis, Engineering Services
RE: Recall Campaign Launch Notification Check Rear Axle Brake Hoses MY24 AMG GLB 35 (247)	DATE: August 16, 2024

Campaign No. 2024080002, August 2024

SUBJECT: **Model AMG GLB 35 (247 platform)**
Model Year 2024

Check Rear Axle Brake Hose

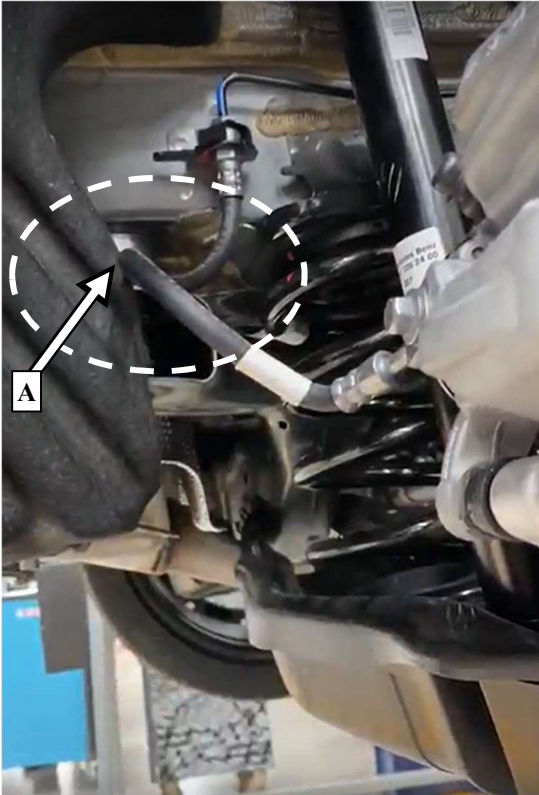
Figure 1

1. Lift vehicle.
2. Inspect the left and right rear brake hoses on the rear axle.
 - i** Left and/or right rear brake hoses could contact the felt wheel arch liner area (**Figure 1, A**) and this could cause the brake hose to rub against the rim or tire.
 - i** The left and right rear brake hose must be routed freely without any points of contact (**Figure 2**).
 - i** Even if the brake hoses are routed correctly, they must be checked for scuff marks/damage!

- a. Brake hose **is damaged** on left and/or right side of rear axle: Carry out **Work Procedure**.
 - b. Brake hoses on the left and right are **routed correctly** and have **no scuff marks or damage**: **End Measure**.
-

1. Replace the damaged brake hose(s) and ensure it is routed correctly (**Figure 2**).
 - i** For basic data, see **AR42.10-P-0013MFA**
-
