IMPORTANT SAFETY RECALL

NHTSA Recall – 24V-799

Spartan Internal Recall No. 24014

Spartan Fire, LLC has decided that a defect which relates to motor vehicle safety exists in certain model year 2024-2025 Metro Star and FC-94, and 2025 Gladiator and KME Panther model emergency response chassis cab vehicles.

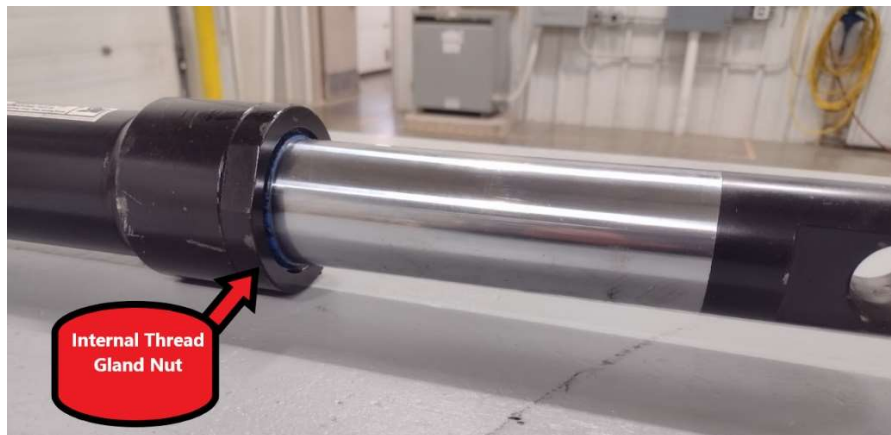
Cab Tilt Cylinder Type 1

Cylinder gland nut has external threads and threads internally into the barrel.

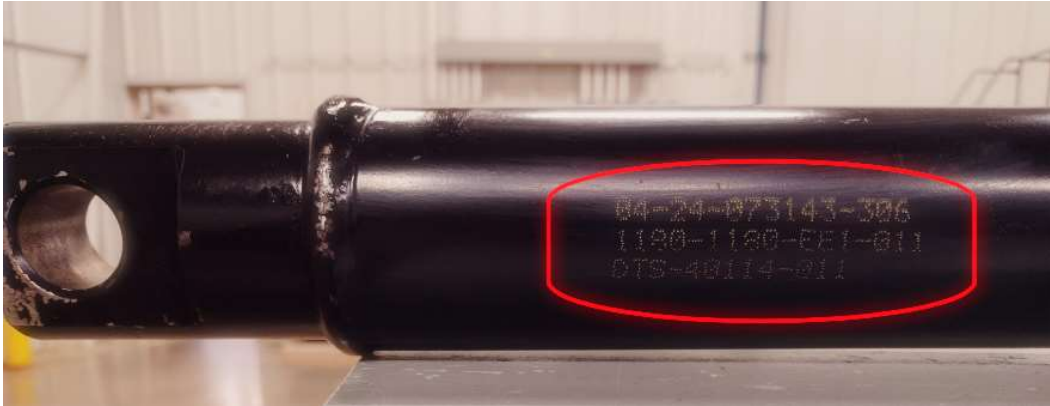
Part Number and Serial Number are laser dot etched into the barrel.

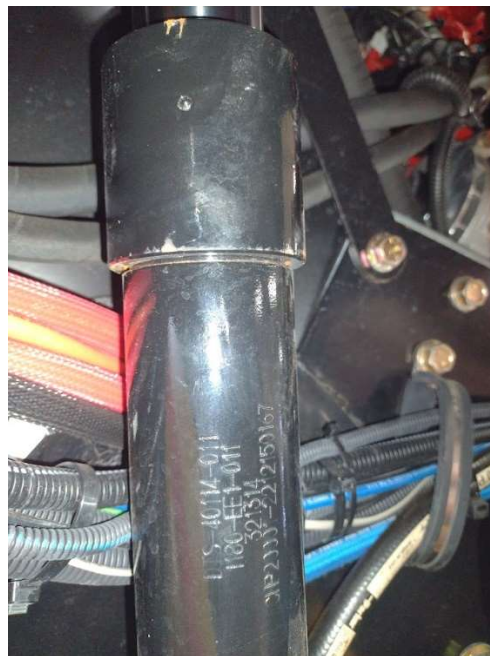
Cab Tilt Cylinder Type 2

Cylinder gland nut threads externally over the cylinder barrel. Part number and serial number are engraved in the cylinder barrel.
