SERVICE PROCEDURE

24516
December, 2024

SUBJECT: SAFETY RECALL
Meritor® Front Steer Drive (FSD) MX-20-130 axles
on certain 2024 and 2025 International® HV™
Series trucks built 10/10/2023 through 09/12/2024
with feature code 0002GAK.

INSPECTING WHEEL ENDS ON FSD 8K-23K SERIES FRONT DRIVE STEER AXLES BUILT OCT. 1, 2023-SEPT. 30, 2024

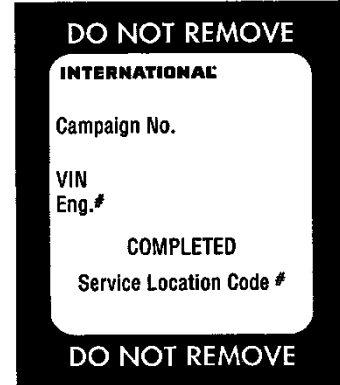
CAMPAIGN IDENTIFICATION LABEL

Each vehicle corrected in accordance with this campaign must be marked with a CTS-1075 Campaign Identification Label.

Complete the label and attach on a clean surface next to the vehicle identification number (VIN) plate.

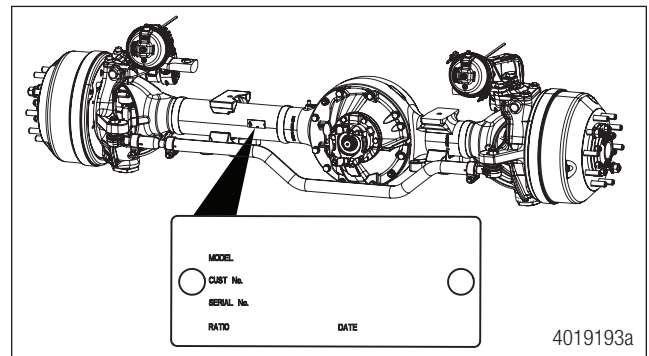
Figure 1

Use ID tag below to identify axle serial number. Figure 1.

- If the axle falls within the affected serial numbers, proceed with the instructions in this document.
- If the axle does not fall within the affected serial numbers, disregard this bulletin and return the vehicle to service.

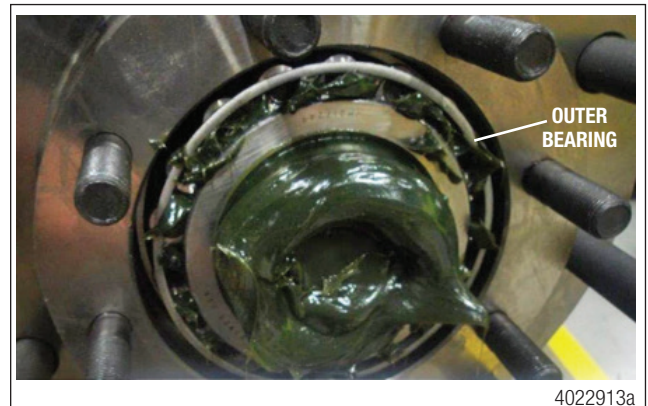
Figure 2

1. Remove the front wheel and tire assemblies, brake drums, drive flange, and wheel bearing lock nut hardware according to the correct model instructions.
2. With the drive flange and lock nut hardware removed, inspect the outer wheel bearing for the presence of grease. Figure 2. Look for damage due to lack of grease and excessive heat. Refer to the Wheel Bearing Cone and Cup Damage Examples on page 3.

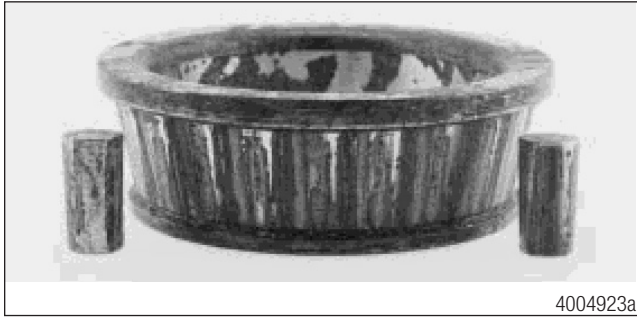
Figure 3

A bearing damaged by insufficient lubricant will overheat, and the color may change from silver to deep blue. Figure 3. If the bearing is black, it is an indication that it seized and caused metal to separate from the bearing and weld to other mating components. Figure 4 and Figure 5. Bearings damaged by insufficient lubricant require replacement.

Replace the inner and outer bearing cones and cups. Replace the hub if the hub is damaged. Refer to the appropriate steps for the axle model being serviced.

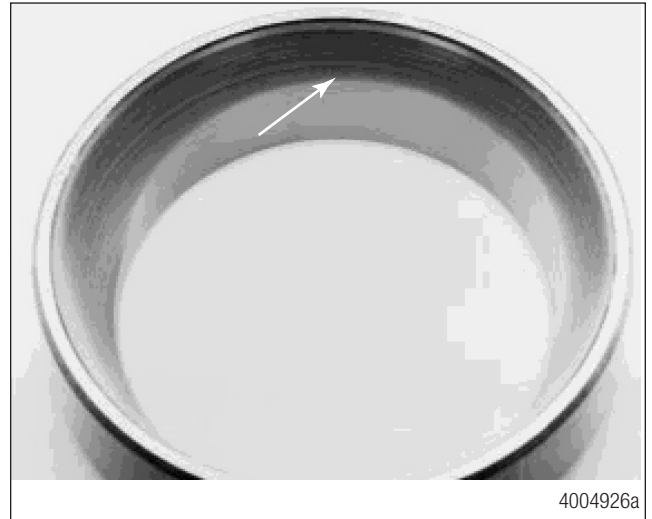
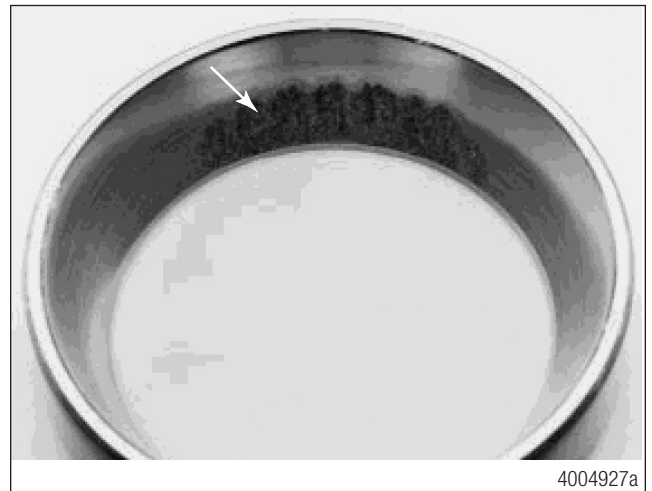
Uneven wear damage on the bearing, as well as spalling on the cup and cone may occur. Both conditions require bearing replacement. Figure 6 and Figure 7.

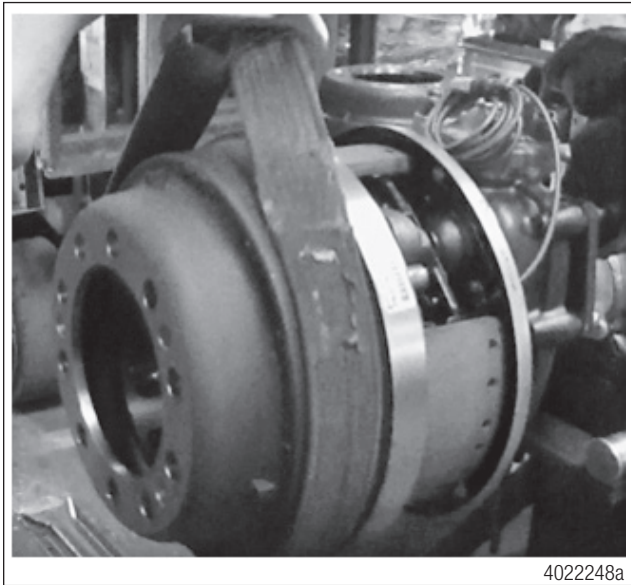
Figure 8

1. Park the vehicle on a level surface. Block the wheels to prevent the vehicle from moving. Raise the front of the vehicle so the front wheels are off the ground. Support the vehicle with safety stands.
2. Remove the front wheel and tire assemblies per the OEM recommended instructions.
3. Remove the brake drums using a suitable lifting device. Figure 8.

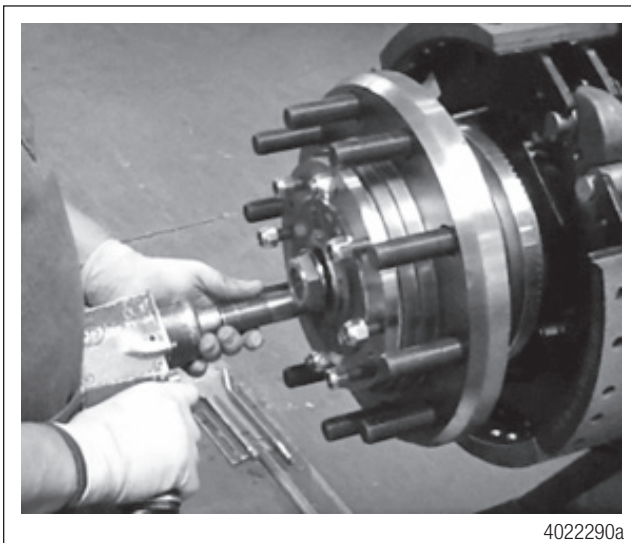
Figure 9

4. Remove the eight 1/2" drive flange lock nuts. Figure 9.

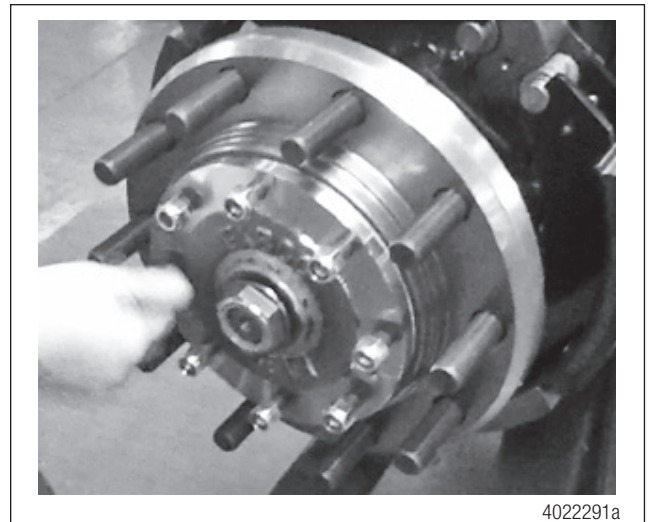
Figure 10

5. Remove the flanged hex nut next to the axle lock nut. Figure 10.

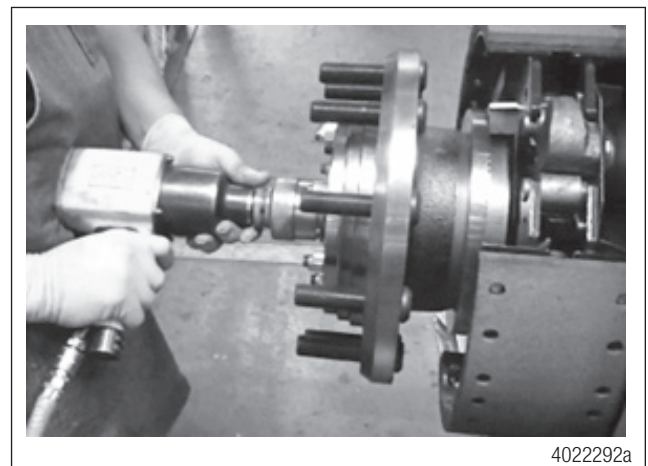
Figure 11

6. Remove the 1-1/4" flanged axle lock nut. Figure 11.

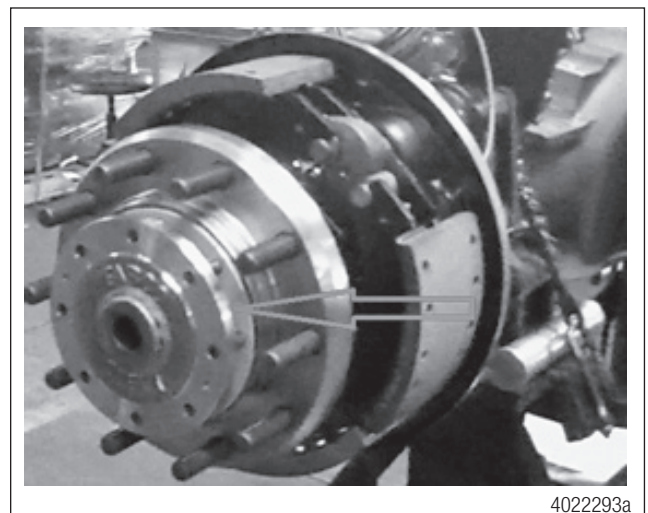
Figure 12

7. Remove the drive flange. If it is not loose enough to remove by hand, install two 3/8"-16 bolts in the extractor holes to loosen the drive flange and then remove it. Figure 12.

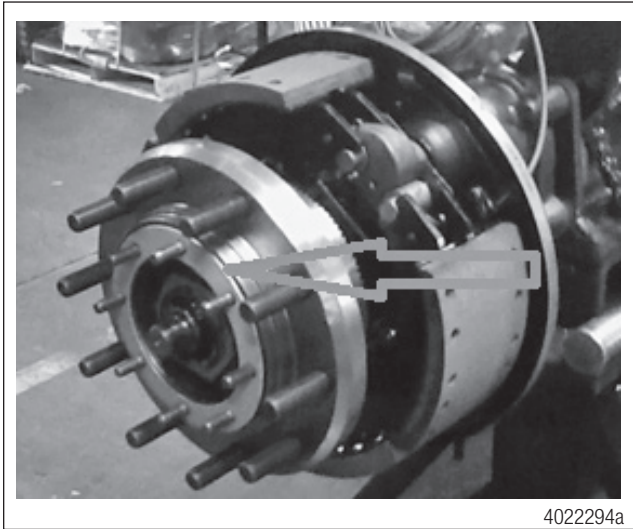
Figure 13

8. Remove the shim pack from the face of the wheel end. Set the shims aside for use during reassembly. Figure 13.

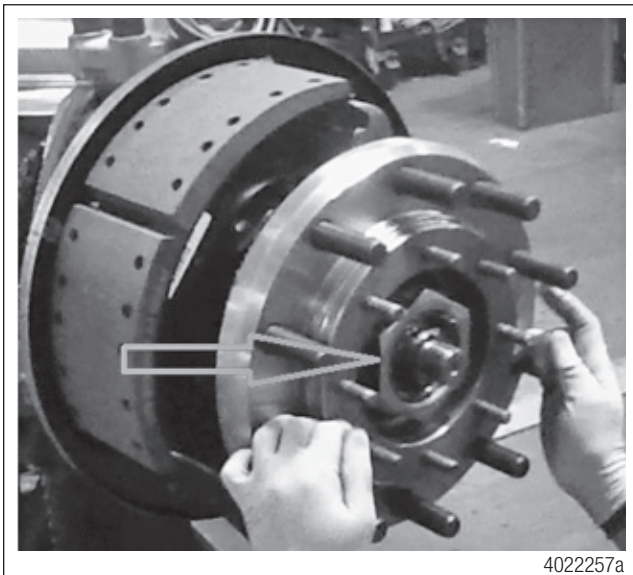
Figure 14

9. Remove the wheel bearing lock nut from the spindle. Figure 14.

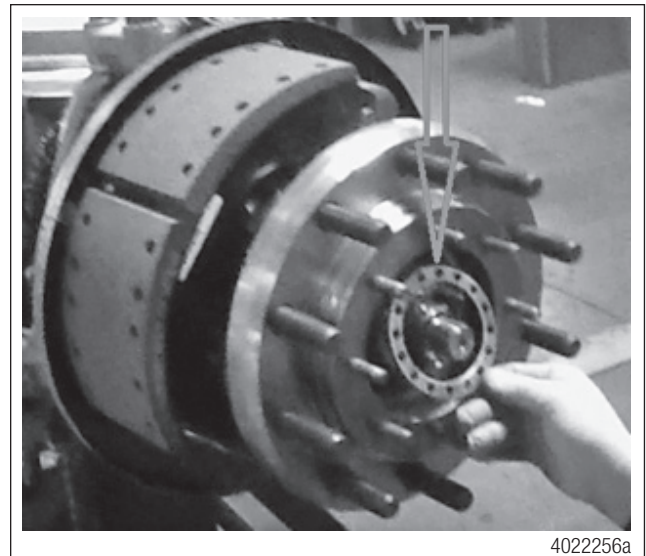
Figure 15

10. Remove the washer with the holes from the spindle. Figure 15.

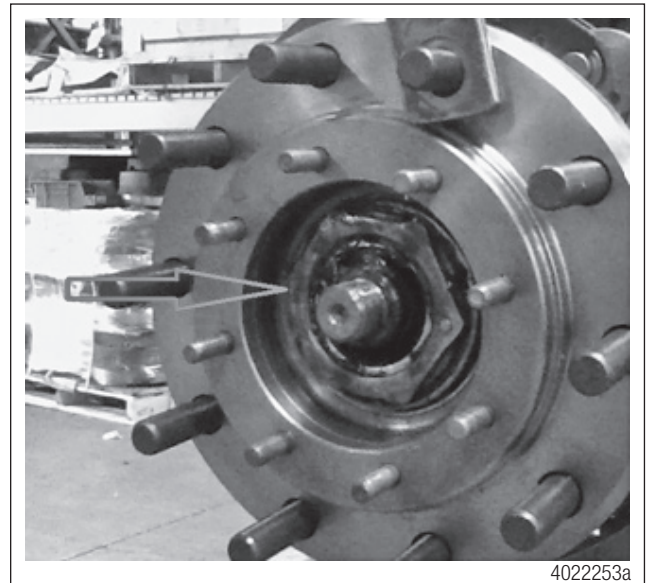
Figure 16

11. Remove the adjusting nut from the spindle. Figure 16.

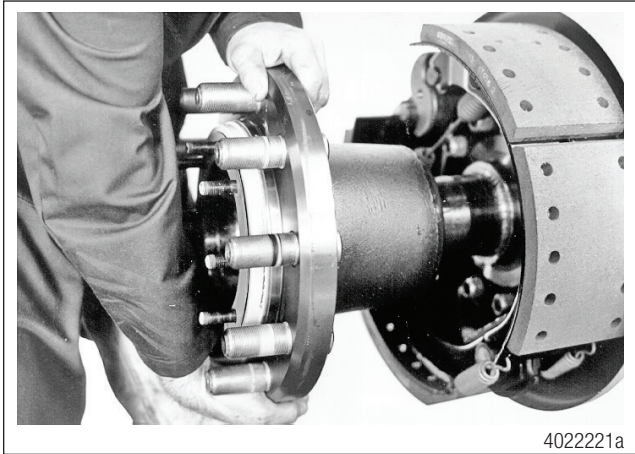
Figure 17

13. Remove the hub from the spindle, pulling the assembly straight out to avoid cocking the inner bearing cone. If the cone binds against the spindle, try rocking the hub to free it. It may be necessary to use a pry bar under the inner surface of the hub to free it. To avoid damaging the inner seal, pry against the hub only. Figure 17.

If the inner bearing remains on the spindle when the hub is removed, use a suitable bearing puller to remove it. Pull only against the bearing race. Alternately, tap lightly on the race's outboard surface with a small drift to straighten the alignment and try to remove it again by hand.

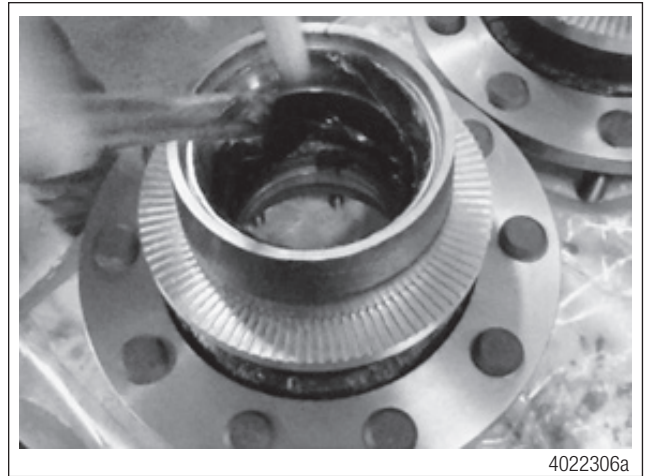
Figure 18

1. If removed, use a suitable driver to install the bearing cups in the hub.
2. Thoroughly pack both bearing cones, and coat the inside surfaces of the hub and bearing cups with grease. Figure 18.

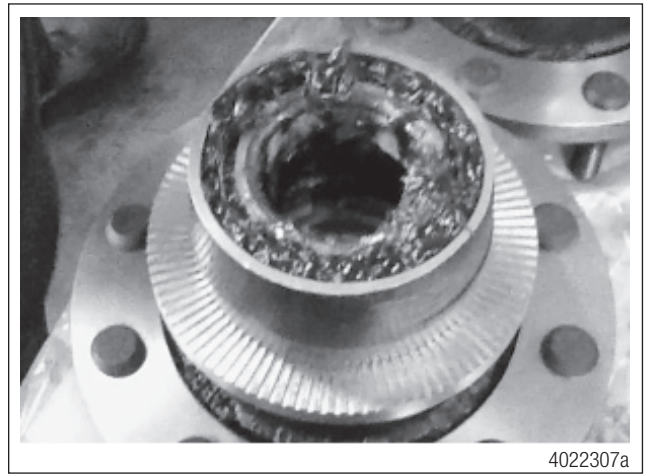
Figure 19

3. Install the inner bearing cone inside the hub assembly. Figure 19.

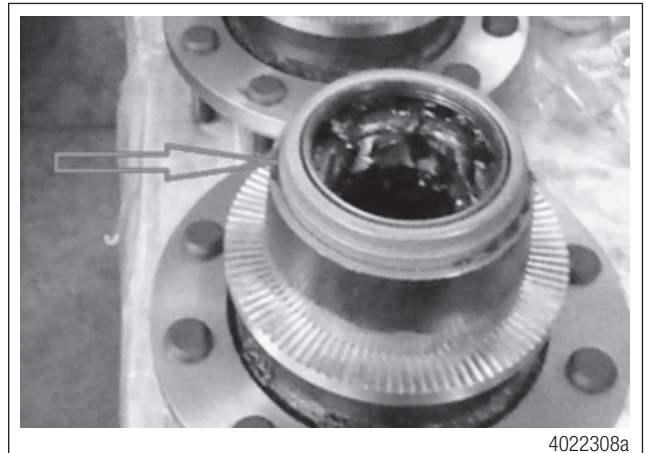
Figure 20

4. Place the wheel seal on the hub assembly. Figure 20.

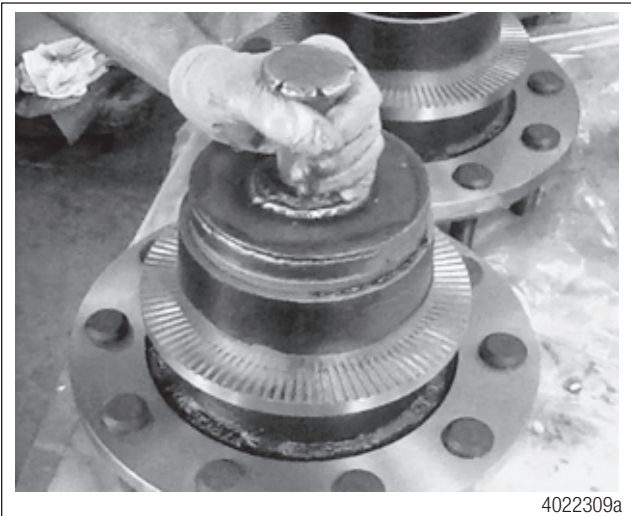
Figure 21

5. Use hub seal driver (866-0707) to drive the seal on the hub assembly until completely seated. Figure 21. Refer to Figure 41 for a tool drawing.

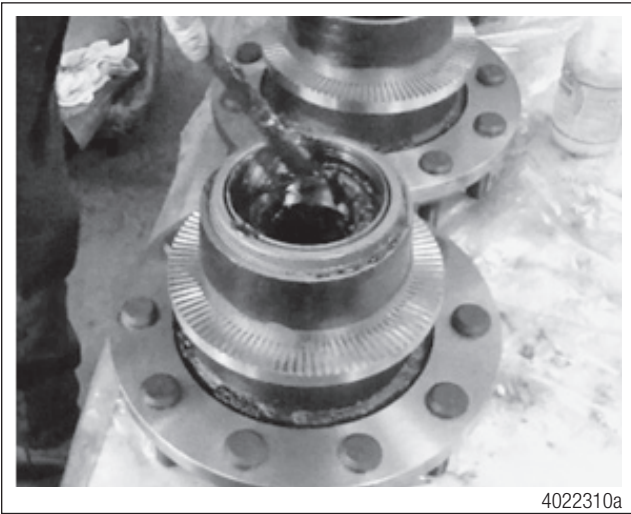
Figure 22

6. Apply more grease to the inner surfaces of the seal and the bearing cone. Figure 22.

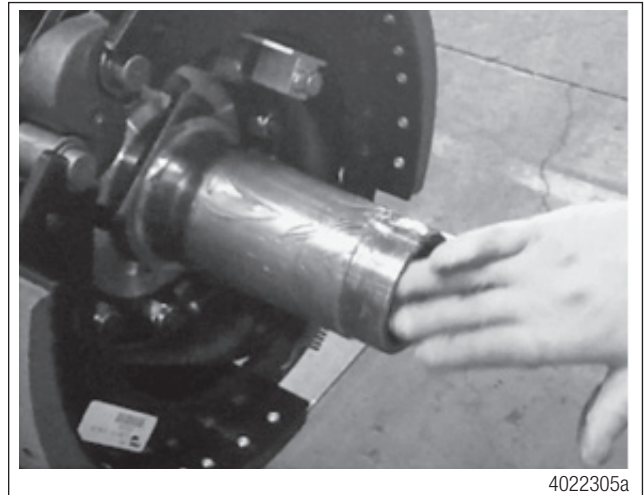
Figure 23

1. Apply grease to the outer surfaces of the spindle and axle shaft. Figure 23.

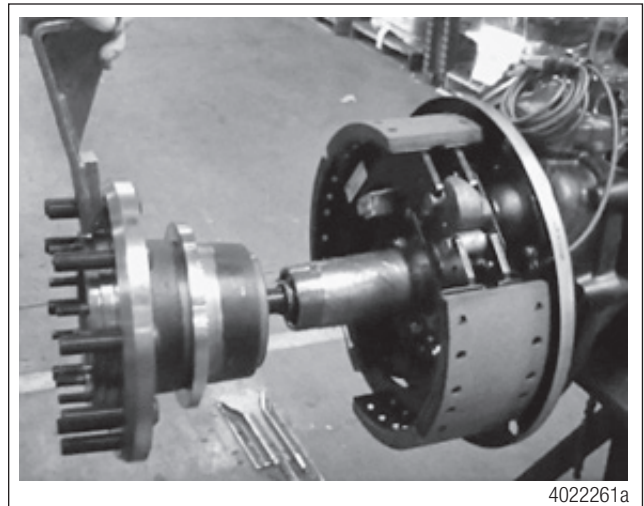
Figure 24

2. Install the hub assembly on the spindle with the help of a crane and hoist. Push the hub in all the way to ensure it is seated against the spindle. Figure 24.

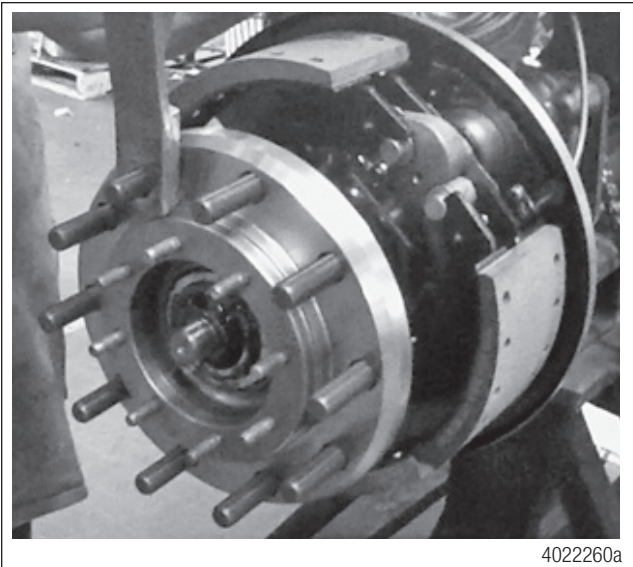
Figure 25

3. Install the greased outer bearing into the hub assembly. Ensure that it is correctly seated. Figure 25.

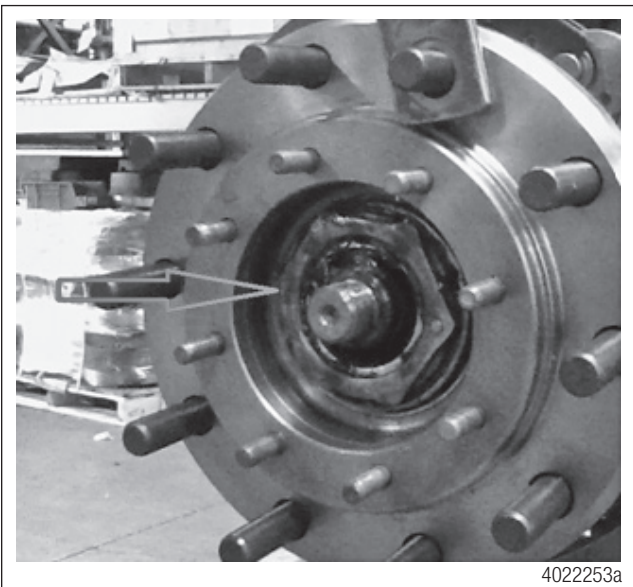
Figure 26

4. Install the bearing adjusting nut (with the dowel facing outward). Figure 26.

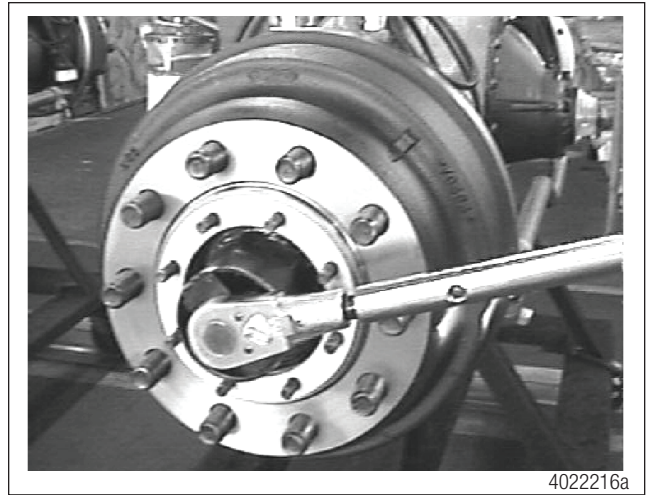
Figure 27

5. Tighten the bearing adjusting nut to 50 lb-ft (68 Nm) while simultaneously rotating the hub assembly. Loosen the nut and repeat this procedure 2-3 times to ensure that the bearings are seated properly. After the final tightening, back off the nut 1/4 turn. Figure 27.

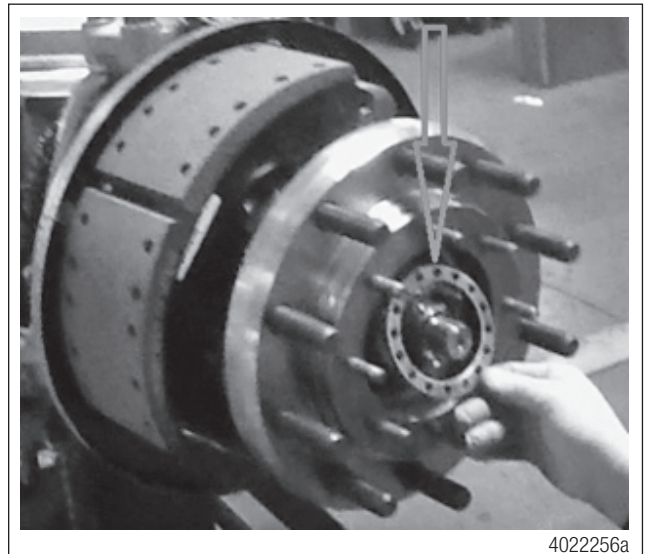
Figure 28

6. Install the lock washer over the nut. If necessary, back off the adjusting nut just enough to allow the dowel pin to engage in the closest hole in the lock washer. Figure 28.

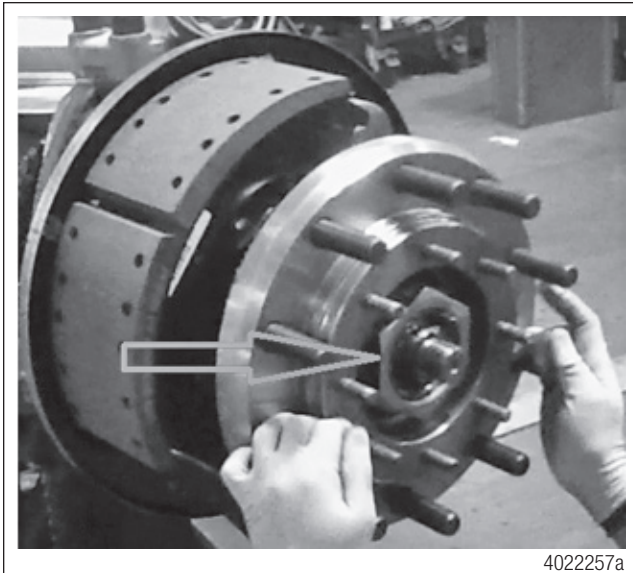
Figure 29

7. Install the lock nut over the washer and tighten to 400 lb-ft (542 Nm). Figure 29.

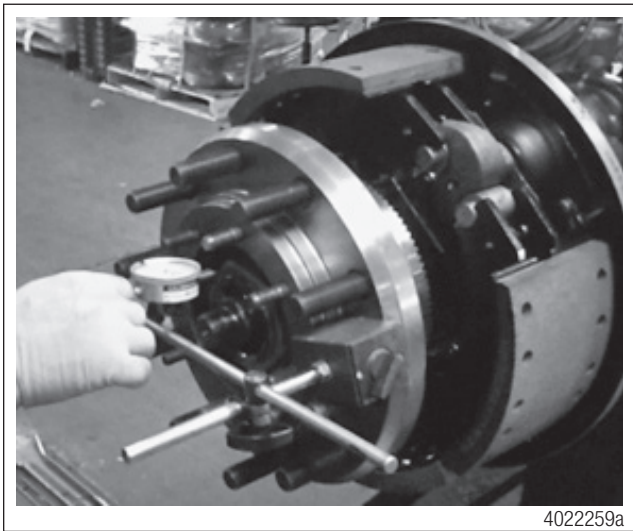
Figure 30

8. Check the end play with a dial indicator. The correct setting is 0.002"-0.004" (0.0508-0.1016 mm). If necessary, repeat the steps until the correct end play is achieved. Figure 30.

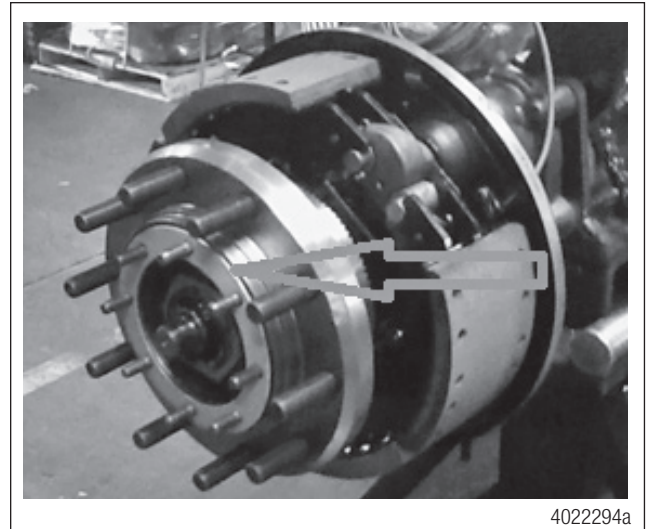
Figure 31

9. Reinstall the shims on the hub. Figure 31.

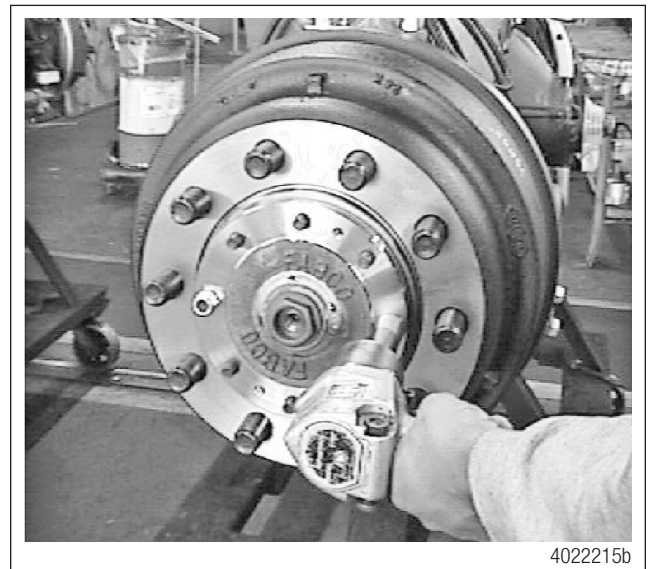
Figure 32

10. Reinstall the drive flange on the hub assembly. Tighten the drive flange lock nuts to 100 lb-ft (135.5 Nm) and the flanged axle lock nut to 400 lb-ft (542 Nm). Figure 32.

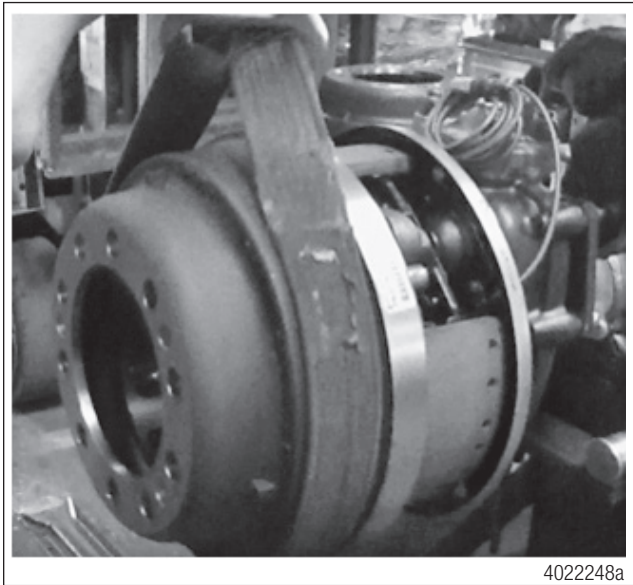
Figure 33

1. Park the vehicle on a level surface. Block the wheels to prevent the vehicle from moving. Raise the front of the vehicle so the front wheels are off the ground. Support the vehicle with safety stands.
2. Remove the front wheel and tire assemblies per the OEM recommended instructions.
3. Remove the brake drums using a suitable lifting device. Figure 33.

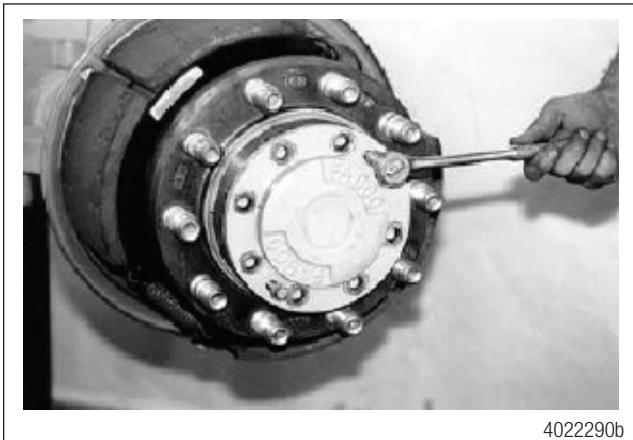
Figure 34

4. Remove the eight 5/8" drive flange lock nuts, then remove the drive flange from the hub. If it is not loose enough to remove by hand, use two 1/2"-20 bolts in the extractor holes to loosen it for removal. Figure 34.

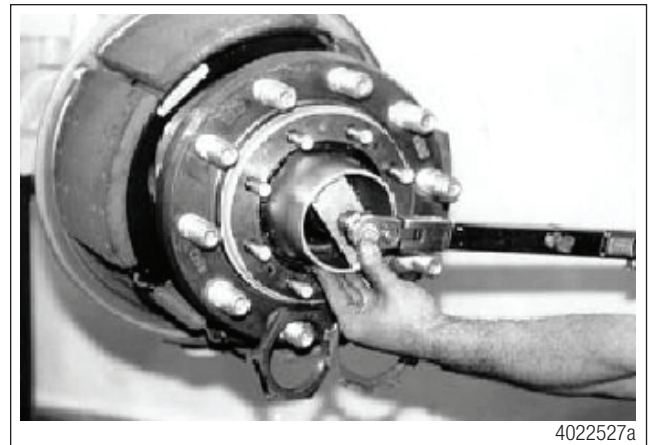
Figure 35

5. Remove the wheel bearing lock nut using a 4-1/8", 6-point socket (OTC 1915 4-1/8" or Snap-On ANS 1915A 4-1/8"). Remove the washer and adjusting nut from the spindle. Figure 35.

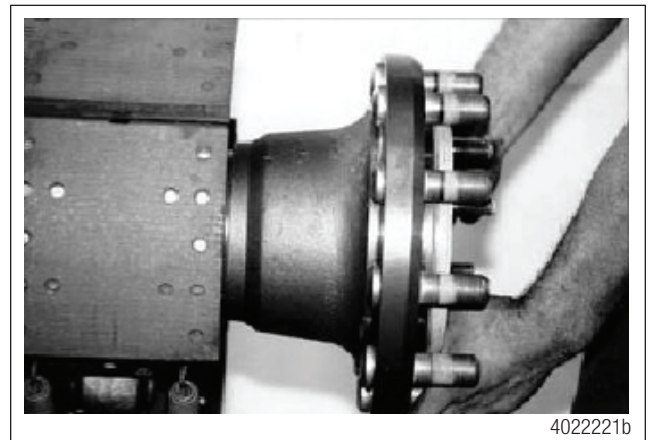
Figure 36

6. Rock the hub in place to loosen the outer wheel bearing cone and remove the bearing from the hub.
7. Remove the hub from the spindle, pulling the assembly straight out to avoid cocking the inner bearing cone. If the cone binds against the spindle, try rocking the hub to free it. If necessary, use a pry bar under the inner surface of the hub to free it. Pry only against the hub to avoid damaging the inner seal. Figure 36.

If the inner bearing remains on the spindle when the hub is removed, use a suitable bearing puller to remove it. Pull only against the bearing race. Alternately, tap lightly on the race outboard surface with a small drift to straighten the alignment and try to remove it again by hand.

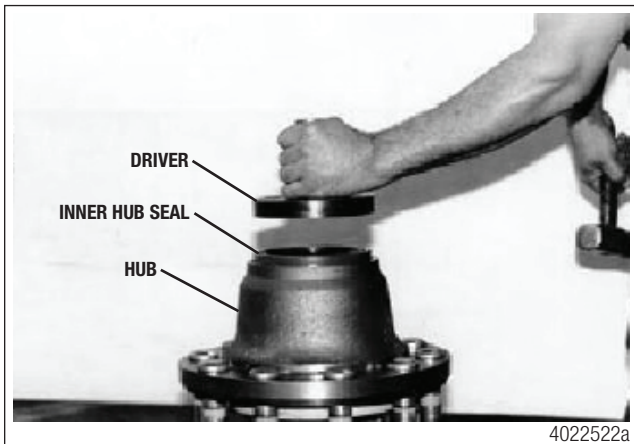
Figure 37

1. Press the wheel bearing cups into the hub using a suitable driver.
2. Thoroughly pack both bearing cones with grease. Coat the inside surfaces of the hub and bearing cups with grease.
3. Install the inner wheel bearing cone.
4. Place the hub seal on the hub assembly.
5. Use hub seal driver (350-0882) to drive the seal on the hub assembly until completely seated. Figure 37. Refer to Figure 42 for a tool drawing.

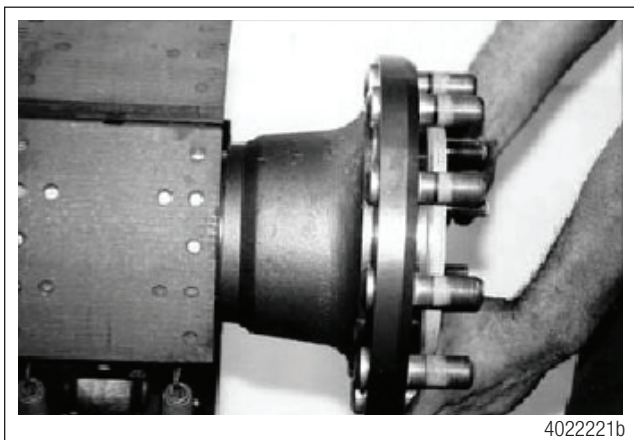
Figure 38

1. Lightly coat the outer surface of the spindle with grease to reduce the chance of the inner wheel bearing cocking when the hub is installed.
2. Grasping the outer part of the hub at the 12 and 6 o'clock positions, push the hub straight on to the spindle. If difficulty is encountered, try rocking the hub slightly to free the inner bearing. Figure 38.

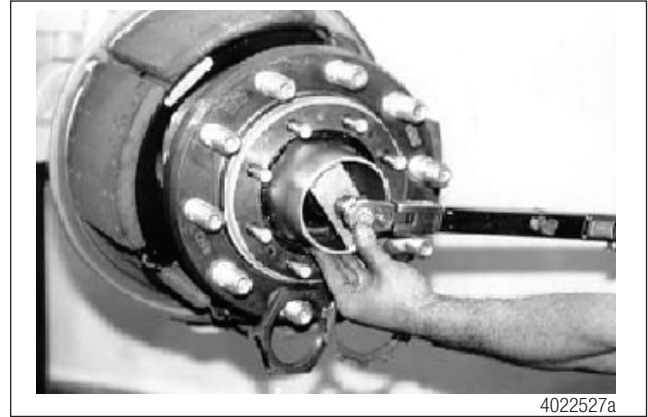
Figure 39

3. Install the greased outer bearing into the hub assembly. Ensure that it is correctly seated.
4. Install the inner bearing adjusting nut. Tighten the bearing adjusting nut to 50 lb-ft (68 Nm) while rotating the hub assembly. Loosen the nut and repeat this procedure 2-3 times to ensure that the bearings are correctly seated. After the final tightening, back off the nut 1/4 turn. Figure 39.

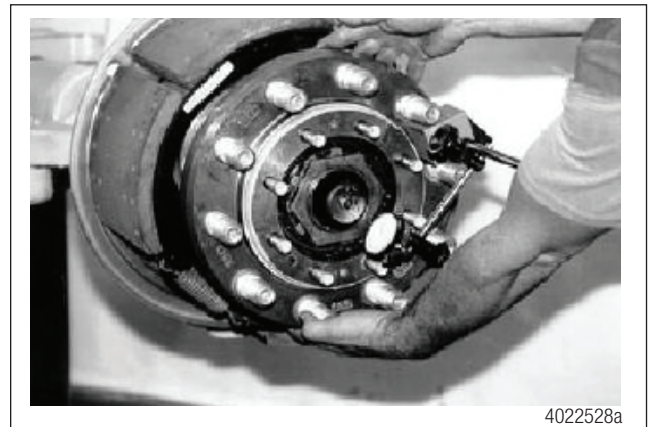
Figure 40

5. Install the wheel bearing lock washer and lock nut, then tighten the lock nut to 400 lb-ft (542 Nm). When the outer lock nut is tightened to specification, the wheel hub should rotate freely.
6. Bend one tab on the lock washer inward and bend one outward across the flattest part of the nut.
7. Check the wheel bearing end play with a dial indicator. The correct end play setting is 0.002"-0.004" (0.0508-0.1016 mm). If necessary, repeat the steps until the correct end play is achieved. Figure 40.

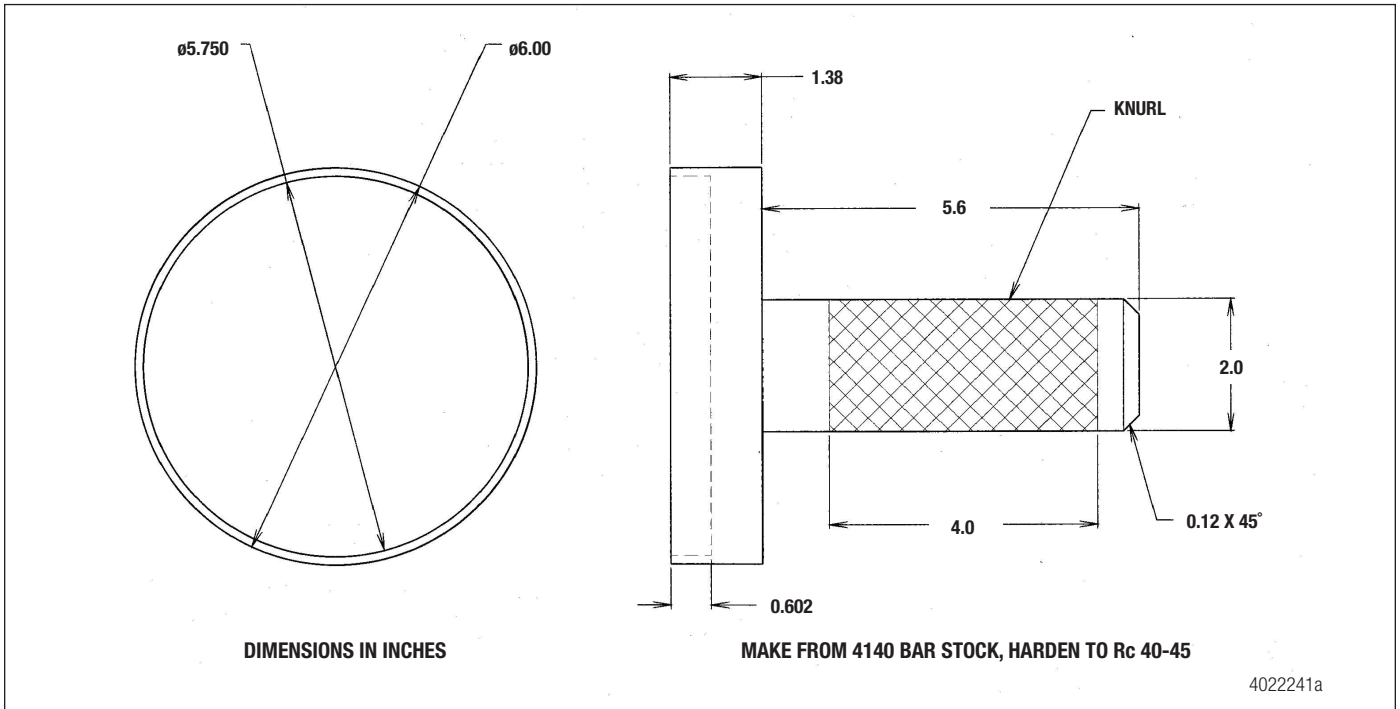
Figure 41

Hub Seal Driver (866-0707) for FSD-08/10/12/13/14

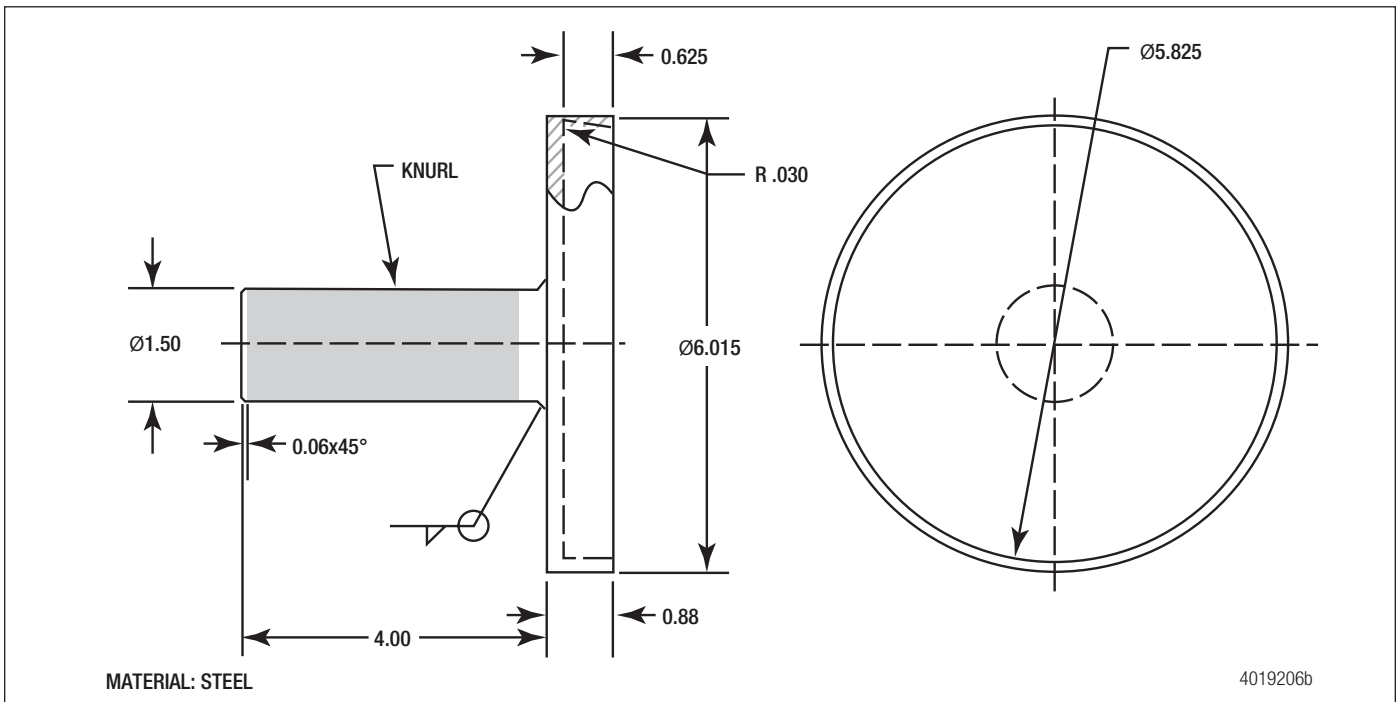
Figure 42

Hub Seal Driver (350-0882) for FSD-18/20/23
