## SAFETY RECALL NOTICE

Subject: Safety Recall Campaign 24V-931

Involving: Featherlite Models 7821,7841,9807 & 9808 Living Quarters trailers

## Cook Top Extension Dealer's Bulletin Instructions

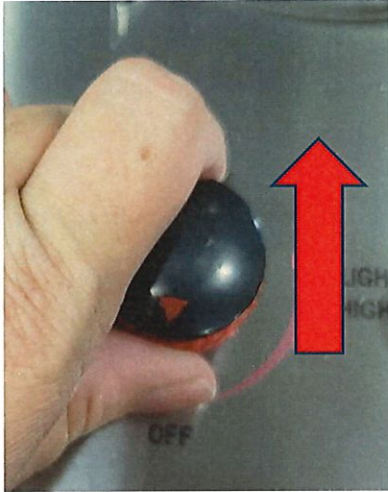
Pull straight up

2. Purge the gas lines of the unit of the remaining LP gas by running the LP appliances in the unit until the appliances no longer have gas to operate.
3. Remove the knobs from the cook top surface element switch by pulling straight up on the knobs.

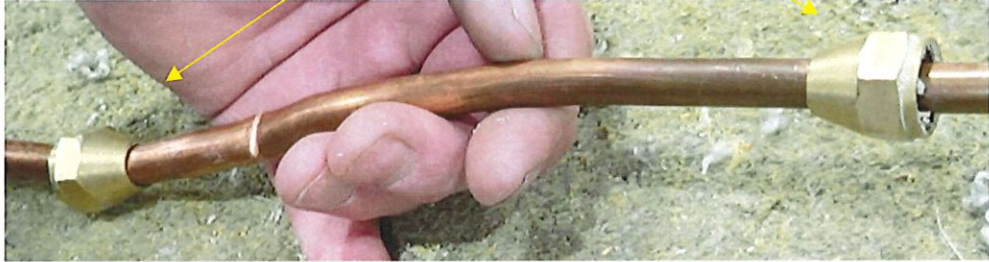
Flare nuts facing opposite directions

12. Verify both flare nuts are on the copper tubing and flare the other end of the tube.

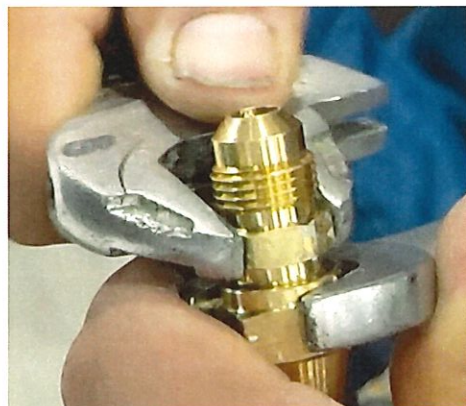
**\*\*\*Note: Flare and Compression fittings do not require pipe dope. \*\*\***

13. Attach the union adapter to one of the flare nuts, this end will be used to connect the copper tubing to the gas hook up located in the burner box.
