Recall Information Bulletin

SUBJECT:

MODELS:

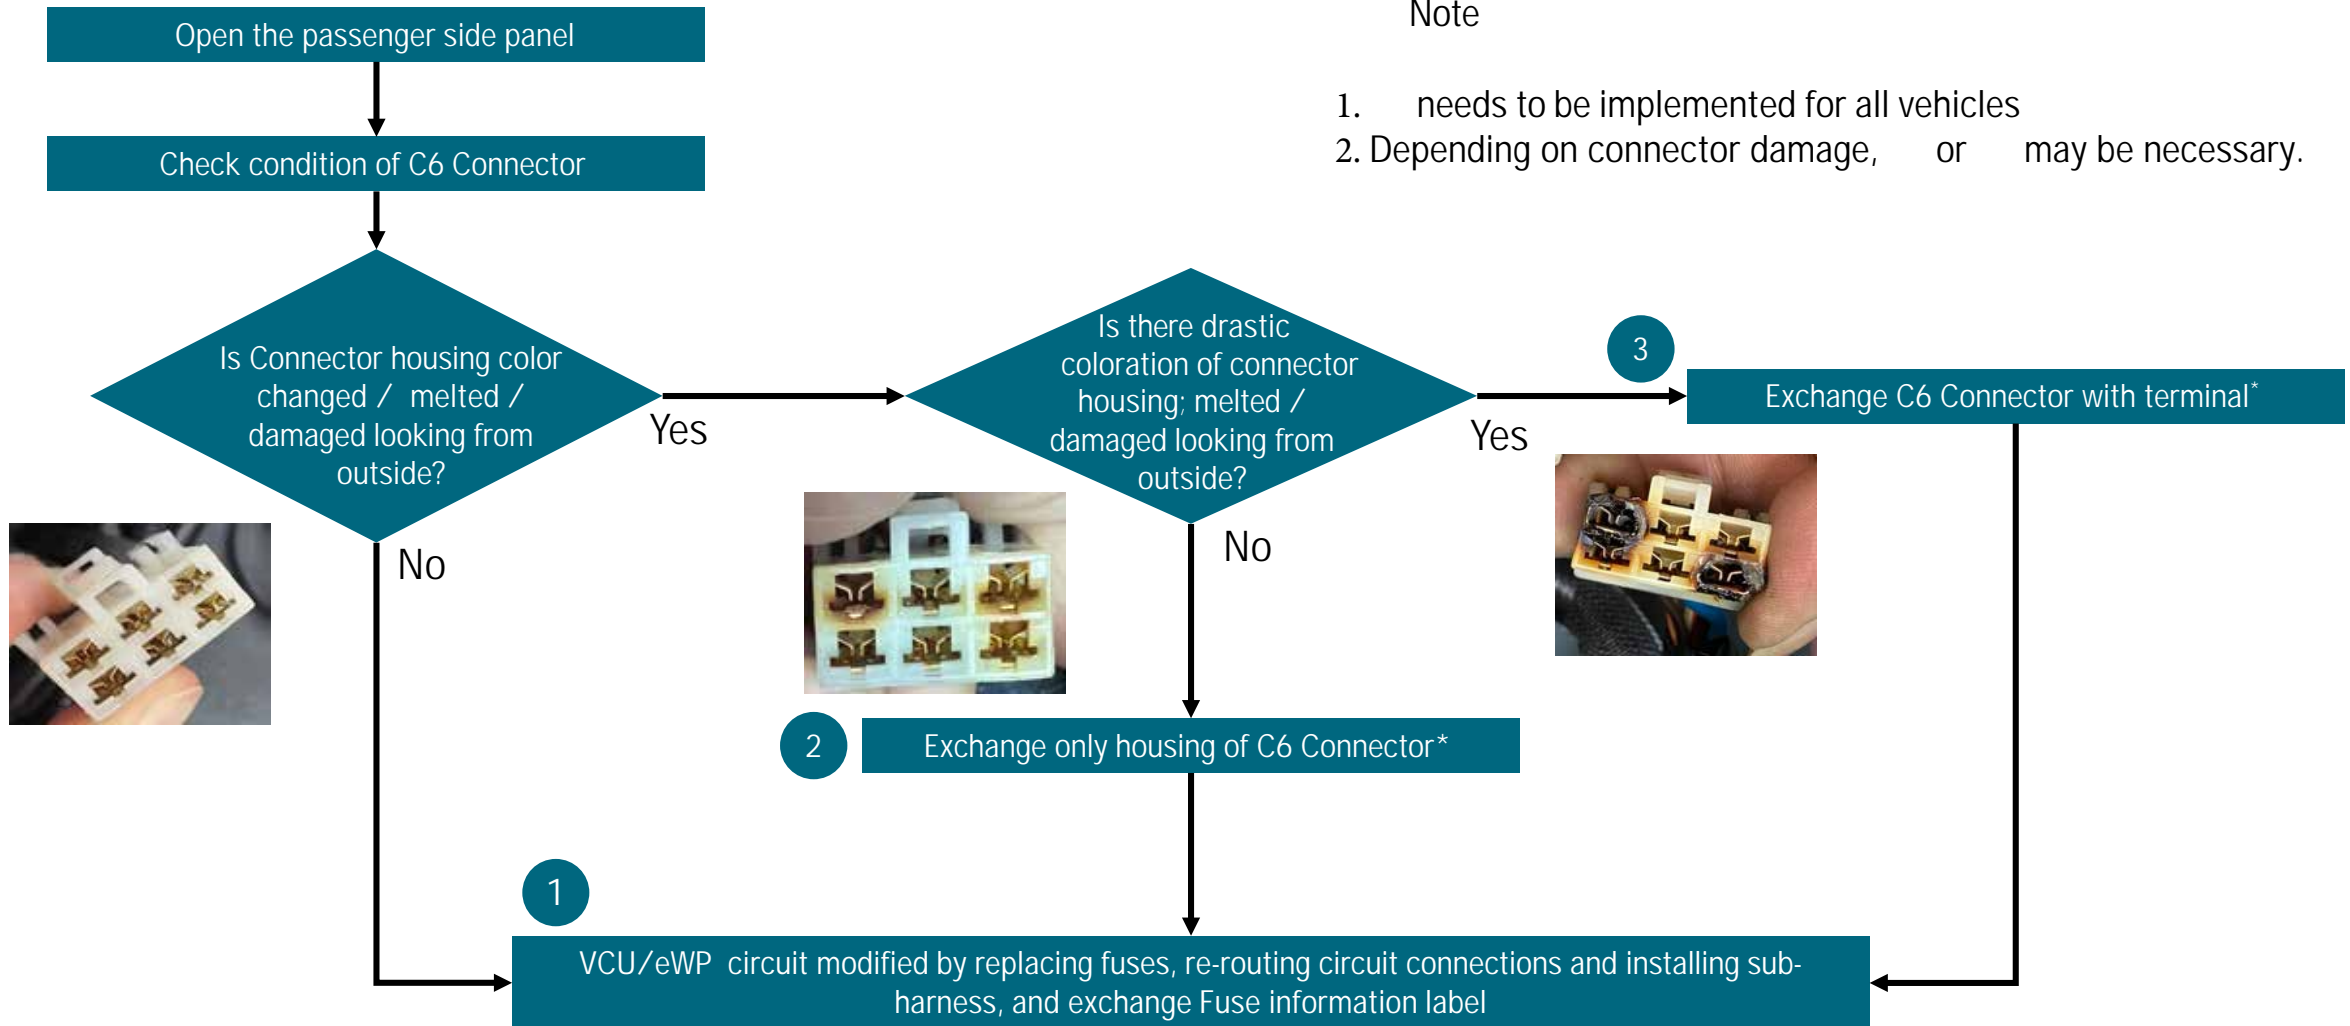
Flow chart for field fix action

1. needs to be implemented for all vehicles
2. Depending on connector damage, or may be necessary.

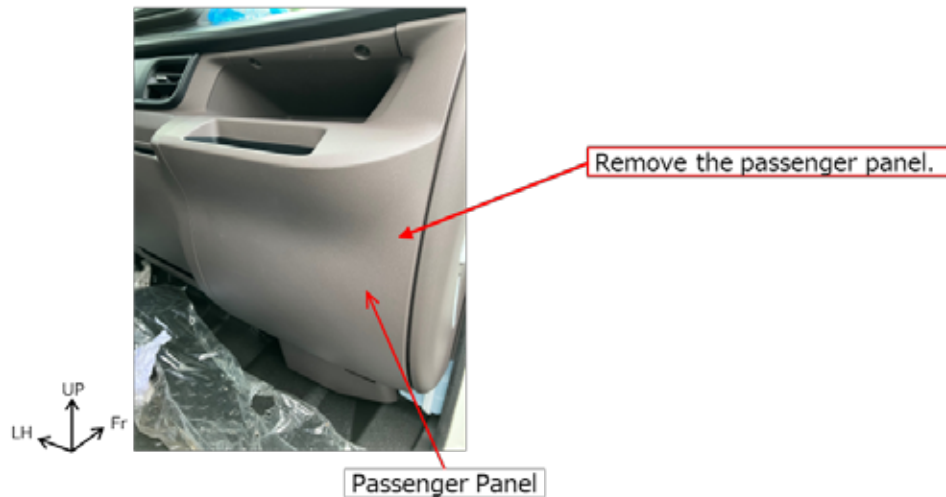
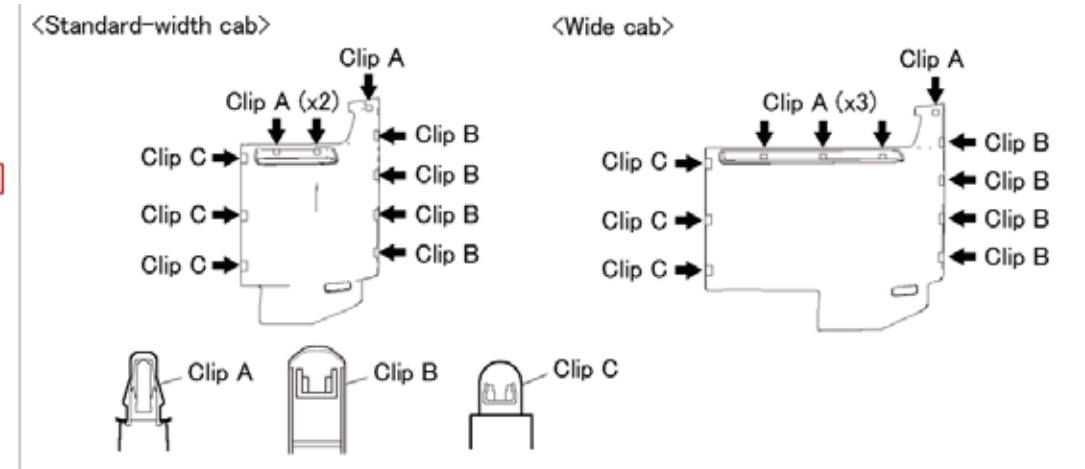
Step-2 :
Remove the passenger side panel.

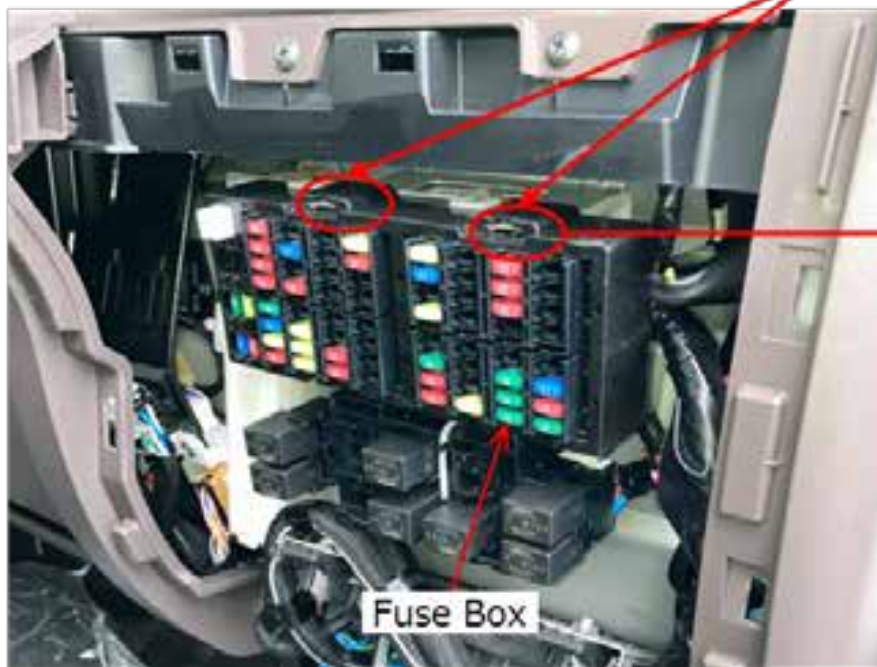
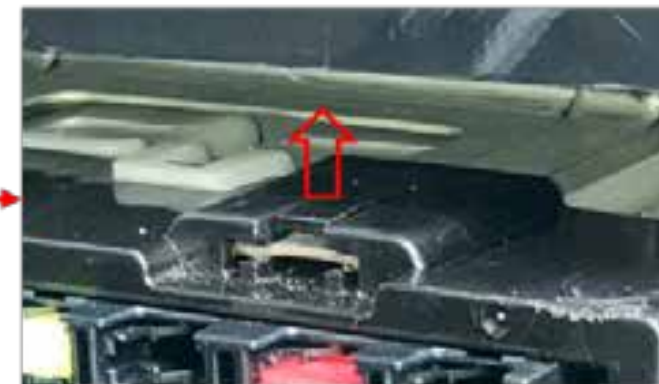
Step-3 :
Remove the fuse box from the bracket.

Lift the tab (2 places) on the fuse box to unlock it, and then remove the fuse box from the bracket.

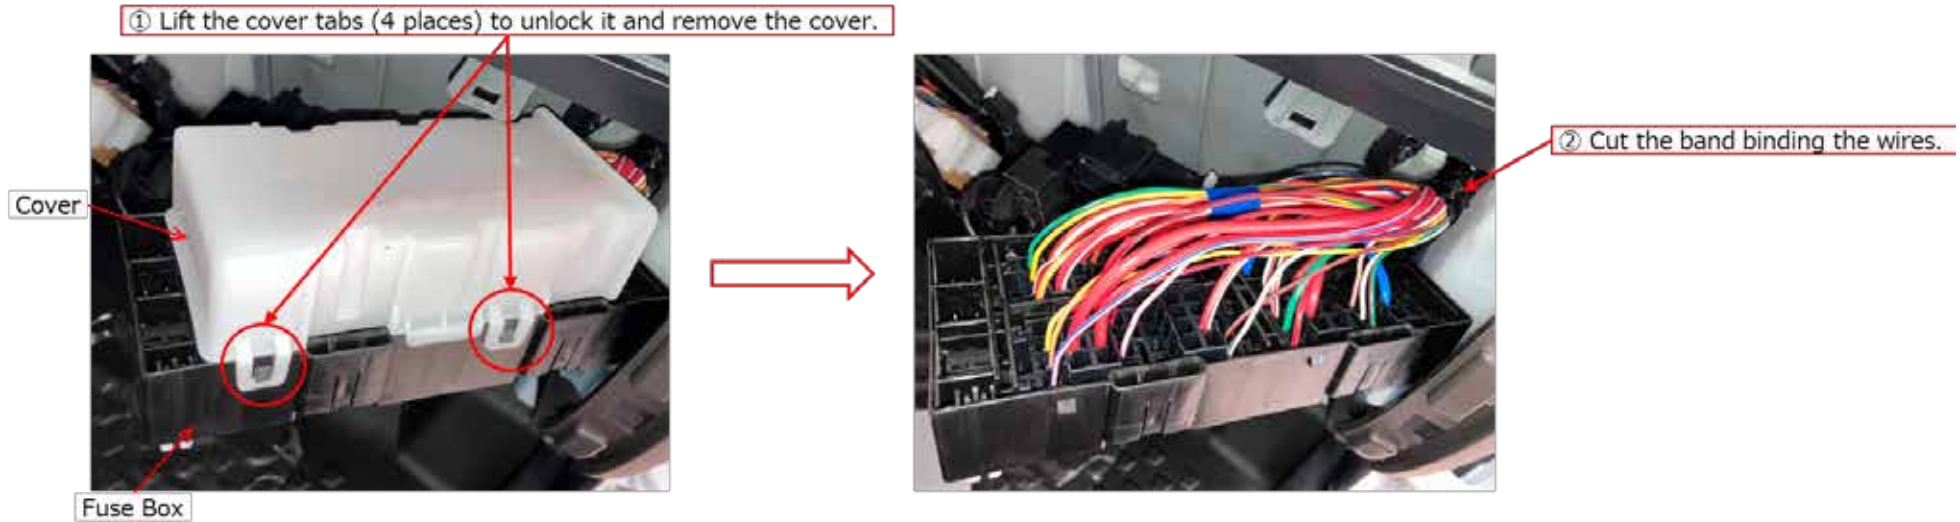
Step-4 : Remove the cover on the back of the fuse box and cut the band binding the wires.

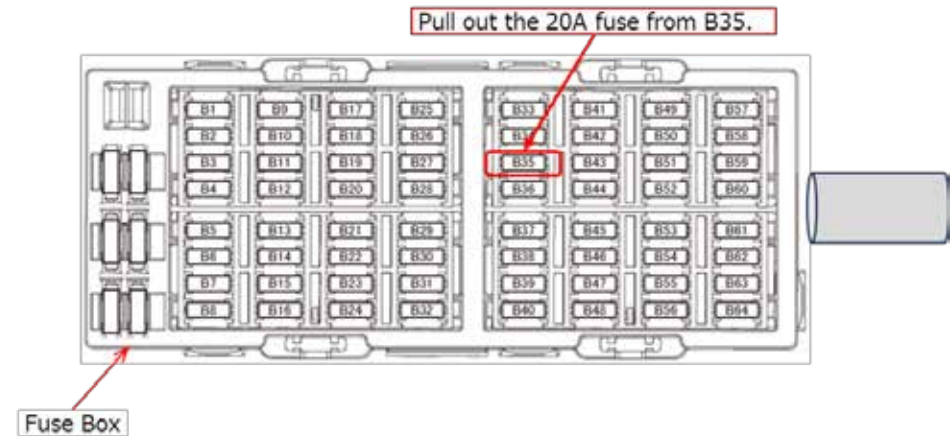
Step-5 : Remove the 20A fuse from B35 in the fuse box.

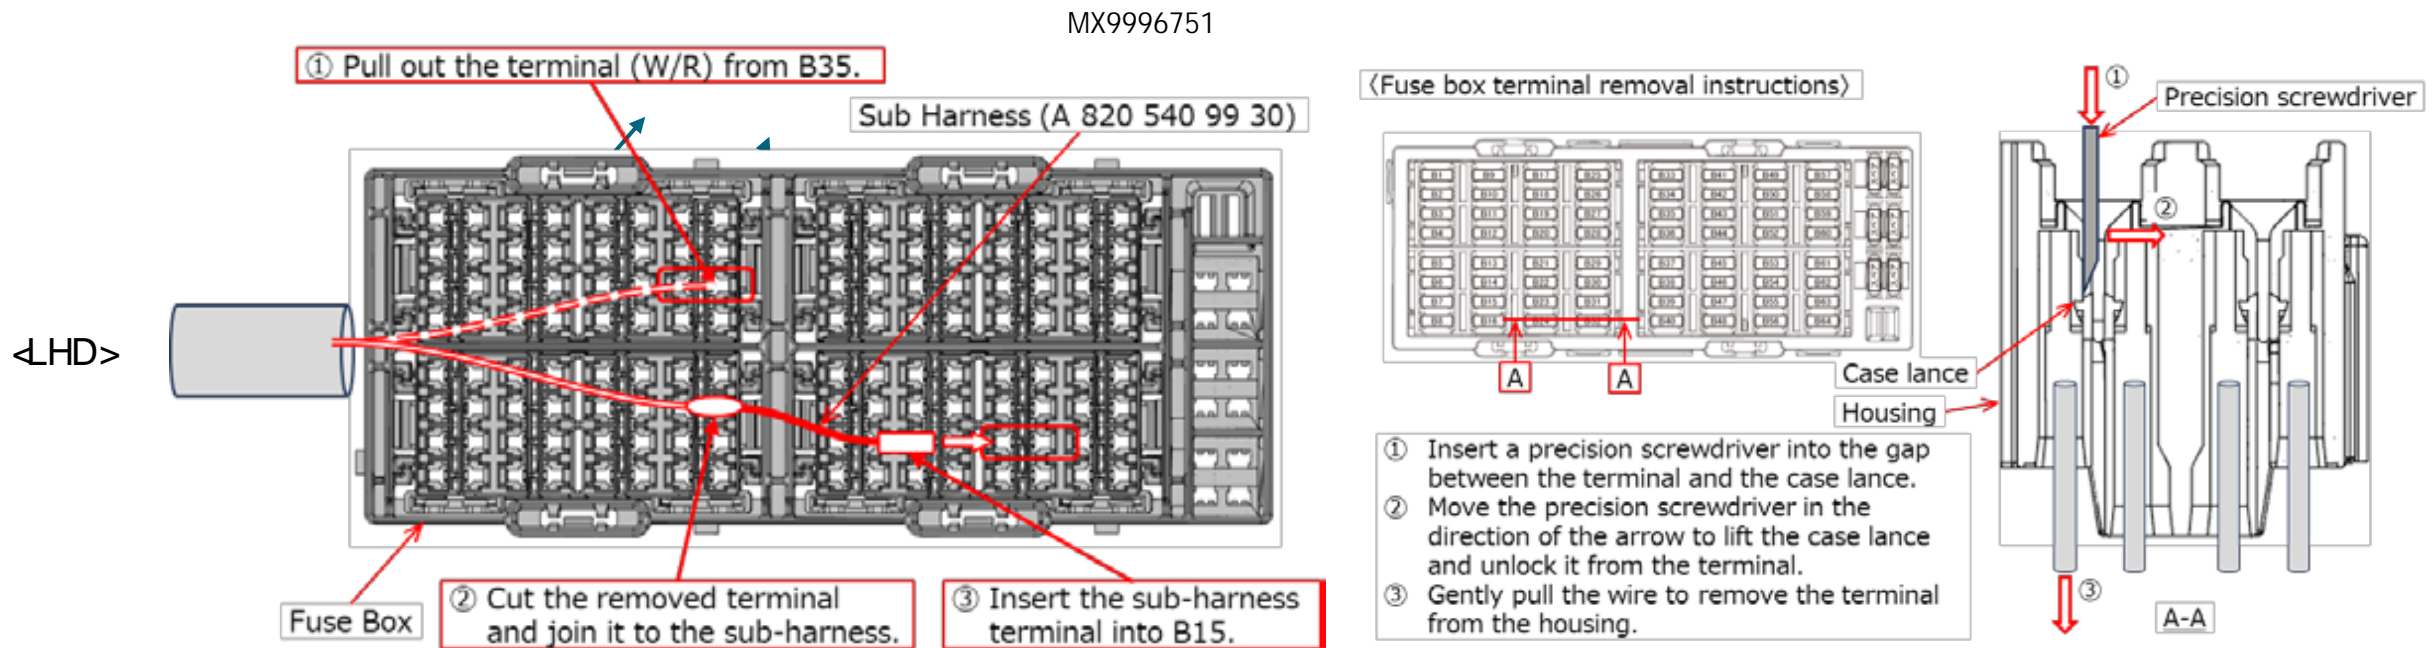
Remove the terminal (W/R) from B35 in the fuse box and connect to B15.(Only LHD : use the sub-harness to extend harness to B15)

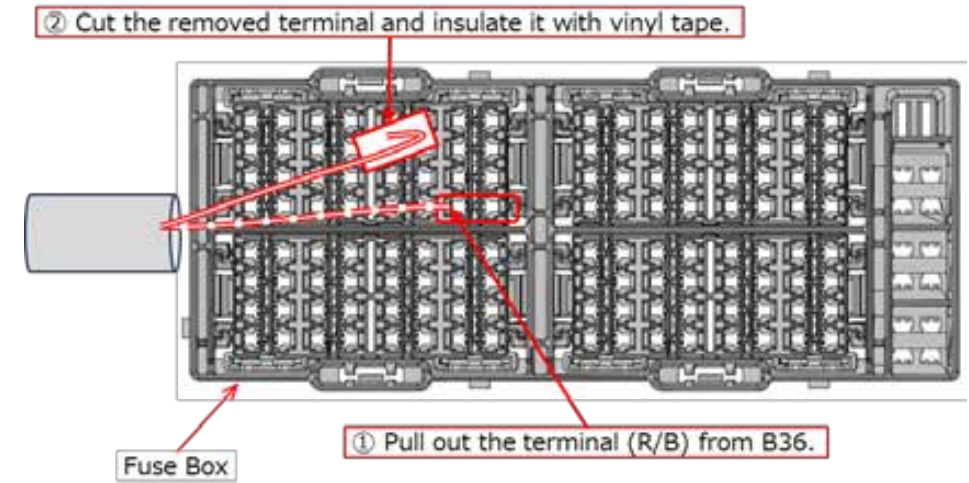
Step-7 :
Remove the terminal (R/B) from B36 in the fuse box, cut the terminal, and insulate it with vinyl tape.

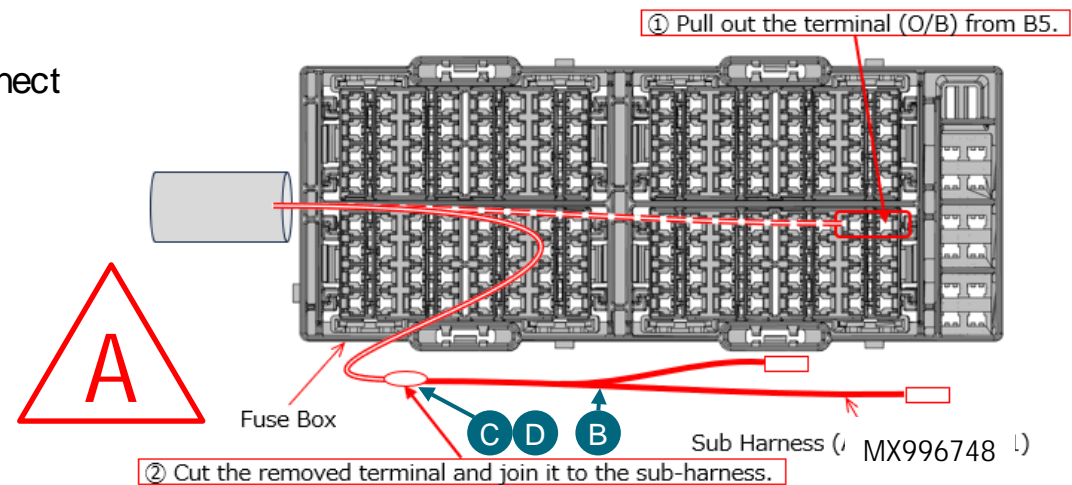
Step-8 :
Remove the terminal (O/B) from B5, cut the terminal, and connect it to the sub-harness.

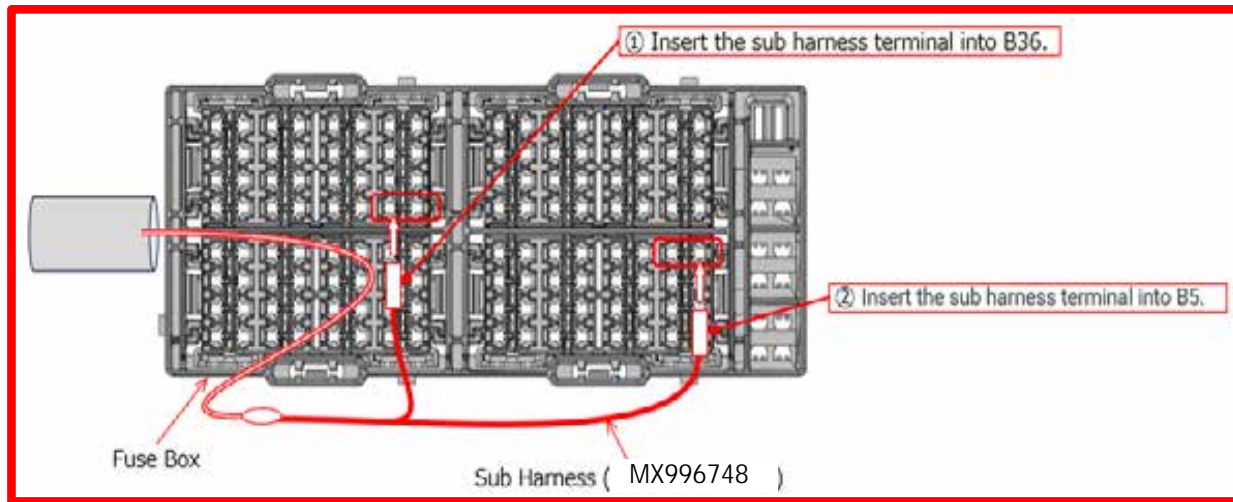
Step-9 : Insert the sub harness terminals into B36 and B5 of the fuse box. <LHD>

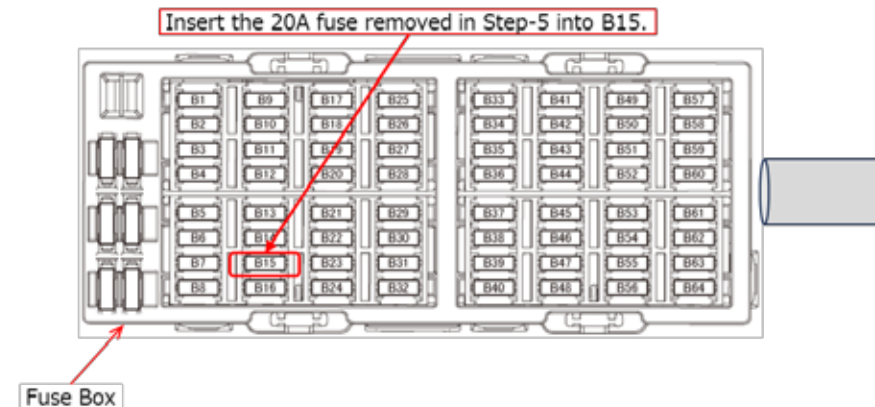
Step-10 : Insert a 20A fuse into B15 in the fuse box.

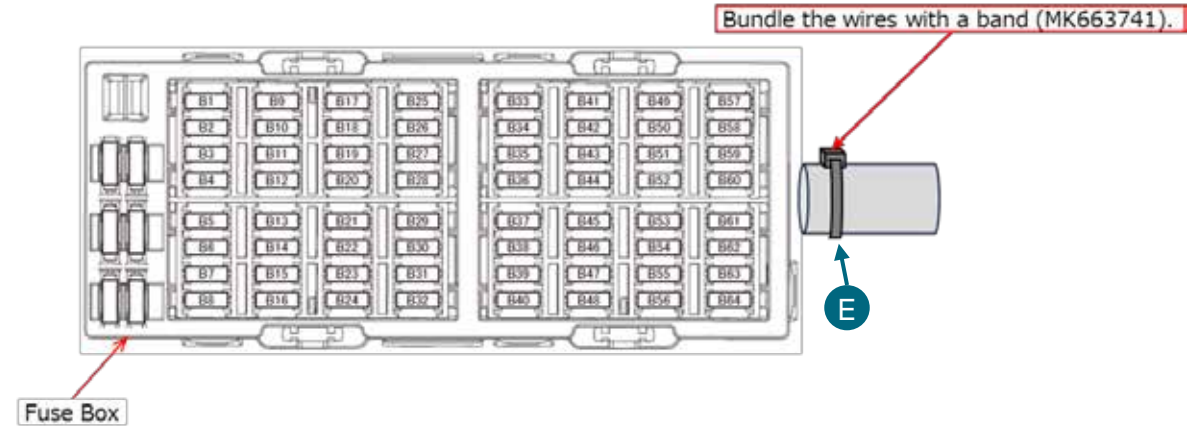
Step-11 :
Bundle the wires with a band (MK663741) and cut off the excess length of the band

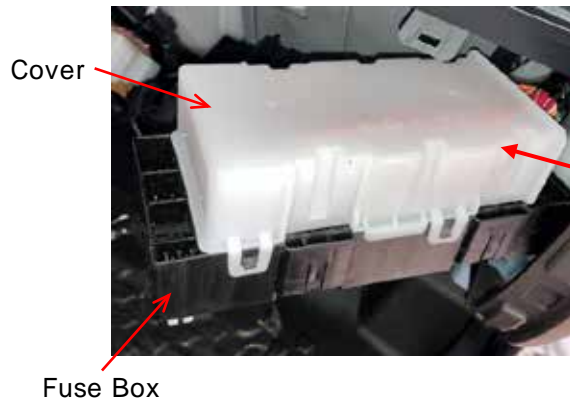
Step-12 :
Restore the vehicle by reversing steps 3 to 4. When installing the cover on the back of the fuse box, be sure to place the insulated wire and added sub harness inside the cover.

When installing the cover, be sure to place the insulated wire (Step-7) and added sub harnesses (Steps-8 to 9) inside the cover.

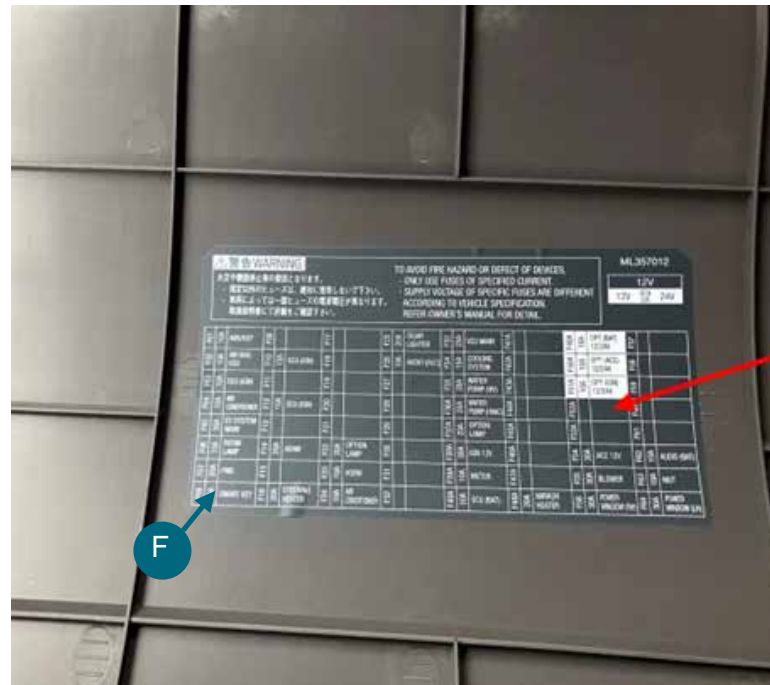
Step-13 :
Remove the fuse information label (MX995730) from the back of the passenger side panel that was removed in step-2 and paste the countermeasure parts.

Peel off the fuse label and paste the countermeasure parts.

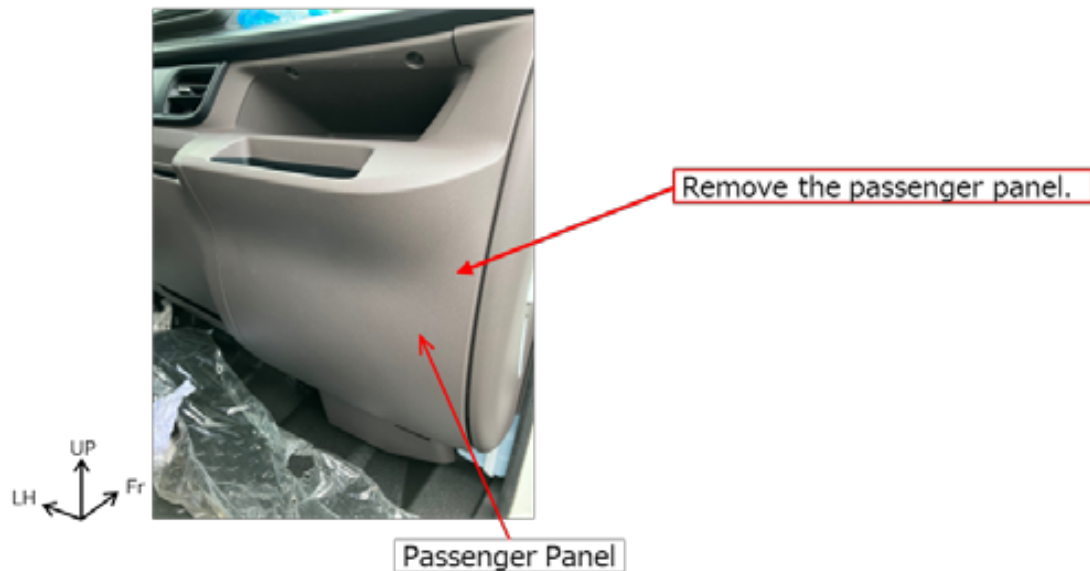
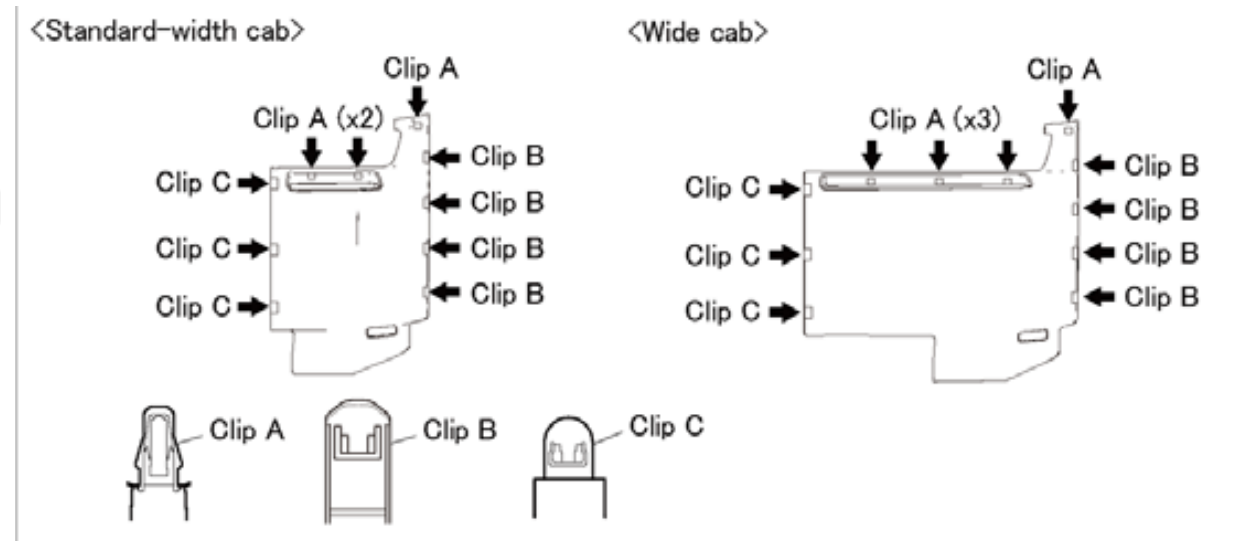
Step-1 :
Remove the passenger side panel.

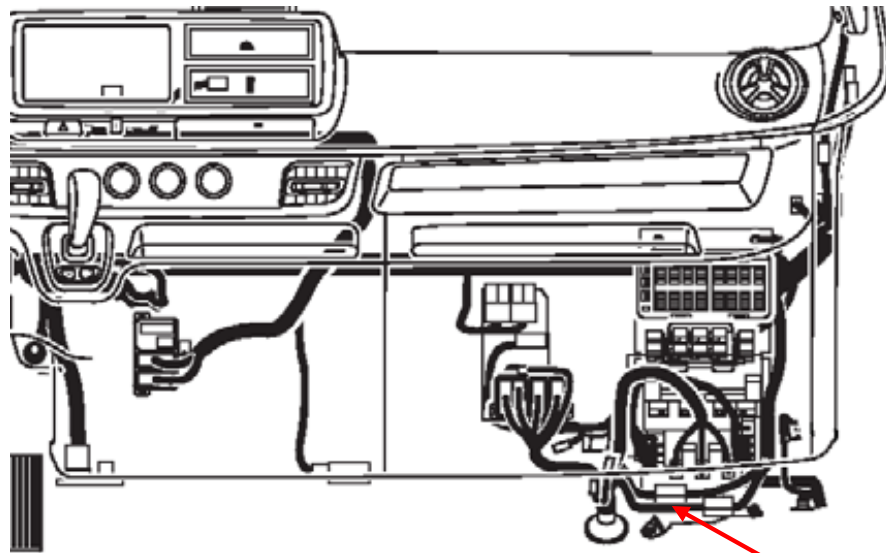
Based on the flow chart for the field fix action, check the condition of the C6 connector.

- If connector housing color change / melting / damage is found, go to Step-3
- If no abnormalities are found, restore the vehicle by reversing step 1 and the procedure is complete.

Check C6 connector condition

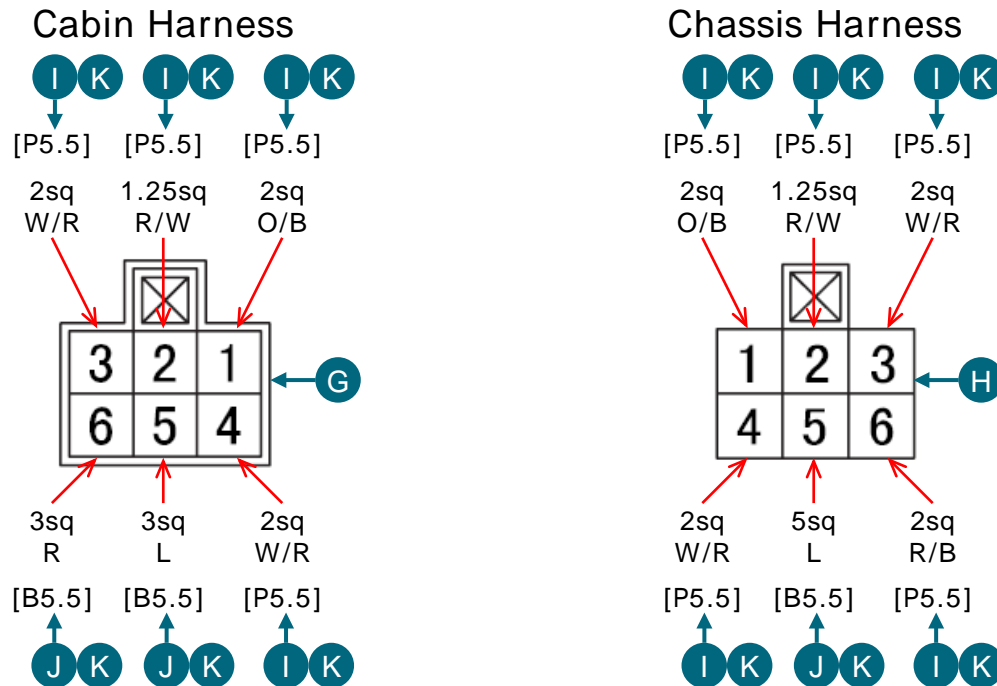
Refer to group 3-07 of 03DXX0001 in the Harness Repair Manual* and replace the parts according to the condition of the connector.

If only the connector housing is discolored but no deformation or other damage is found in the housing:

2 à Replace only the connector housing (do not use the terminal kit from the repair kit). **G H**

If the connector housing is melted or deformed:

3 à Replace both the terminal kit and the housing.

Please refer to the following for the joint terminals to be used.

(Please note that it is necessary to use P-Type or B-Type depending on the wire diameter.)

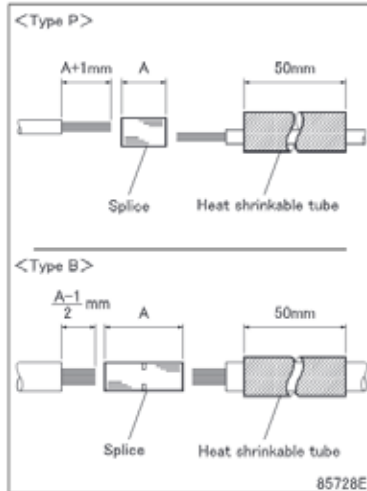
Slide a piece of heat shrinkable tube over the wire on one side, then strip the plastic insulation off the wire ends on both sides. (See *5. Stripping insulation off wires* in P1-20.)

Heat shrinkable tube
MC037692 (Inner diameter: 7.4mm)
MK410770 (Inner diameter: 7.5mm)

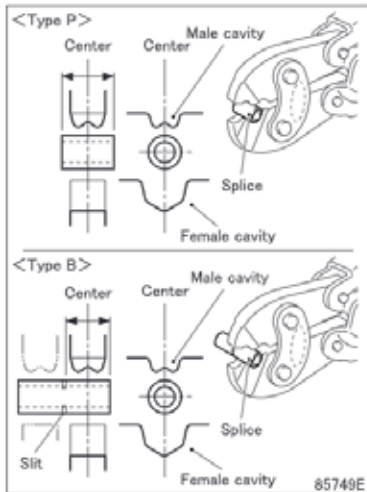
- Open the jaws of the wire clamping tool to a sufficient width.
- Place the splice sleeve on the crimping section of the wire clamping tool as described below, then gradually close the handles until the sleeve is held securely.

<Type P>
Center the splice on the crimping section of the tool.

<Type B>
Align the midpoint of one sleeve segment (section from sleeve end to center slit) with the longitudinal centerline of the tool.

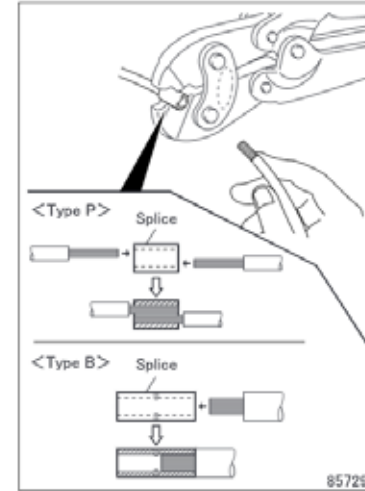
<Type P>

With the splice sleeve held in this position, insert the wires to be joined into the sleeve, one from each end, until the insulation-stripped sections of the wires overlap each other up to their root.

<Type B>

With the splice sleeve held in this position, insert each of the wires to be joined into the sleeve until the insulation comes in contact with the sleeve end face.

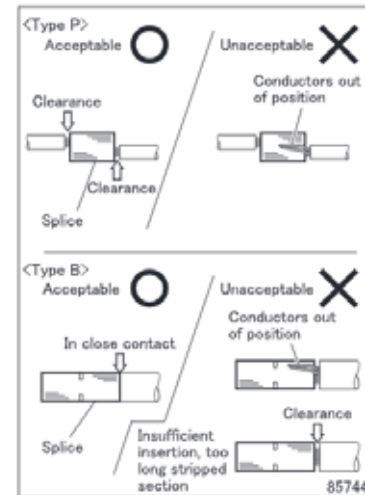
Condition judgment of wires inserted in splice.

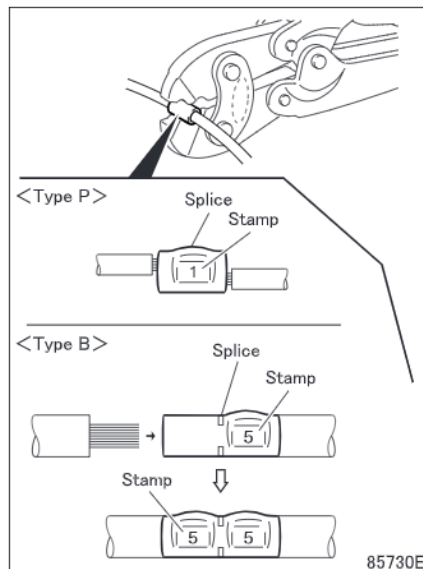
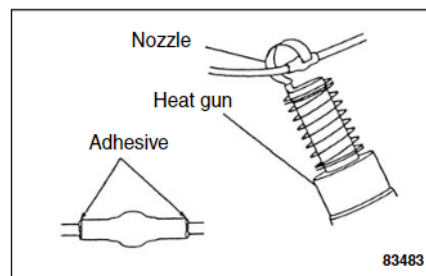
- Fully close the handles of the wire clamping tool. The handles will then come open again and the crimping operation will be complete.
- The area crimped with the wire clamping tool is stamped on the splice.

Area crimped	Stamp
1.25	1
2	2
5.5	5

- Make sure that the wire clamping force satisfies the values in the table below.

Wire size	0.5	0.85	1.25	2	3	5
Wire clamping force (N {kgf} or more)	88 {9}	125 {13}	165 {17}	245 {25}	345 {35}	390 {40}

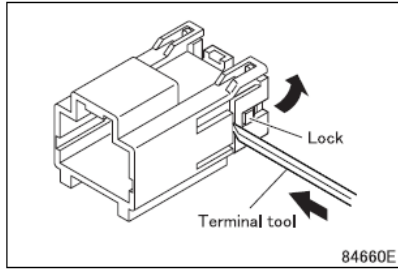
I Removal/fitting of retainer

- <Retainer for 4 or more pin>
- Insert the tip of the terminal tool (MH062845) into the gap between the retainer and the housing near at one of the two locks.
 - Pry up the retainer to release the lock.
 - Release the other lock on the opposite side in the same manner. Then, pull out the retainer while turning it.

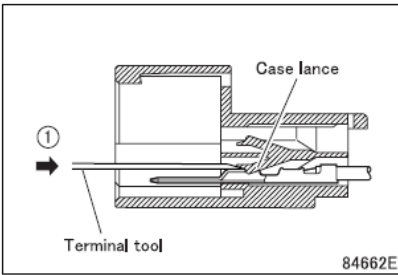
I Removal of terminal

- Removal of male terminal
- ① After removing the retainer, insert the tip of the terminal tool (MH062846) into the gap between the terminal and the case lance.

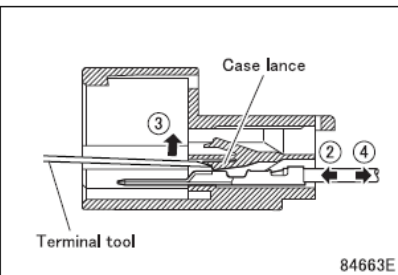
- ② Push in the terminal until it stops moving.
- ③ Move the terminal tool in the direction shown in the figure to push up and release the case lance from the terminal.

When pushing up the case lance, never allow the terminal tool to come in contact with the terminal. Contact may deform the terminal. The terminal then may be bent when the connector is mated with a female connector, which can cause the terminal to come out of position, resulting in poor continuity.

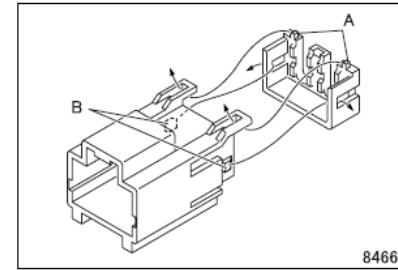
- <Retainer for 4 or more pin>
- Fit the projections A into the corresponding openings in the housing, then fit the projections B on the housing into the slits in the retainer.
 - Check to confirm that the retainer is held evenly on both sides and that it is firmly locked into the left and right arrester section on the housing.

If the retainer fails to be fitted into position, it is suspected that the terminal is not inserted fully into the housing or it is inserted upside down. Check to ensure that no such deficiencies are included.

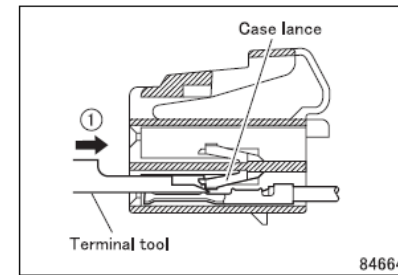
- Removal of female terminal
- ① After removing the retainer, insert the tip of the terminal tool (MH062844) into the gap between the terminal and the case lance.

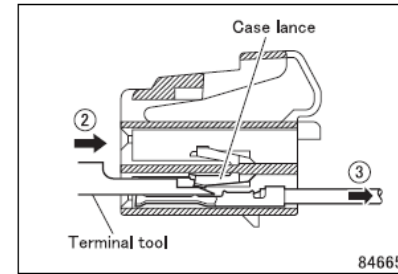
- ② Insert the terminal tool farther, and the case lance will be pushed up and the terminal will be unlocked.
- ③ Pull the wire gently to remove the terminal from housing.

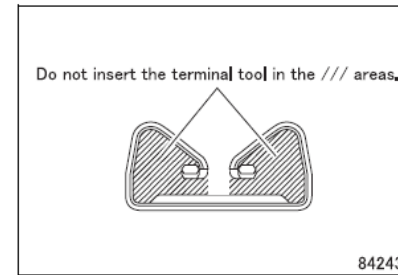
Never insert the terminal tool in the terminal socket. This can lead to deformed or damaged terminal contact and thereby to poor contact. If the terminal tool is inserted in the socket accidentally, always replace the terminal with a new one even if it appears to be free from any damage.

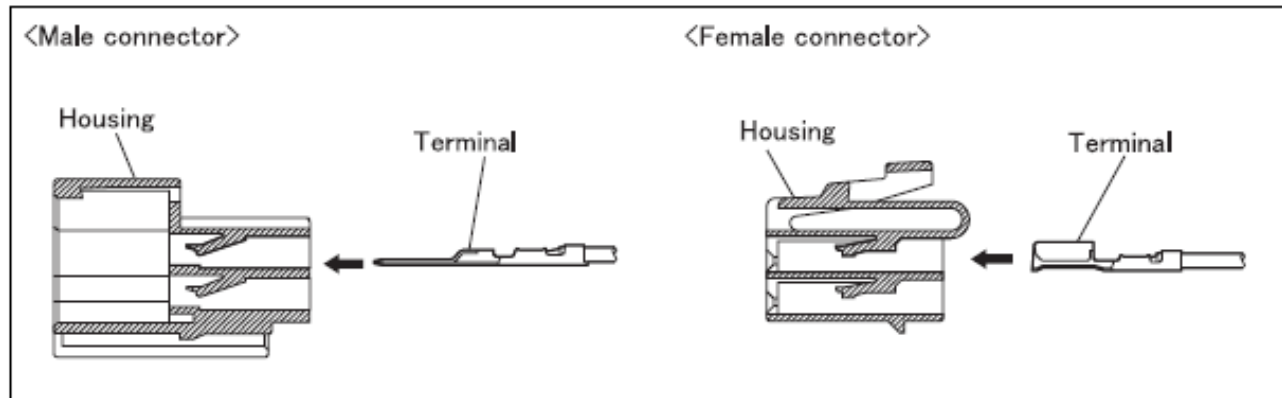
I Fitting of terminal

- Insert the terminal straight into the housing from the backward.
- Push in the terminal until a "clicking" sound for locking is heard.
- After completing the insertion, pull the wire gently to verify that the terminal is securely locked.

If the terminal falls to be fitted into position or if it comes out of position when pulling the wire after fitting, upside down fitted terminal, deformed case lance or deformed terminal is suspected. Determine the cause and replace the faulty parts if any. Then, repeat the steps.
