## Safety Recall 24V182 - Steering Gear Assembled Incorrectly

This notice applies to your vehicle with VIN {XXXXXXXXXXXXXXXX} - Chassis Serial Number { UE } XXXX

Kalmar has decided that a defect, which relates to motor vehicle safety, exists in certain Ottawa T2 model terminal tractors manufactured between June 30, 2023 - October 31, 2023. As a result of this decision Kalmar has initiated a recall of the affected vehicles.

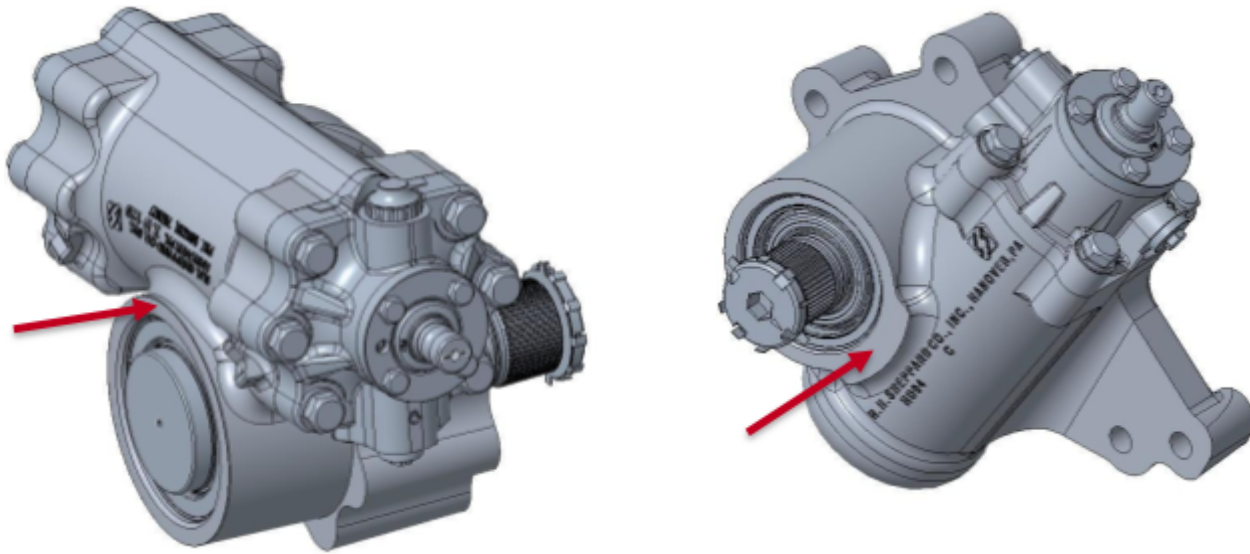
### Location of Serial Number

## Identify Steering gear mounted to truck

In order to remedy the situation, customers should inspect their steering gear for the serial number, see attached guide showing serial number location and then check the attached serial number list. If the serial number is on the list of suspect gears, contact your local Kalmar dealer. A new steering gear will be provided under warranty. The remedy should be performed at no cost to the customer and Kalmar / R.H. Sheppard will reimburse dealers for their work.

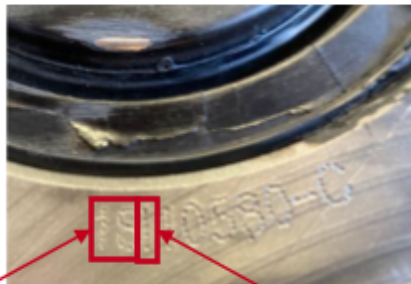
The serial number is a 2 digit year followed by an alpha numeric month Example pictures show 18H (2018 August)

Year of Manufacture

Month of Manufacture

Approximate location of steering gear part number

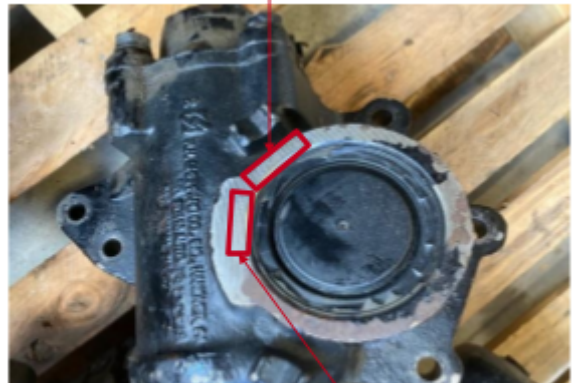
Approximate location of steering gear serial number

Typical steps to expose part number and serial number if not legible once surface is clean: rotary air tool with circular wire brush to remove paint
