Release Date: February 2024

Revision: 01

ConditionGeneral Motors has decided that a defect which relates to motor vehicle safety may exist in certain front-
driver airbag modules produced for use as service replacements for 2011 – 2012 model year Chevrolet
Silverado 1500, Suburban, and Tahoe vehicles. These front-driver airbag modules, which may have
been installed as service/replacement parts and not original equipment, may contain an inflator that was
built with a supplier-manufacturing defect that may prevent the proper deployment of the second-stage
of the airbag in certain high-speed crashes. If the vehicle is involved in a high-speed crash that triggers
the second-stage deployment of the driver frontal airbag, the inflator may not fill the airbag as completely
and as quickly as designed, which could lead to an increased risk of injury to the driver.CorrectionDealers will inspect the driver air bag module and replace if necessary.

GM Recall: N232432520

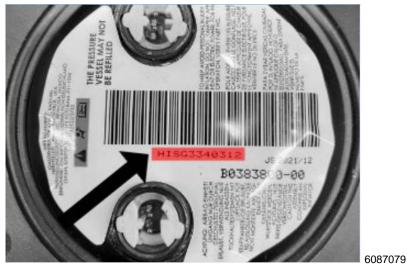
1. Remove the Airbag Steering Wheel Module. Refer to Airbag Steering Wheel Module Replacement in SI.

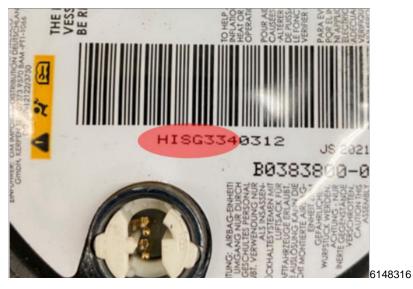
2. Locate the lot number on the back of the airbag inflator

- o If the lot number begins with HISG334, HITG334, OR HIUG333, proceed to step three.
- If the lot number does not begin with HISG334, HITG334, OR HIUG333, no further action is required. Record the serial number of the steering wheel airbag. Reinstall the steering wheel airbag assembly. Refer to Steering Wheel Airbag Replacement in SI.
