SIB 77 01 24

RECALL 24E-029: REWORK VARIO SIDE CASES AND INFO774190:  
REWORKING CENTRAL LOCK

## 0M21 - R 1300 GS

### 00 60 442 Replacing Vario case retaining hook and hinges

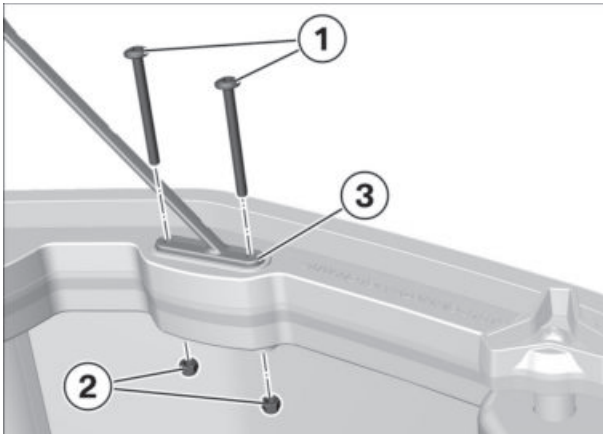
#### 1

#### ► Removing case lid

- Open the lid of the case.
- Remove screws (1) and nuts (2).
- Loosen securing band (3).

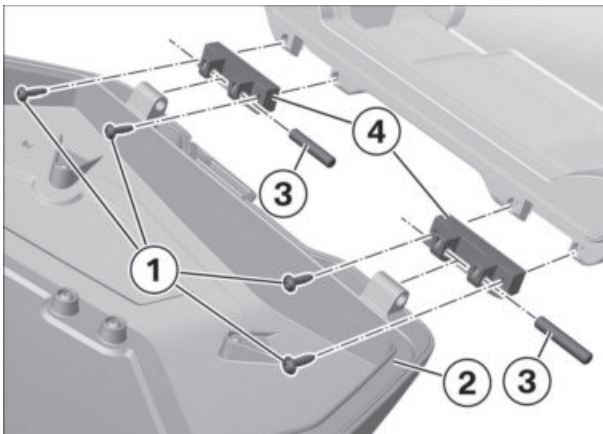
- Remove screws (1) and take off case lid (2).
- Remove bolt (3), take off hinges (4).

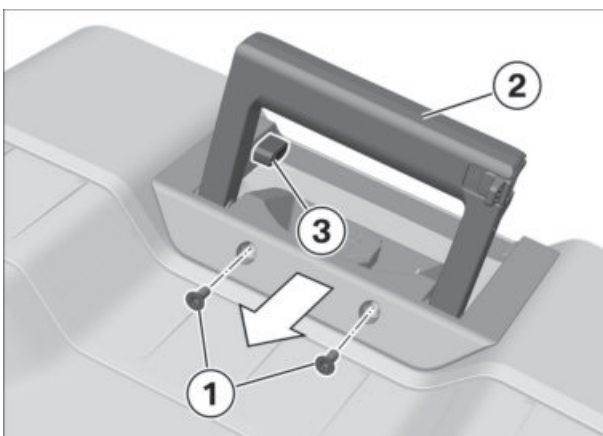
#### 2

#### ► Removing carry handle for case

- Fold carry handle up.
- Remove screws (1).
- Push carry handle (2) in the direction of the mount and remove upwards noting release button (3).

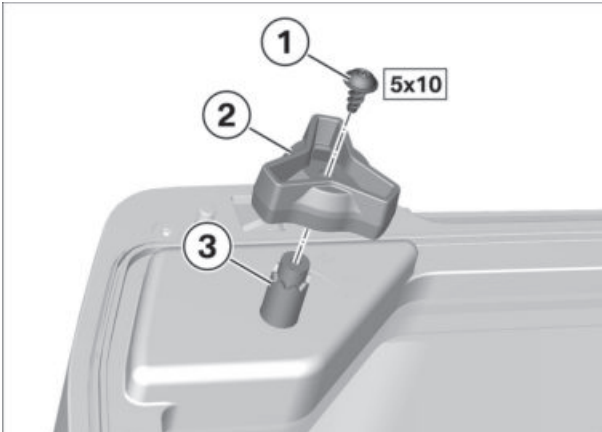
## 3

► **Removing outer frame**

- **Extend the case to its maximum dimensions.**
- Remove screw **(1)**, remove adjuster knob **(2)** from shaft **(3)**.

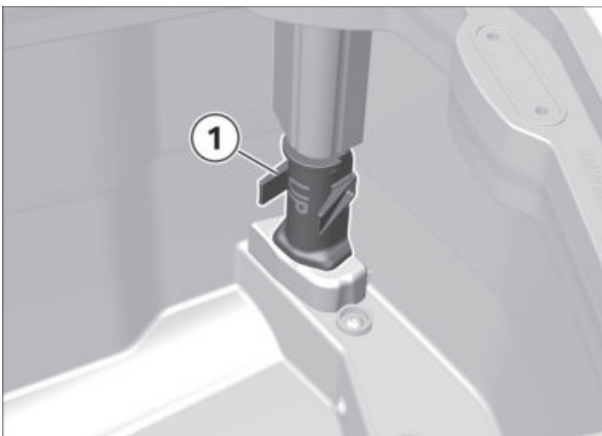
- **Secure support (1) in case.**
  - At one of the short adjustment pillars, designation **UP** must face upwards.
  - Support **(1)** must engage securely.
  - » Insert must not drop later on.

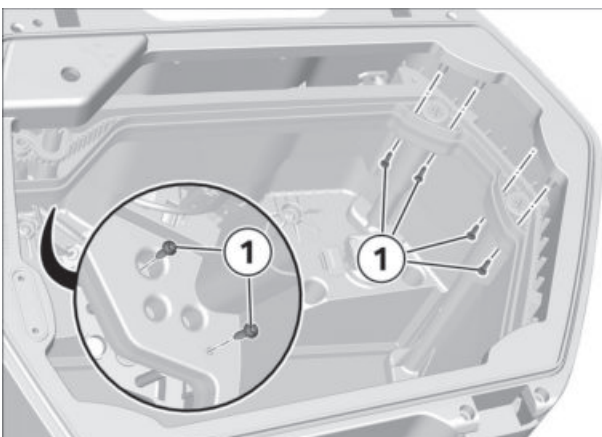
- Remove screws **(1)**.

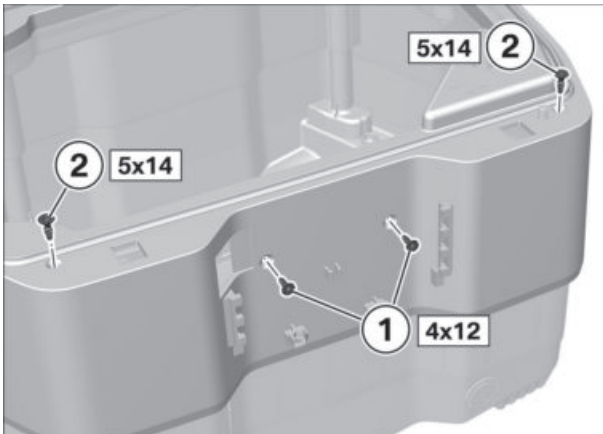
- Remove screws (1).

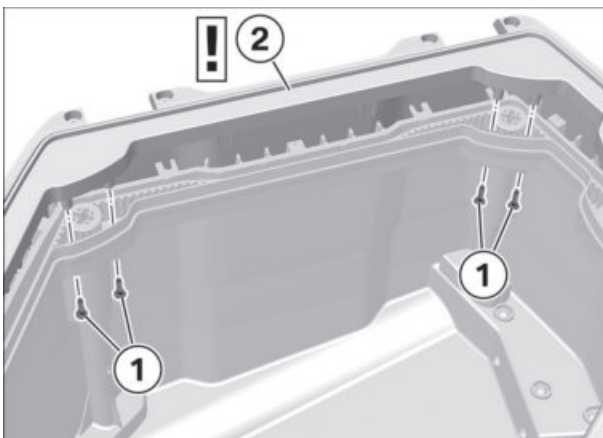
- Remove screws (1).
- Remove outer frame (2) by lifting upwards, taking care not to tilt it.

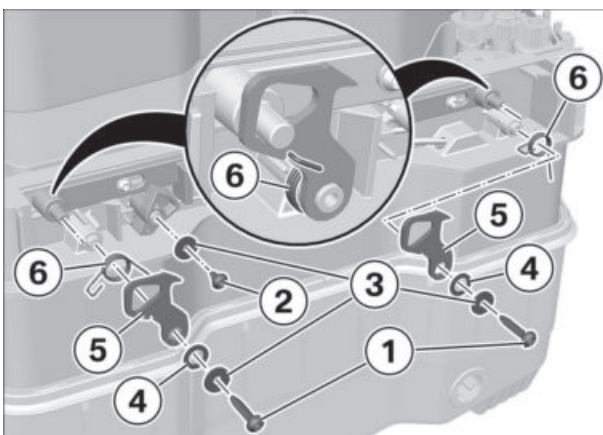
## 4

### ► Removing locking hook

- Remove screws (1) and (2), remove washers (3).
- Remove shims (4).
- Remove locking hook (5) with springs (6).

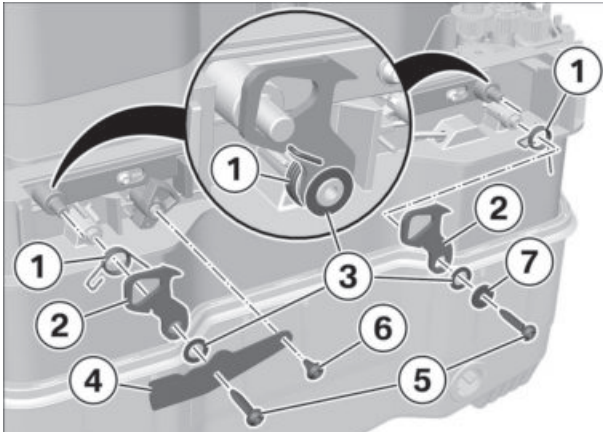
5

► **Installing lid hook and reinforcement panel**

- Install springs (1), lid hook (2) and shims (3).
  - Insert lid hook (2) in opener slider.
  - Shims (3) are correctly seated on the axles.
  - Both washers on the left (side with eccentric shaft) are omitted.
- Position reinforcement panel (4), install screws (5) and (6).
- Install washer (7) (only on right) and screw (5).
- Check lid hook (2) for ease of movement, loosen screw slightly if necessary.

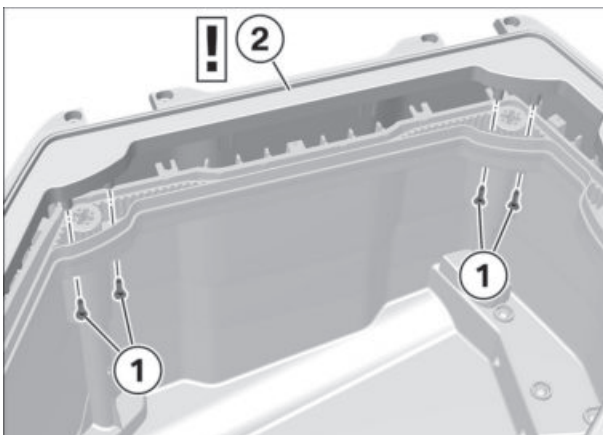
6

► **Installing outer frame**

- Place outer frame (2) evenly, taking care **not to tilt it**.
  - Counter-hold adjusting frame, toothed belt must not slip off guide pulley.
- Install screws (1).

Tightening torques		
Outer frame to adjusting frame		
Inside	1.6 Nm

- Use new screws from the repair kit (approx. 2 mm longer)

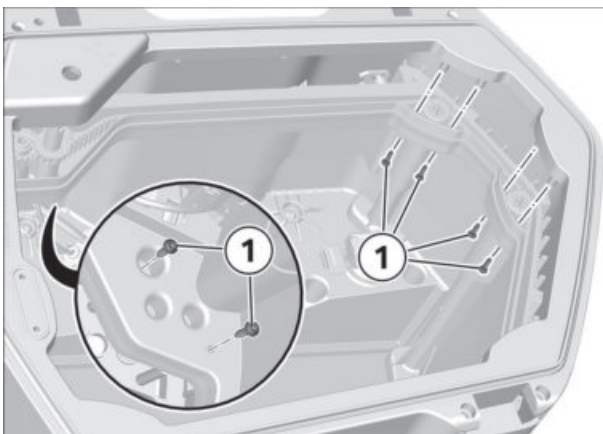
- Install screws (1).

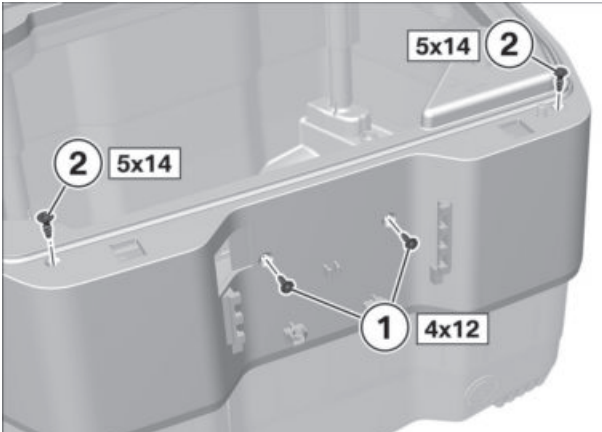
- Install screws **(1)** and **(2)**.

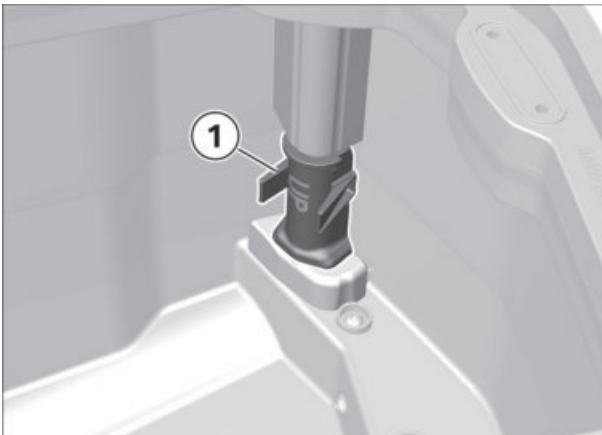
- Remove support **(1)**.

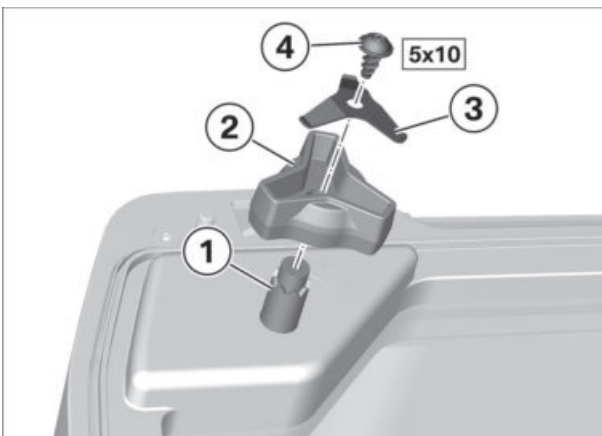
- Do **not** clean lubricating material off shaft gearing **(1)**.
- Install adjuster knob **(2)** with spring **(3)**.
  - Arms of spring must press on adjuster knob.
- Install screw **(4)**.
  - Bring cases together using adjuster knob **(2)** if necessary.
  - **Install the screw hand-tight, then loosen by 90°.**

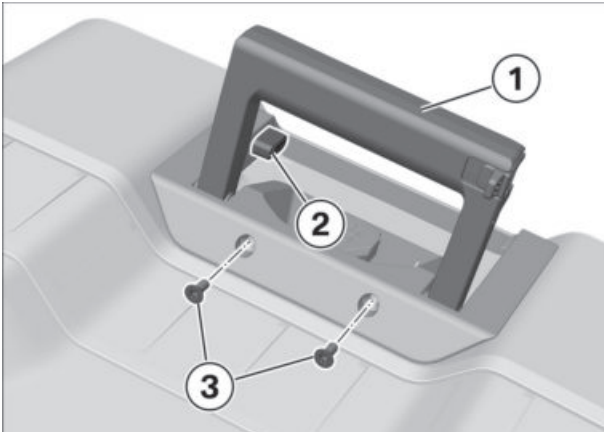
## 7

► **Installing carry handle for case**

- Align carry handle (1) with release button (2).
- Install screws (3).
  - M4 × 10 countersunk head screws
- Check function of release button.

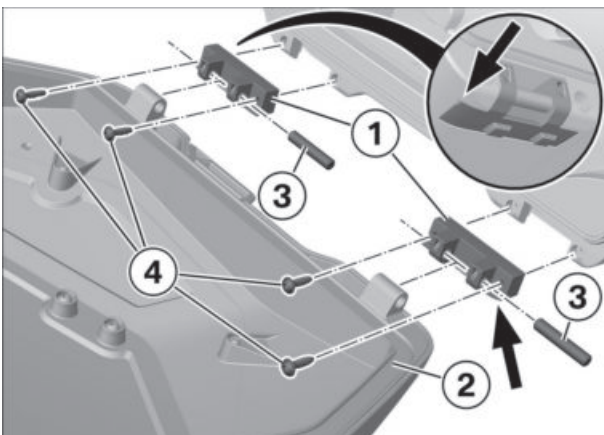
## 8

► **Installing case lid**

- Replace hinge at rear in direction of travel.
- Position hinges (1) on case lid (2) and install bolts (3).
  - Install hinges on the basis of the outer contour (arrows)!
  - Hinges for **left case** are marked with **LH**, hinges for **right case** with **RH**.
- Position case lid (2) on case and install screws (4).

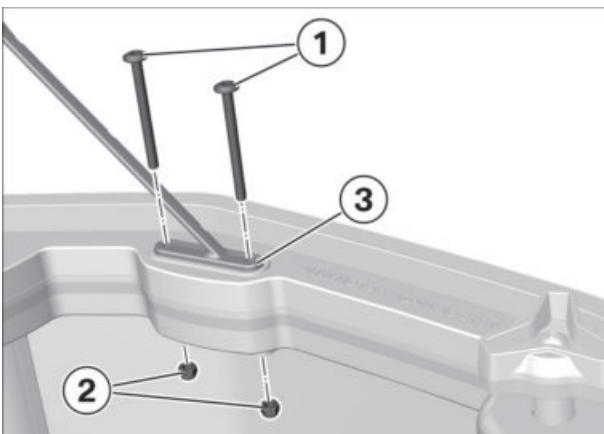
- Align securing band (3) and install with screws (1) and nuts (2).
- Closing cases.

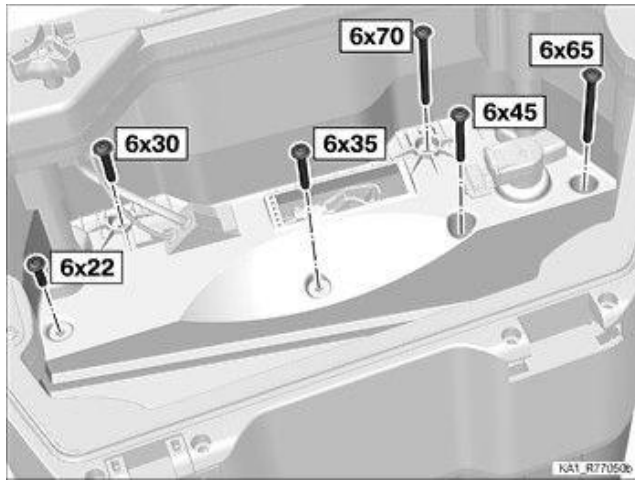
### Loosening case latch

- Open the case.

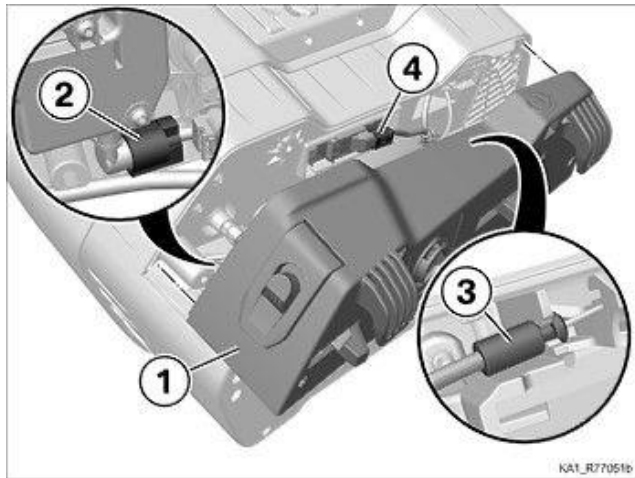
- Remove the screws.
