Ekko ASA Blind Spot Update:

Part required - SC7843-24-705 Ekko Blind Spot Upgrade

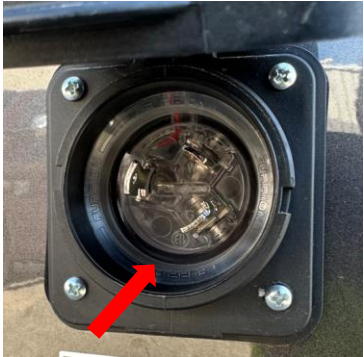
Image 1

1. Disconnect the 110v power cord from the coach, **See Image 1.**
2. Turn off the house disconnect switch, **See Image 2.**
3. Turn off the 12v battery 250-amp main breaker/breakers, **See Image 3.**
4. Turn off the inverter disconnect, **See Image 4.**
5. Turn off the 12v house battery/batteries by holding down the power button on the top of the battery/batteries for 3 seconds. Make sure the blue LED lights are off, **See Image 5.**
6. Allow for engine bay area and exhaust to cool.

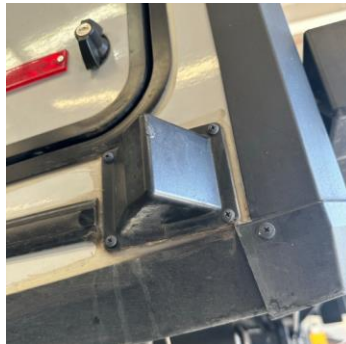
Image 1

1. Locate the ASA blind spot monitor sensors located at the rear of the coach, **See Image 1.**
2. Under the coach, disconnect the blind spot sensors from the original ASA harness.
3. Starting from the rear and working towards the engine bay, pull the harness out of P-clamps or cut zip ties as necessary. Make note of the routing of the original harness as this will be roughly followed by the new harness.
4. Gain access to the ASA ECU module, located under the steering column in the dash area. Access can be achieved by removing the closeout panel - attached via clips, below the steering column. **See Image 2**, Yellow arrow for ECU module location.
5. Disconnect the harness 16-pin plug from the module.
6. Cut all 5 butt splices made between the ASA harness and the Winnebago harness. Leave part of the ASA harness for easy identification when reconnecting the new harness. **See Image 3.**

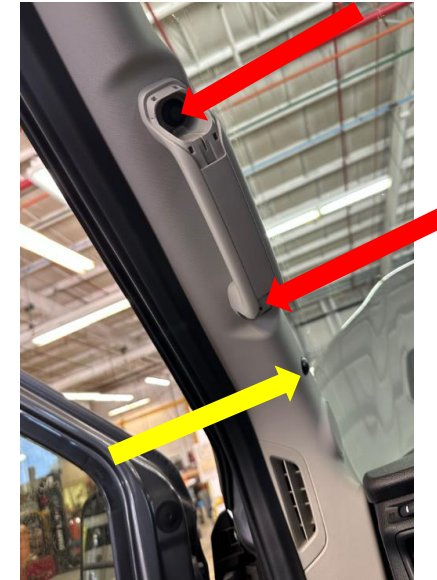
Image 2

- b) The GPS module and left LED connectors are both routed toward the driver side A-pillar, **See Image 1 and 2**, Yellow arrows for respective component locations. Remove the Driver side assist handle using a 10mm socket on the two mounting bolts, **See Image 2**, Red arrows. Using plastic trim tools or by hand, detach the Driver side A-pillar cover which is now secured only by tabs, **See Image 3**. Additionally, remove the Driver side dash cupholder by rotating to disengage the mounting features and pulling out, **See Image 4 and 5**. With these removed follow the wires and locate the connectors for each component. Disconnect and pull the ASA harness side back through leaving the components in place.

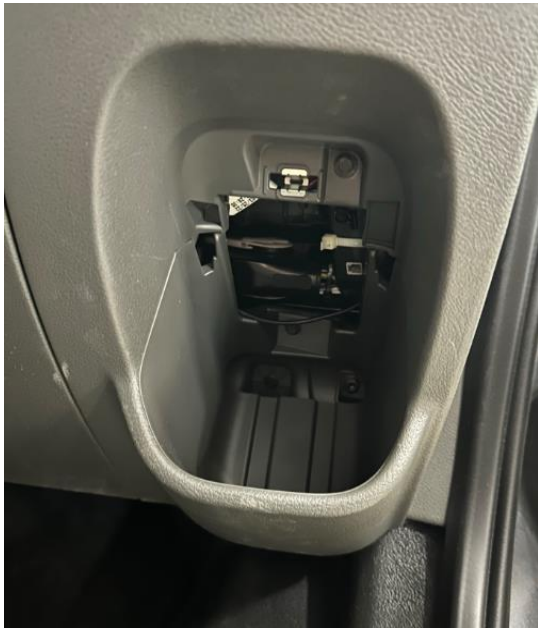
c) The right LED connector is routed toward the passenger side A-pillar. Remove the same parts as listed in b), along with removing the passenger side stepwell cupholder and center console covers, **See Image 1 and 2**. The glove box can also be dropped down to gain additional access, **See Image 3**. With these removed follow the wires and locate the 2-pin connector for the LED. Disconnect and pull the ASA harness side back through leaving the LED in place.

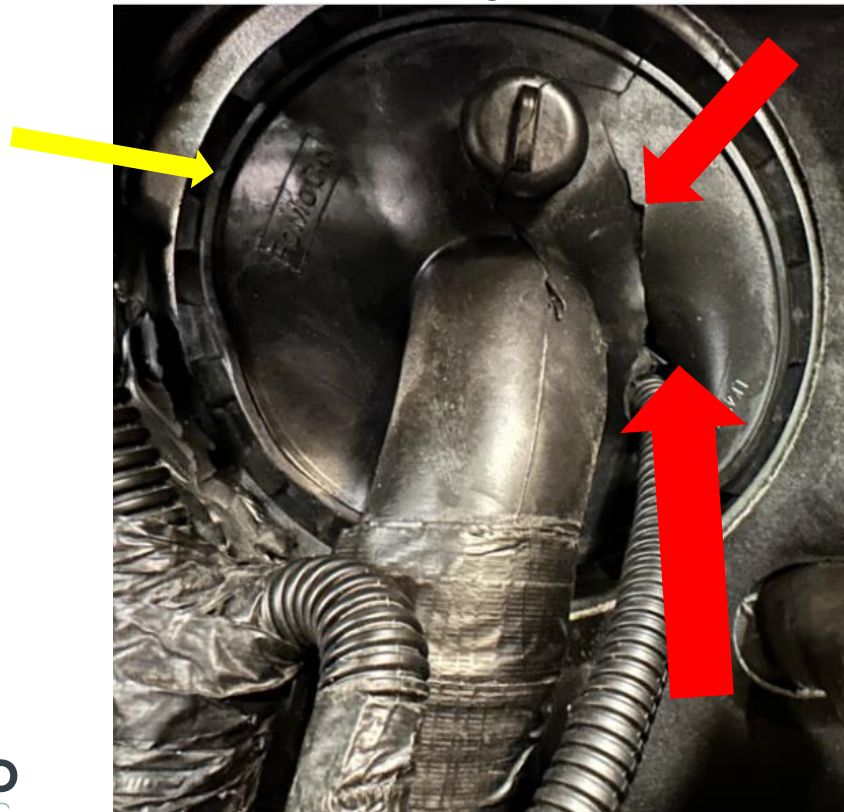
Image 1

1. With the ASA harness removed, there still may be some Winnebago harnesses passing through the firewall outside of the Ford grommet. If this is the case, disconnect the harnesses and pull back until nothing is passing between the grommet and the firewall, ensure the grommet is fully seated in the cutout, **See Image 1**, Yellow arrow.
2. Mark and cut a roughly 2" slit into the Ford grommet, ensuring that no wiring is damaged in the process and the integrity of the grommet is retained. Be careful as there is both Ford and Winnebago harnesses on either side of the grommet, **See Image 1**, red arrows.
3. If any Winnebago harnesses were disconnected, pass them through this new opening in the Ford grommet and reconnect, **See Image 2**.

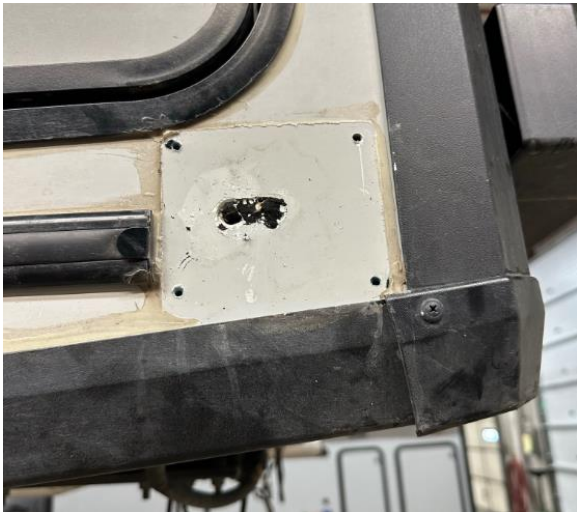
1. At the rear of the coach, use the screw gun with #2 Philips bit to remove the 4 screws mounting each blind spot sensor to the sidewalls. Use a putty knife and surface cleaner as needed to remove the sensors and clean away any residual sealant to ensure a clean and smooth mounting surface, **See Image 1 and 2.**

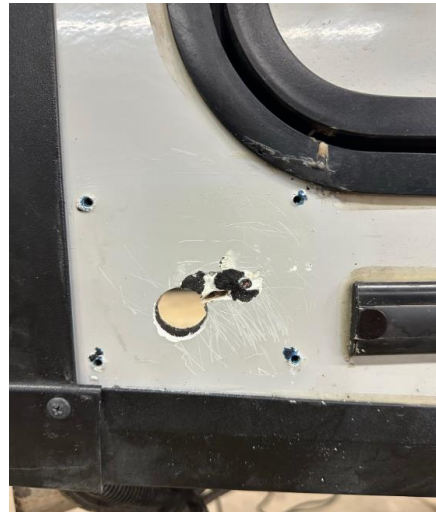
Image 2

2. Using a drill equipped with a 1"-hole saw, cut hole for the new blind spot sensor wiring. Locate this hole on the rearward side of the original sidewall slot, **See Image 2.** Drill from underneath the coach on the inside of the sidewall towards the exterior to ensure you go through the correct area of the sidewall tube, **See Image 3 and 4.** As you cut, be careful not to apply excessive force or drill speed to avoid damage to the exterior fiberglass. Once cut, use a half round file to clean up the hole and ensure no sharp burrs or edges are present to potentially damage the sensor wire.

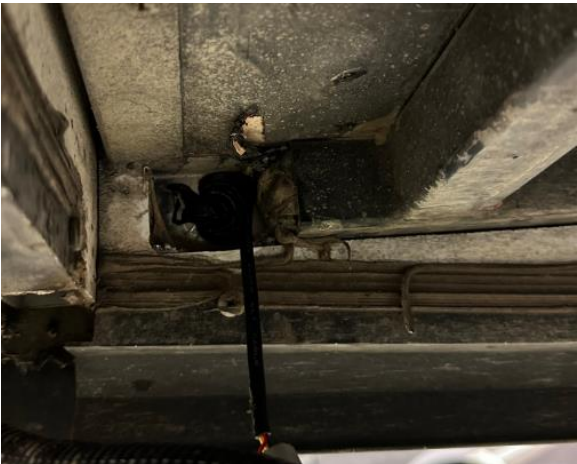
Image 1

- b) Cap sealing the sensor to the sidewall is not necessary.
2. Use sealant to seal the 1" holes from beneath the coach, **See Image 1**. Tool to ensure no water intrusion into sidewall.

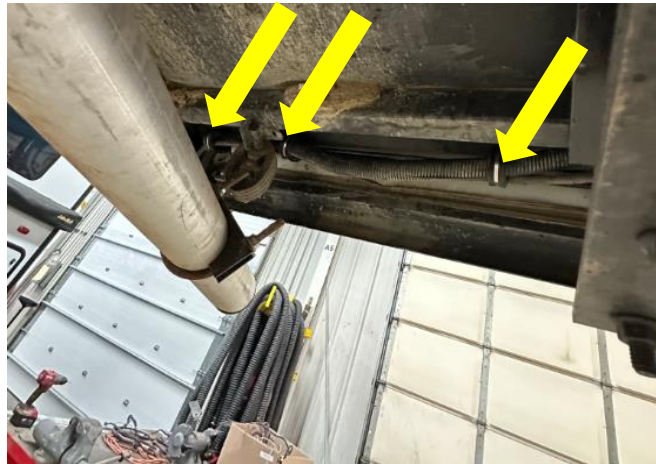
Image 2 – Passengers Side

3. Connect the sensors to the correct plugs in the harness. Harness branches are labeled for left or right.
4. At the backwall, secure immediately before and after the connector with P-clamps, and at least every 18" as the branches follow the backwall. Clamps should be screwed up to the metal tubes or trim, do not screw into the floor as it has minimal screw retention. If other clamps or screw-mounted zip ties are fastened to the floor, replace with a P-clamp fastened to a metal tube. Ensure the harness is fully secured up and away from the exhaust, **See Image 2 and 3**, Yellow arrows.

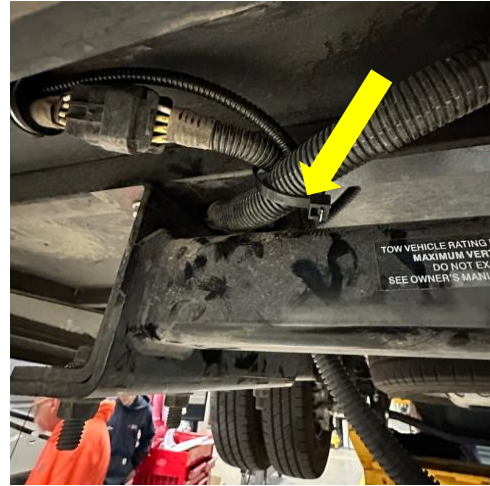
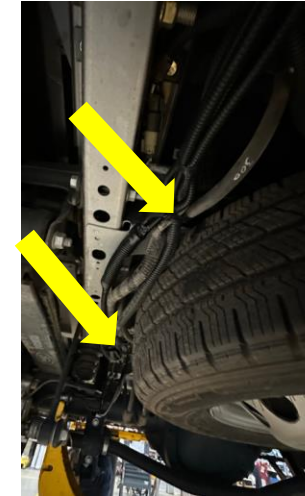
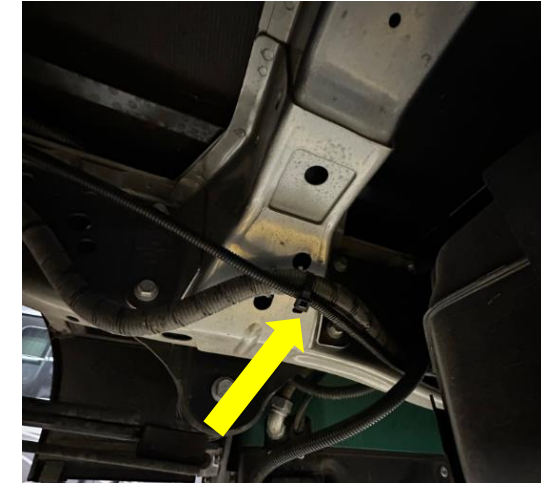
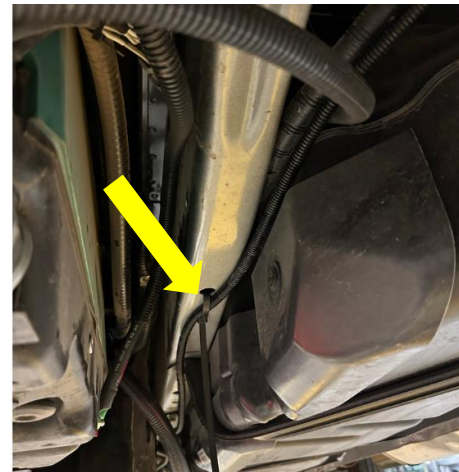
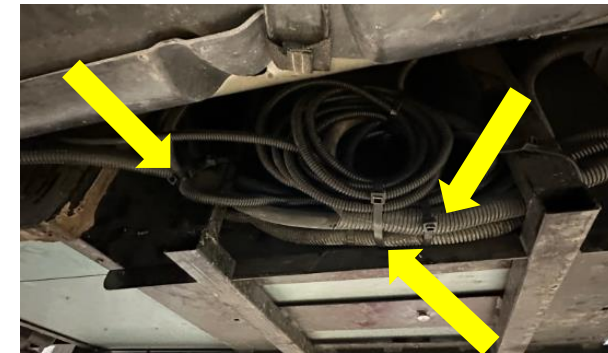
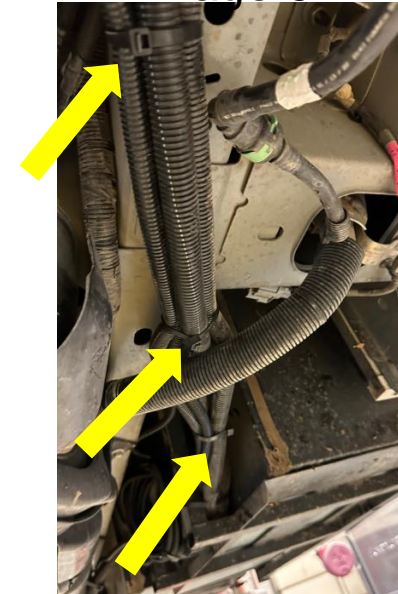
1. From the backwall, follow the original ASA harness path with the new ASA harness, secure at least every 18" with zip ties to the other below floor wire looms and/or chassis frame mounting holes, **See Image 1 through 6** which are in order starting from the hitch and ending just forward of the battery compartment and show examples of zip tie locations. Yellow arrows highlight zip ties that were added to support harness.
 - a) Ensure the harness does not have freedom to sag down or chafe during coach operation.
 - b) Support harness at least every 18".
 - c) Coil excess ASA harness length and secure between the battery compartment paneling and the tube structure supporting it, **See Image 5**.

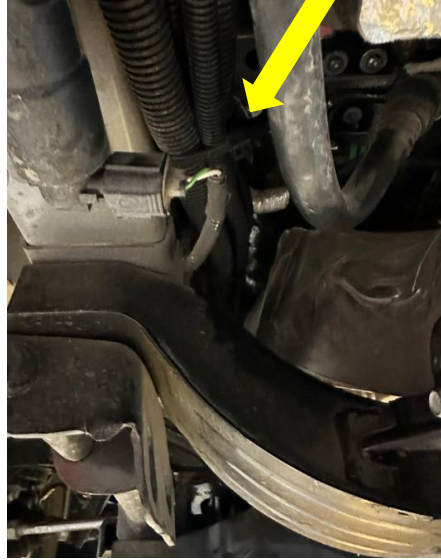
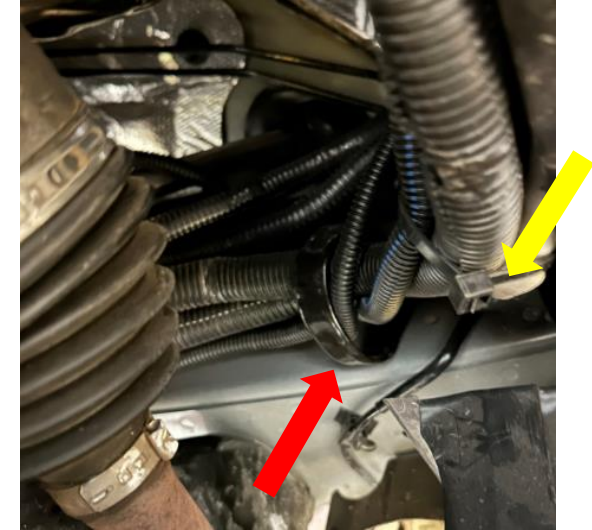
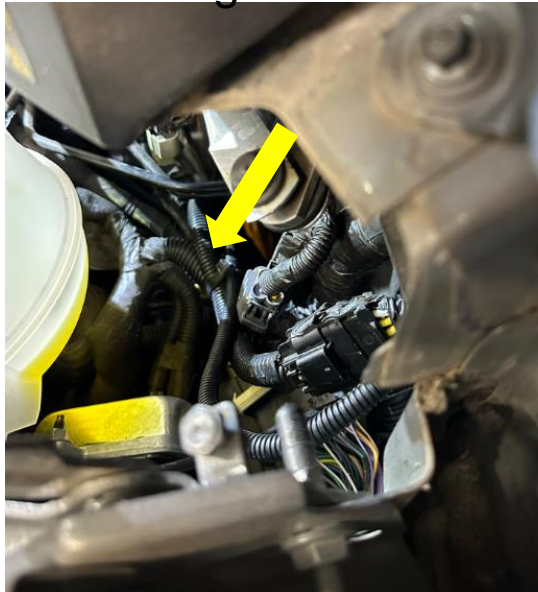
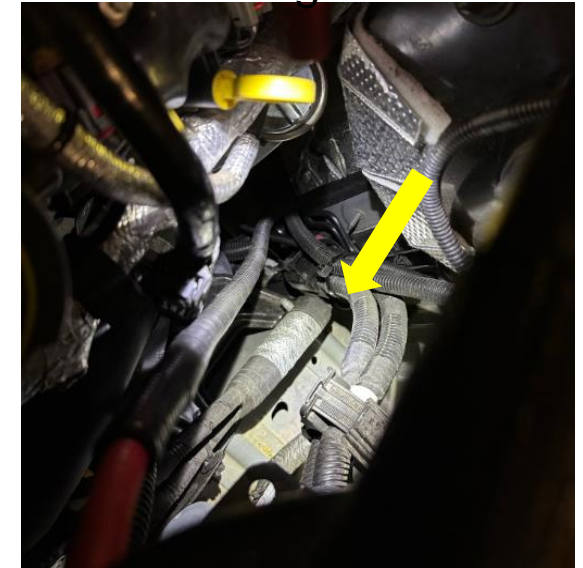
1. As the harness reaches the engine bay area, ensure it cannot contact any hot or moving components. Follow Winnebago harness bundles and secure every 18" or closer to ensure a safe wire path, **See Image 1 through 4** Yellow arrows, which are in order from forward of the battery compartment to just before the Ford firewall grommet.
2. If the Ekko Charging Recall #174 was completed there should be a 2.5" P-clamp over the driver side of the front axle; ensure the harness passes through this P-clamp, **See Image 2**, Red arrow. If the clamp is missing, check the serial number for any other open Recall or Service Campaigns.
3. Pass the harness through the firewall using the previously created cut into the Ford grommet.

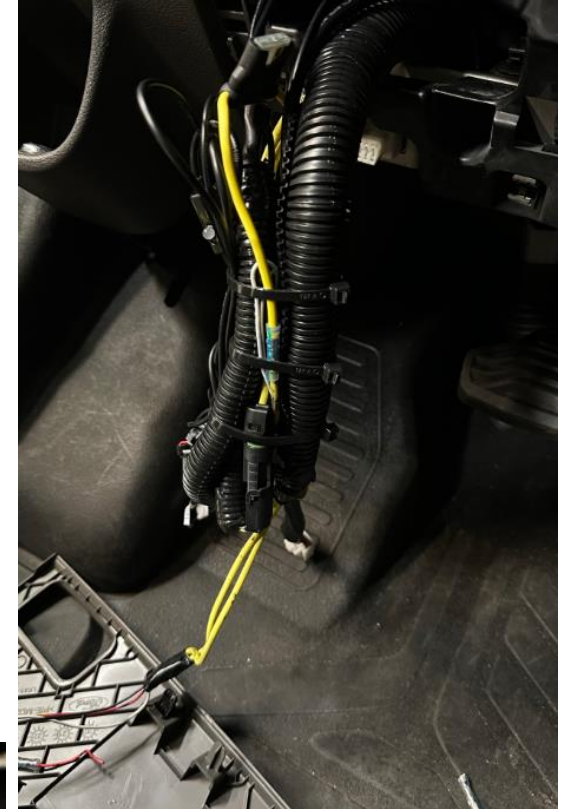
Image 1

1. Connect the passenger side LED to the harness branch labeled 'Right LED'. Follow the original harness path from under the steering column, under the center console, behind the glove box, and up to the A-pillar.
2. Secure excess wiring with zip ties to ensure no wires are visible to the owner and the wire will not get pinched, chafed, or otherwise damaged during reinstallation or operation of the coach, **See Image 1** for example of excess cable management.
3. Reinstall all Ford plastic trim components, cup holders, and assist handles.
4. In the engine bay, use sealant to seal around the cut in the Ford grommet and any harness passing through it. Tool to protect from water intrusion into coach, **See Image 2.**

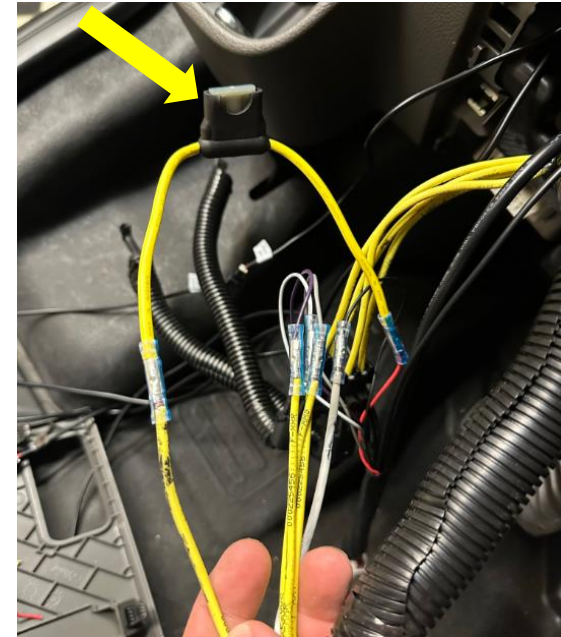
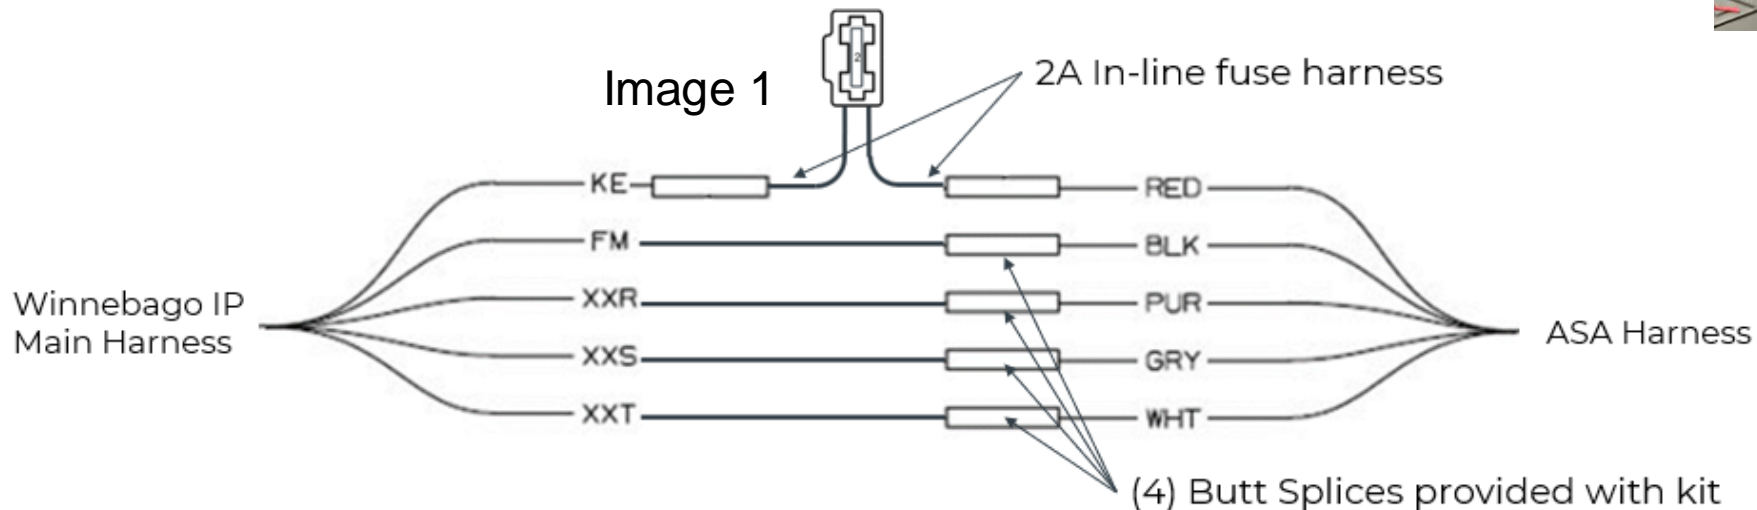
Image 2

1. Connect the ASA harness 12 pin connector to the ASA ECU module.
2. Make the 5 butt splice connections between the ASA harness and Winnebago harness under the steering column, **See Image 1**.
 - a) Check for a 2A fuse attached to the red/ power KE circuit underneath the steering column. If it is not present, add the 2A in line fuse between the Winnebago harness and the ASA harness, **See Image 2** Yellow arrow.
3. Connect the ASA harness branch labeled 'Buzzer' to the Buzzer under the steering column.
4. Connect the driver side LED and GPS module to their respectively labeled branches. Follow the original harness path from under the steering column up to the A-pillar.

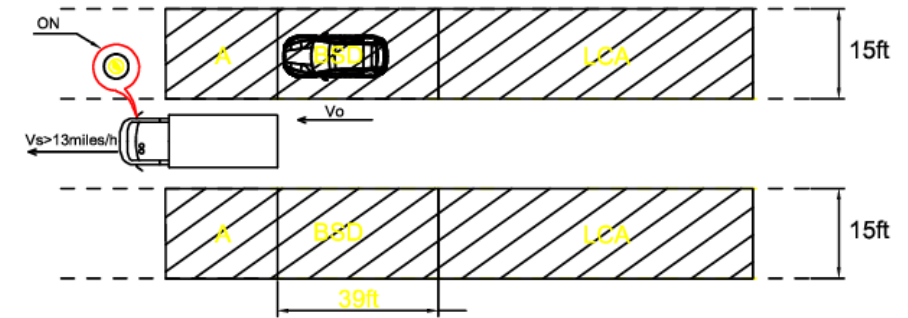
a. The warning light will be lit if there's approaching target vehicle ($V_o > V_s$) in BSD detection area.

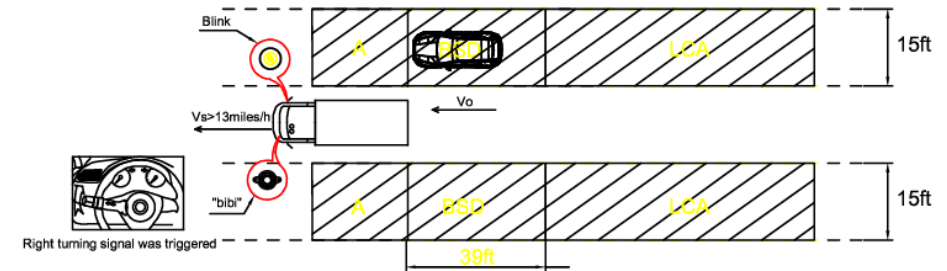
d. If LED lit, and then turning signal was triggered, LED will blink; the buzzer will give out "bibi" warning beep.
