GROUP	MODEL
Safety Recall Campaign	2023-2024MY Sportage (NQ5a) and 2022-2024MY Carnival (KA4) <u>without Roof Rails</u>
NUMBER	DATE
SC292 (Rev 2, 07/24/2025)	March 2024

### ROOF MOLDING INSPECTION, RETENTION AND REPLACEMENT (SC292)

This bulletin provides information to inspect and, if necessary, secure or replace the roof molding on certain 2023-2024 Sportage (NQ5a) vehicles produced from January 12, 2022 through November 29, 2023, and certain 2022-2024 Carnival (KA4) vehicles (not equipped with roof rails) produced from January 5, 2021 through November 24, 2023. The roof molding may become loose or detach under certain circumstances either due to interference of the roof molding retaining clip(s) with excessive roof panel sealer or due to improper installation of the roof molding during vehicle assembly. A detached roof molding can create a road hazard for other vehicles, increasing the risk of a crash. Follow the procedure, outlined in this publication to inspect the roof moldings, and if necessary, secure the affected molding or replace and secure it with a new part. Before conducting the procedure, verify that the vehicle is included in the list of affected VINs.

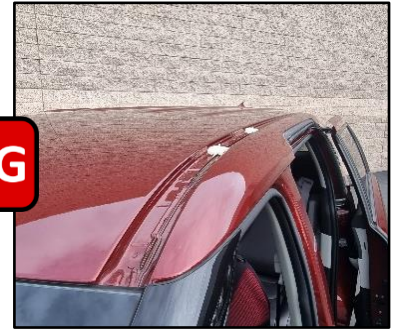
Missing Molding

- If the roof molding is not secured and/or is found to be loose/detached (NG), take one video starting from the VIN label and show the loose/detached (NG) roof molding(s) and proceed to the 'Replacement Procedure' on page 5 and replace the affected roof molding (LH, RH or Both).
- If the roof molding is missing (NG), take one video starting from the VIN label and show the missing (NG) roof molding(s) and proceed to the 'Replacement Procedure' on page 5 to replace the affected roof molding (LH, RH or Both).

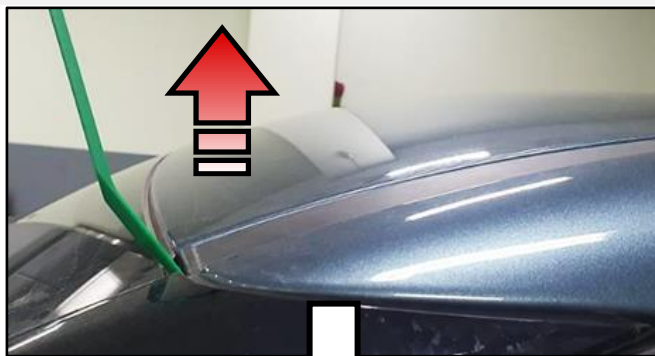
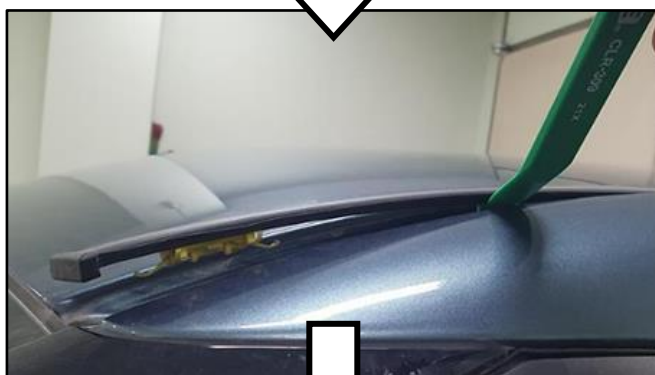
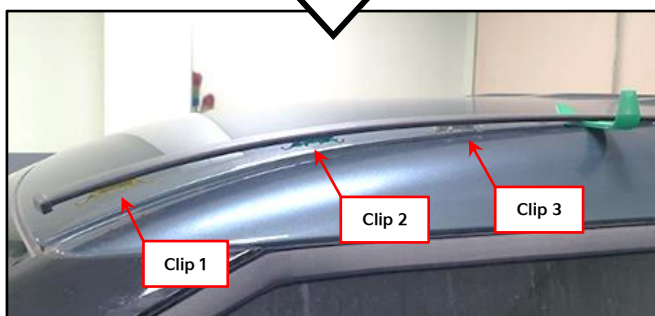
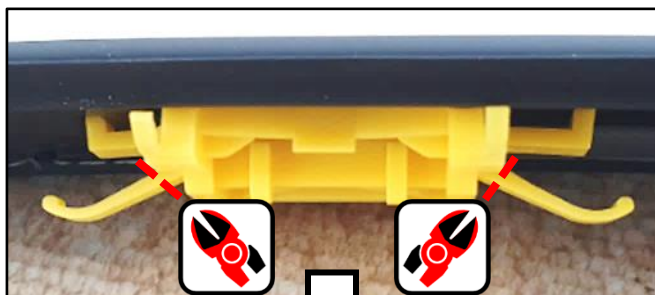
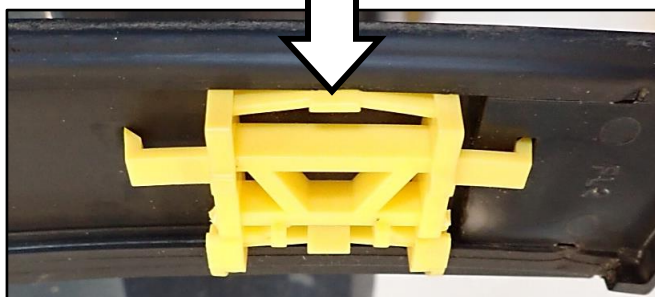
Roof moldings removed for illustration purposes only.

- 1a. **Carnival (KA4):** Using a non-marring trim removal tool, lift the front of the roof molding by detaching only the first three (3) clips.

**Sportage (NQ5a):** Using a non-marring trim removal tool, lift the front of the roof molding by detaching only the first two (2) clips.

- 1b. Place the trim removal tool and/or a soft cloth between the molding and roof to prop up the molding, behind clip 3. (KA4 shown)

- 2a. **Carnival (KA4) ONLY:** Using diagonal cutting pliers, cut off the two (2) supporting legs from clip 1:

- **Yellow** (Left Side)
- **Blue** (Right Side)

The legs must be cut flush with the clip base as shown.

- 2b. **Sportage (NQ5a) ONLY:** DO NOT cut any of the clips from the roof molding for this model.

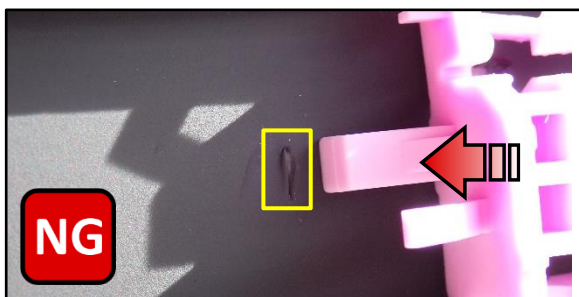
Sportage (NQ5a) - Seven (7) clips.

**BEFORE INSTALLING THE NEW ROOF MOLDING TO THE VEHICLE:** The clips can slide during delivery and may need to be adjusted back to the indent marking on the trim as shown below. Failure to attach misaligned clips may damage the new molding and clips.

2. **If needed:** Slide the clips (fore or aft) so they align with the body roof tabs per the applicable model.

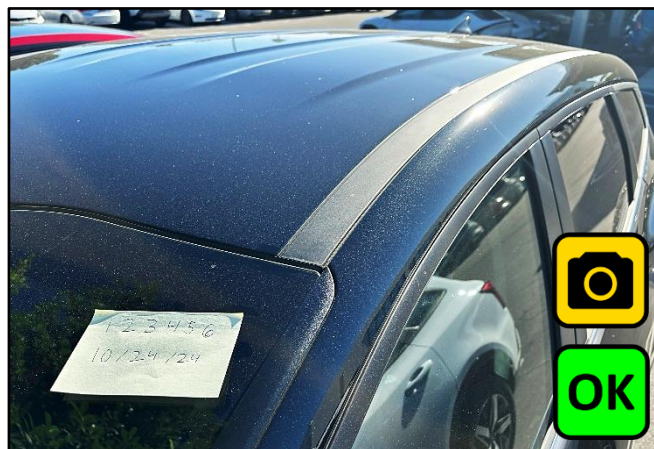
**Note:** Be sure to review the Notice and Tech Tip boxes.

6. Repeat steps 1-5 for the opposite side (if applicable).

The vehicle may be moved by driving slowly and carefully avoiding harsh movements. **Allow sealant to cure for at least thirty (30) minutes before returning vehicle to the customer.**
