## RECALL 24V034 REMEDY INSTRUCTIONS

Make(s): NOVA  
Model(s): NAB20C, NAB20D & NAB20RB  
Model Year(s): 2024

Concern:  
A bleeder valve on the LP Gas tank may leak.

**Subject: Liquid level remote fill gauge has potential to leak in the OPEN position.**

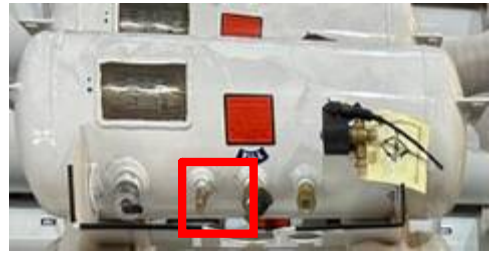
Product Group: ASME LP Tanks  
 Model: 10.75x31" 10.3 gallon remote fill ASME LP Tank  
 Manufacturer Name: Industria Gutierrez, S.A. de CV (INGUSA)  
 Valve Manufacturer Name: Grand Gas Co, Taiwan  
 Manufacture Year: 2023  
 Serial Number Range:  
 U-199923 – U-200122

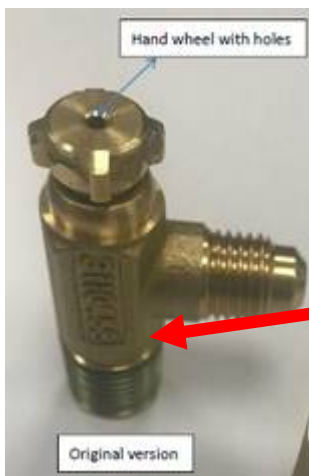
MFG#  
11045B

**Identification:** Subject liquid level gauges will have part number 11045B stamped on the side, with a discharge hole in the hand wheel manufactured by Grand Gas.

1. Using information on the tank's data plate, confirm the capacity, dimensions, manufacturer, and serial number range.
2. Check the part number on the installed liquid level gauge – insure it is marked as 11045B and an outlet hole on the hand wheel.
3. Prior to first fill, qualifying tanks should be pressurized with a minimum of 100 PSI of air prior to filling to perform leak test in indicated area around the valve stem.
2. Open the liquid level gauge to the open position and spray the liquid level with soapy water. Insure no leaks.

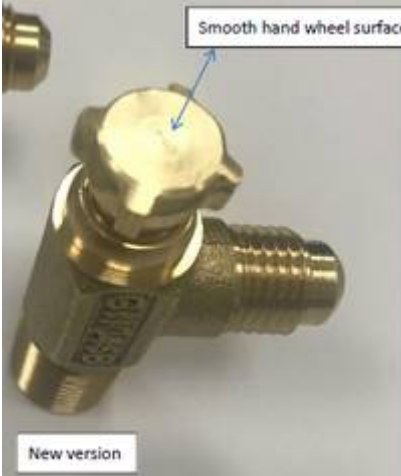
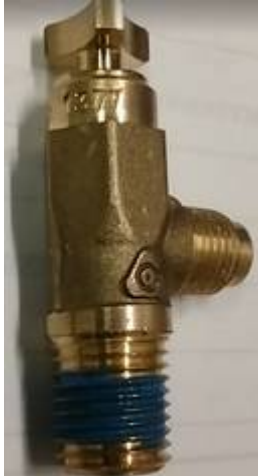
**Replacements:** Grand Gas Model 11045B with no hole in the hand wheel, or Cavagna Model 66-1377 with hand wheel in shape of a triangle shown below – Gauges are available for replacement.

1. If diagnosis reveals leakage in the open position, empty air from tank.
2. Remove old liquid level gauge
3. Replacement gauges should be doped with PTFE tape prior to installation.
4. Apply SAE cap to close side outlet, or, reattach the SAE fitting connected to outlet hose but insure external liquid level gauge is closed.
5. Fill to at least 100 psi of compressed air.
6. Open the tanks liquid level gauge.
7. Perform leak check to insure repair is complete.
8. Ensure to properly purge all compressed air from the LPG Tank
9. Fill with LP and perform additional leak test as required before putting into service.
