Recall Inspection and Repair Instructions

NHTSA Recall # 24V-036

Tiffin Motorhomes Recall # TIF-135

Models Involved: 2022 Allegro Bus Motorhomes, 2022 Phaeton Motorhomes, 2022 Allegro RED 360 Motorhomes, and 2022 Zephyr motorhomes built between January 3, 2022, and April 28, 2022.

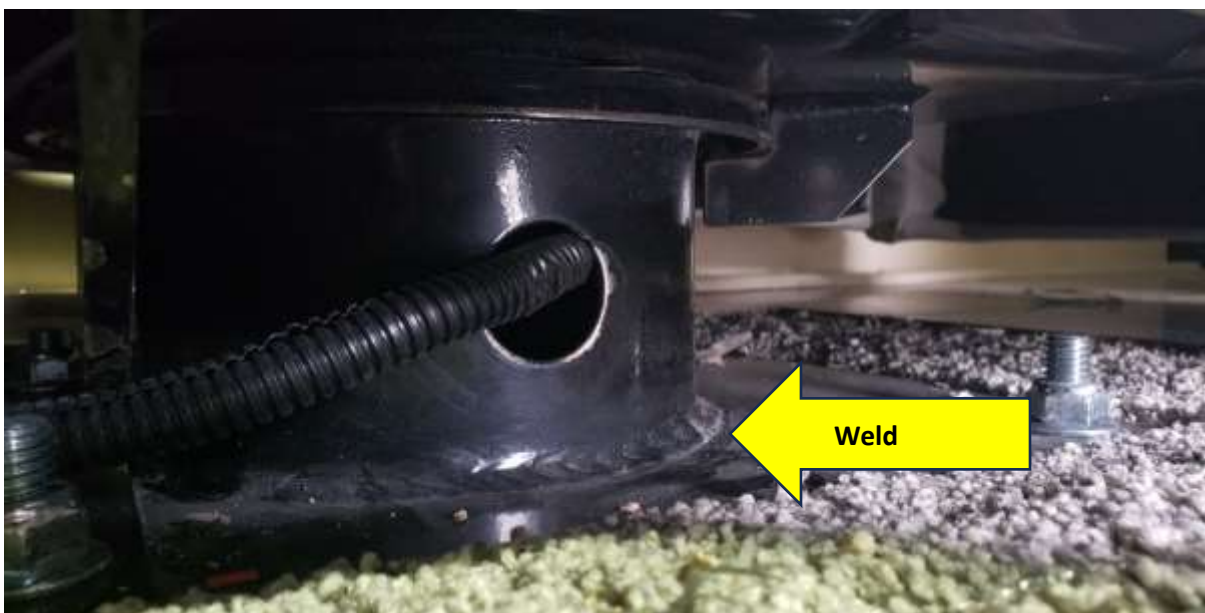
1. Inspect the driver's side seat pedestal to verify the weld is complete around the base of the seat pedestal. See Figure 1 and 2 below to help determine if the weld is correct or not.

2. If the weld is complete around the entire pedestal base, there is no further work to be done.
3. If the weld is missing, please take a picture and email to jim@villainternational.com for authorization to replace the seat base and to order a new part.

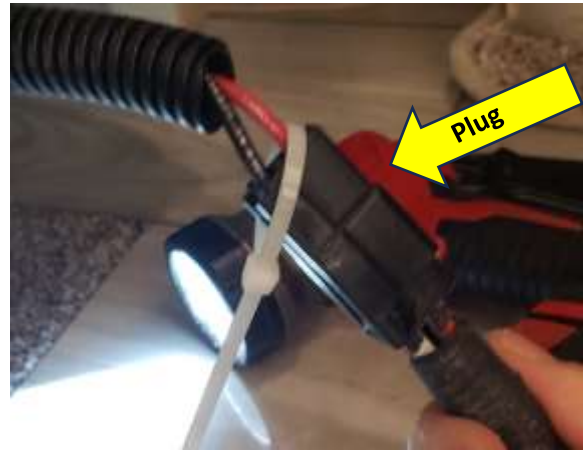
1. Raise the seat full up and then remove the zip tie securing the electrical harness and unplug the connection from the chair to the chassis power. See Figure 3 & 4.

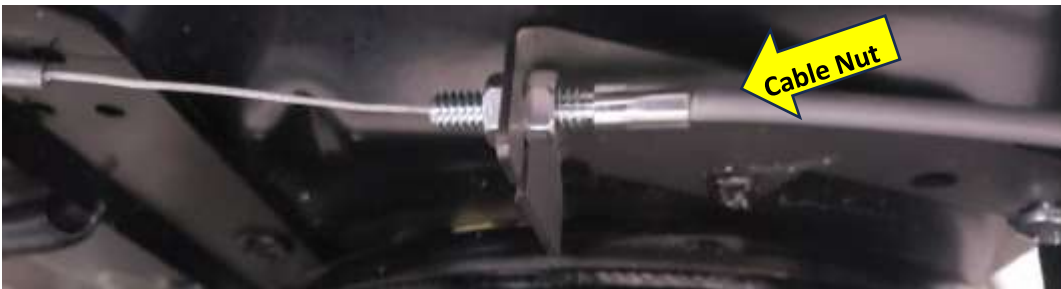
2. Disconnect the swivel cable from the seat pedestal. See Figure 5
