## Recall Inspection and Repair Instructions

**NHTSA Recall # 24V-049**

**Tiffin Motorhomes Recall # TIF-136**

**Purpose:** To provide instructions on how to replace the aluminum solar panel brackets with stainless steel brackets.

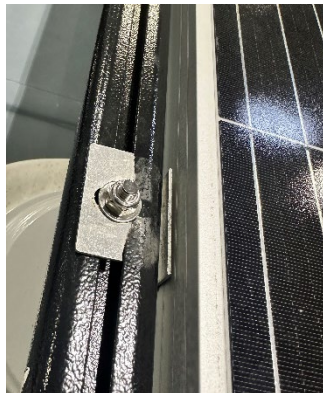
Figure 1A, recalled aluminum bracket.

1. Verify which brackets are installed on the motorhome. If they are the updated brackets made from stainless steel, please verify the hardware used to secure the solar panel is correct, if the washers or bolts are incorrectly sized, please update the hardware as needed. See figures 1A, 1B, 1C & 1D below.

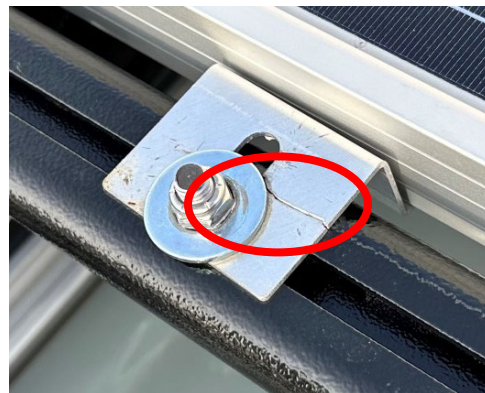
Figure 1B, recalled aluminum bracket with stress fractures & incorrect washer.

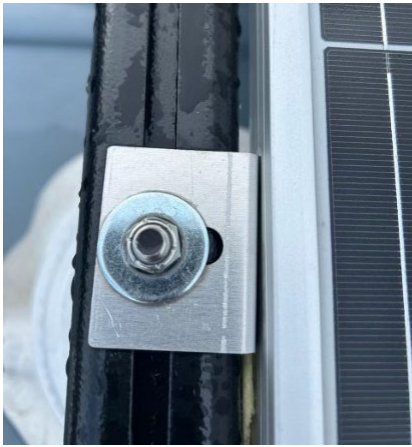
Figure 1C, updated stainless steel bracket, washer too large for nut.

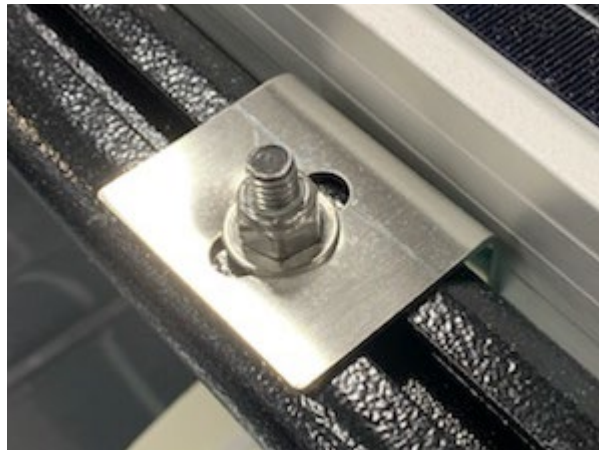
Figure 1D, updated stainless steel bracket, correct washer.

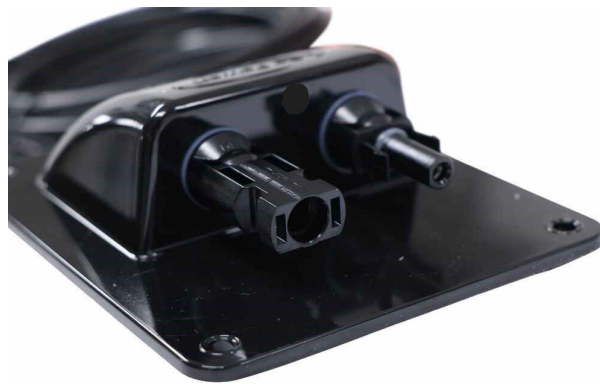
Figure 7B, Docking Plate

7. Reconnect the solar panel MC4 connectors to the jumper harness that connects the panel to the docking plate. See Figures 7A & 7B below.
