July 17, 2024

## Safety Recall: 2022 Civic Seat Weight Sensor (DTC U3000-49)

Supersedes 24-041, dated March 19, 2024, to revise the information highlighted in **yellow**.

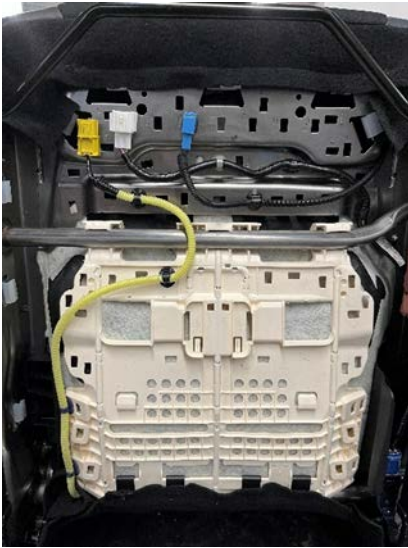
3. Disconnect all connectors,

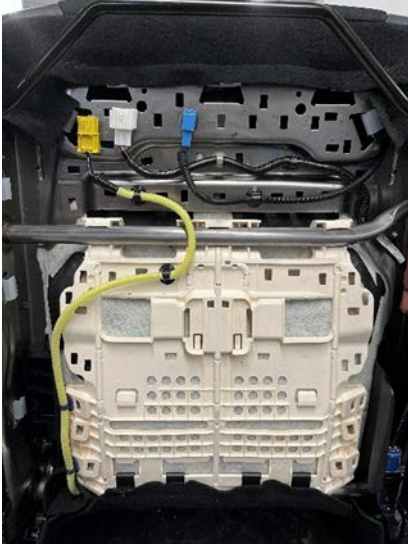
4. Carefully remove the seat from the vehicle and place it on a clean and suitable work area.
5. Carefully lay the seat on the seatback and take a photo of the wire harness layout for future reference.

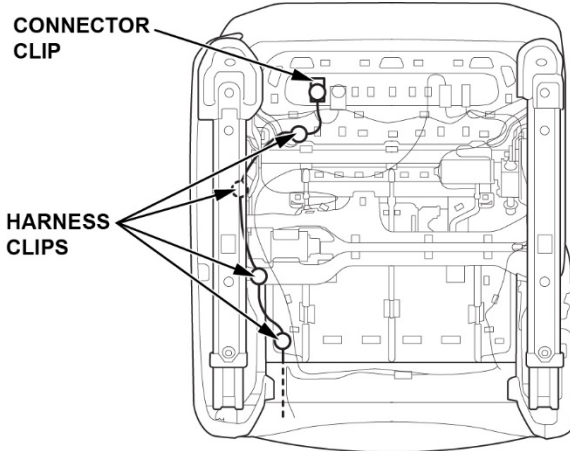
11. Remove the side airbag harness from the seat cushion frame.

- Remove the harness clips and the connector clip.

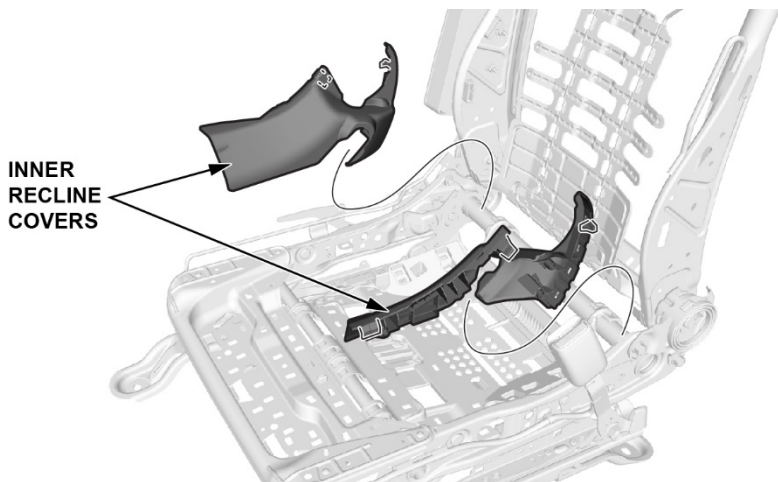
19. Remove the Inner recline covers.
