Safety Recall: 2021 Civic Type R Seat Weight Sensor (DTC U3000-49)

BACKGROUND

Affected vehicles may be equipped with seat weight sensors that are not built to proper specifications. Improperly built sensors could lead to cracking and/or a short circuit of the sensor, resulting in the illumination of the SRS warning light and the passenger airbag indicator remaining OFF. In certain collisions, these seat weight sensors may cause improper deployment of the front passenger airbags, increasing the risk of injury.

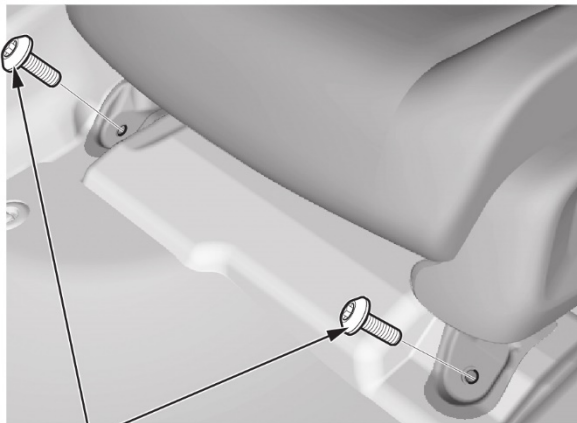
FRONT SIDE

1. Check for the SRS warning light on the dash.
2. If the SRS warning light is on, connect the HDS to the vehicle. Do an All DTC check.
3. If DTC U3000-49 is present, continue to step 4.
If DTCs other than U3000-49 are found, this service bulletin does not apply. Continue with normal troubleshooting.
4. Remove the front side fasteners from the passenger's seat.

BOLTS
43 N·m
(32 lb-ft)

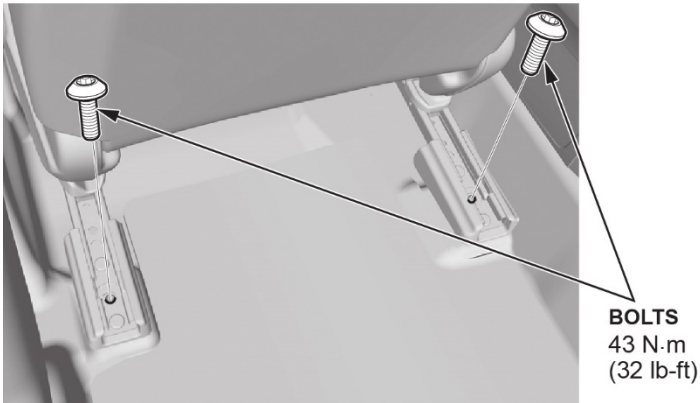
REAR SIDE

- Slide the seat all the way forward, and remove the rear side fasteners.

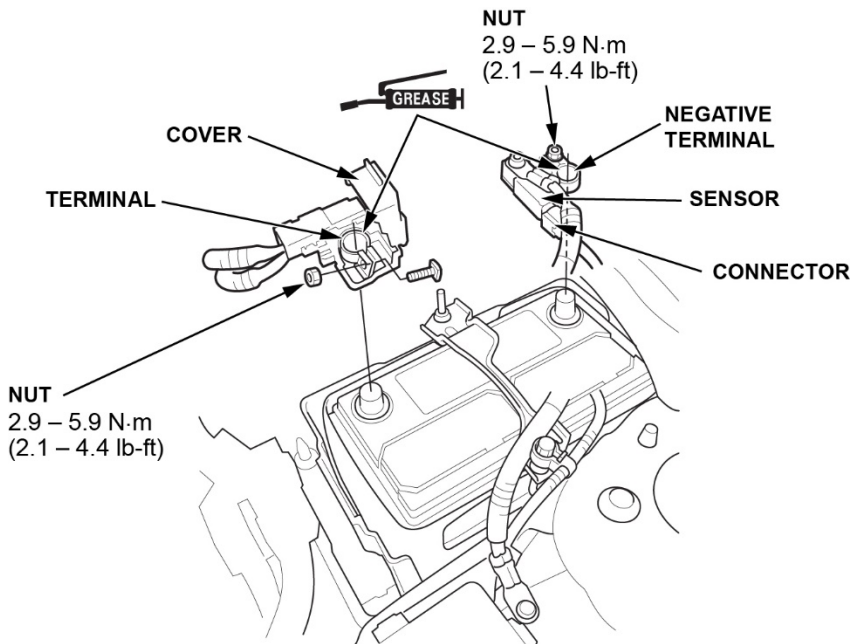
- Disconnect the negative terminal of the 12-volt battery.

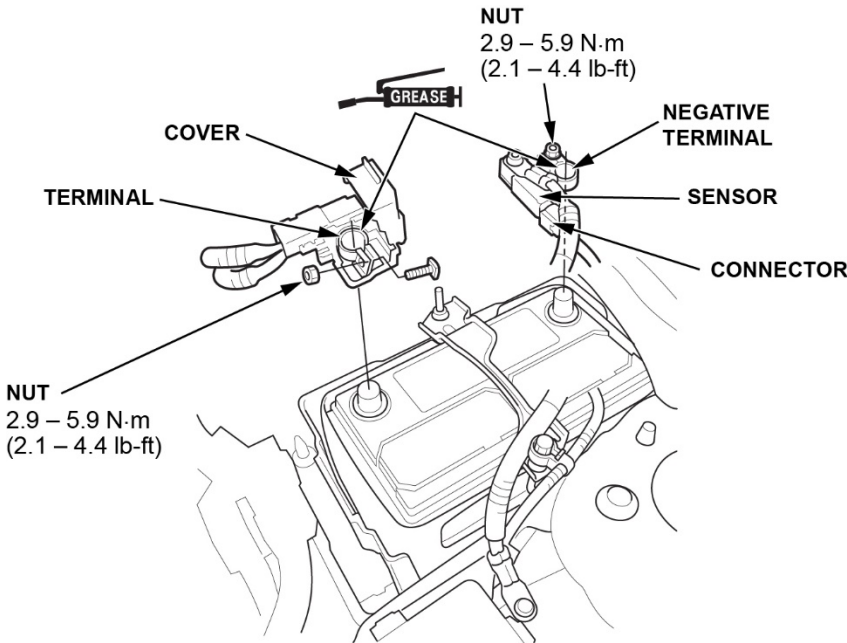
1. Disconnect the negative terminal of the 12-volt battery.

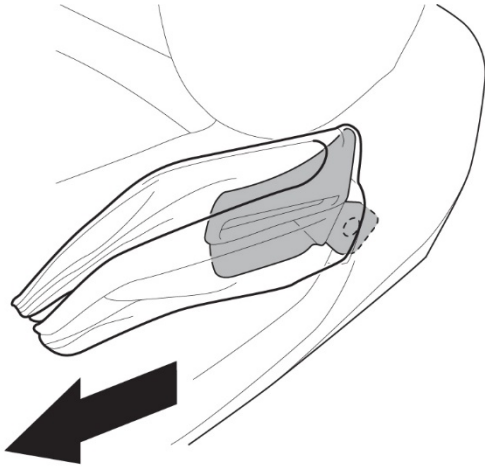
- Slide the seat forward and backward, then remove the seat back recline lever.

NOTE: Using a shop towel wrapped around the lever, grab each end of the towel and pull the towel hard to remove the lever cover.

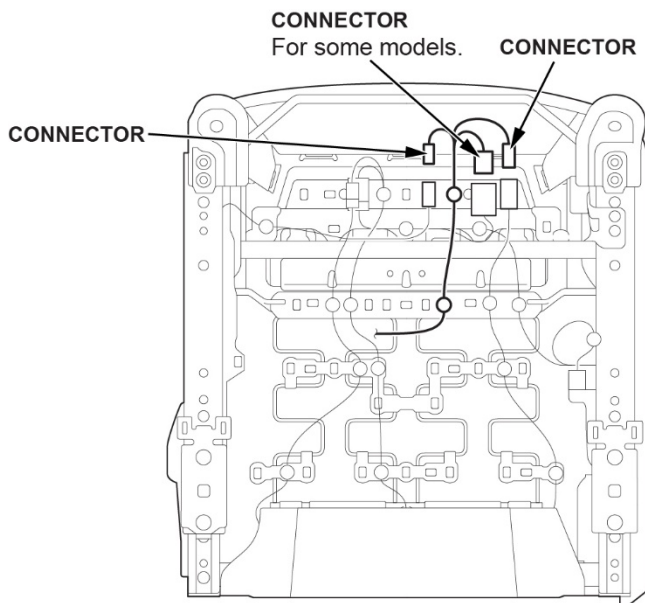
- Lift the seat up, then disconnect the connectors.

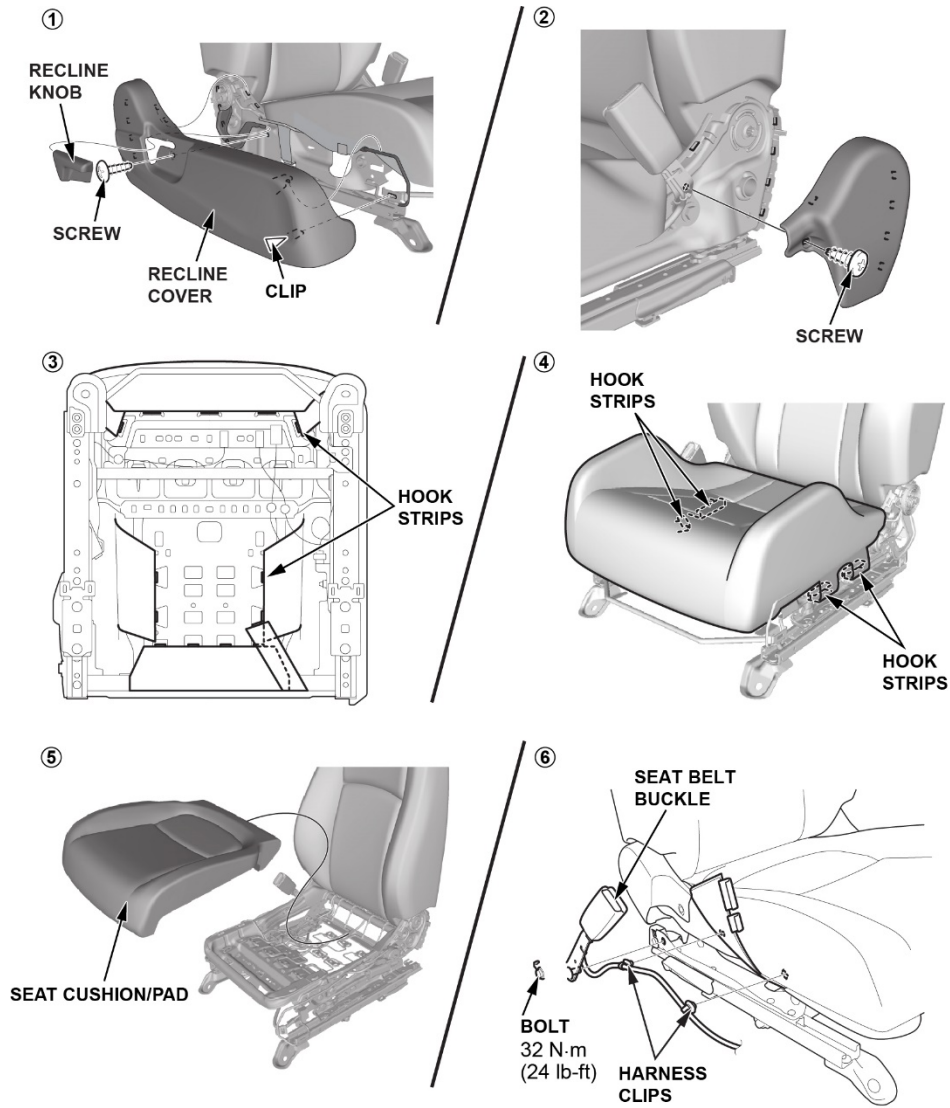
5. Remove and/or release the following:

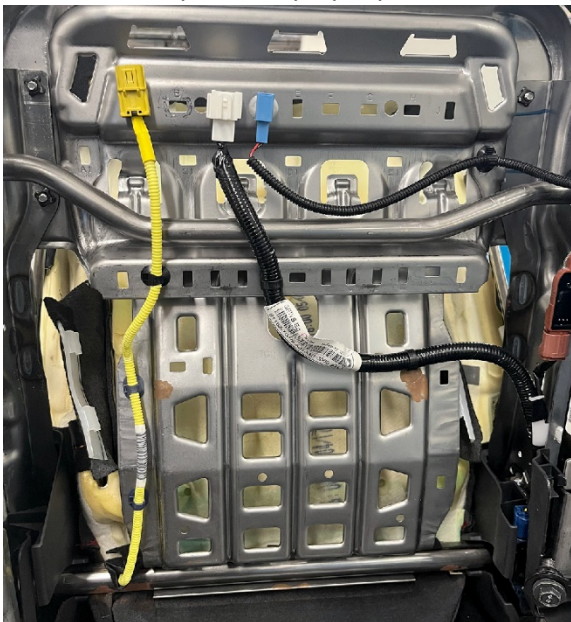
6. Remove the wire harness.

NOTE: Take a photo for proper placement during reinstallation.

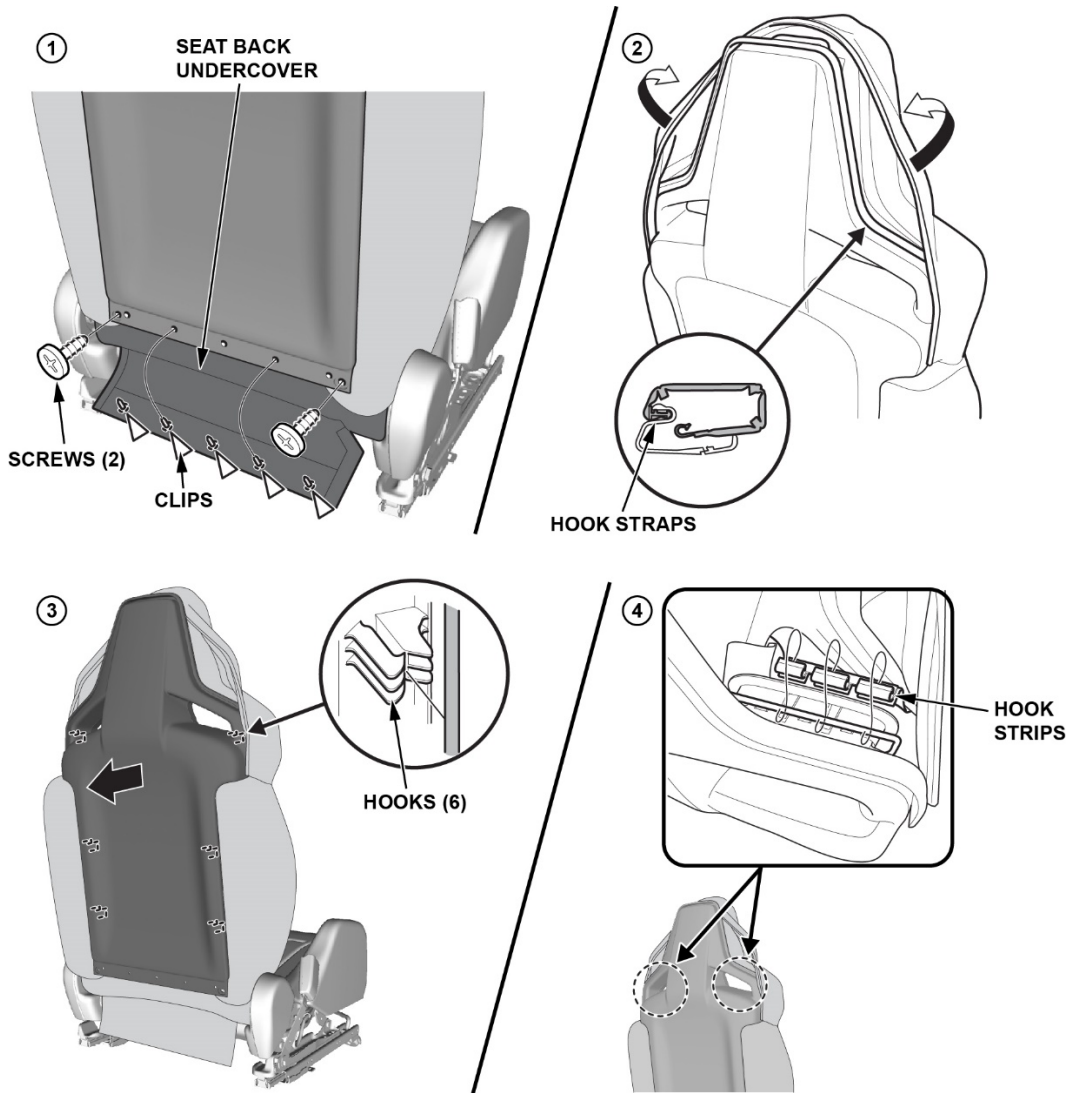
7. Remove and release the following:

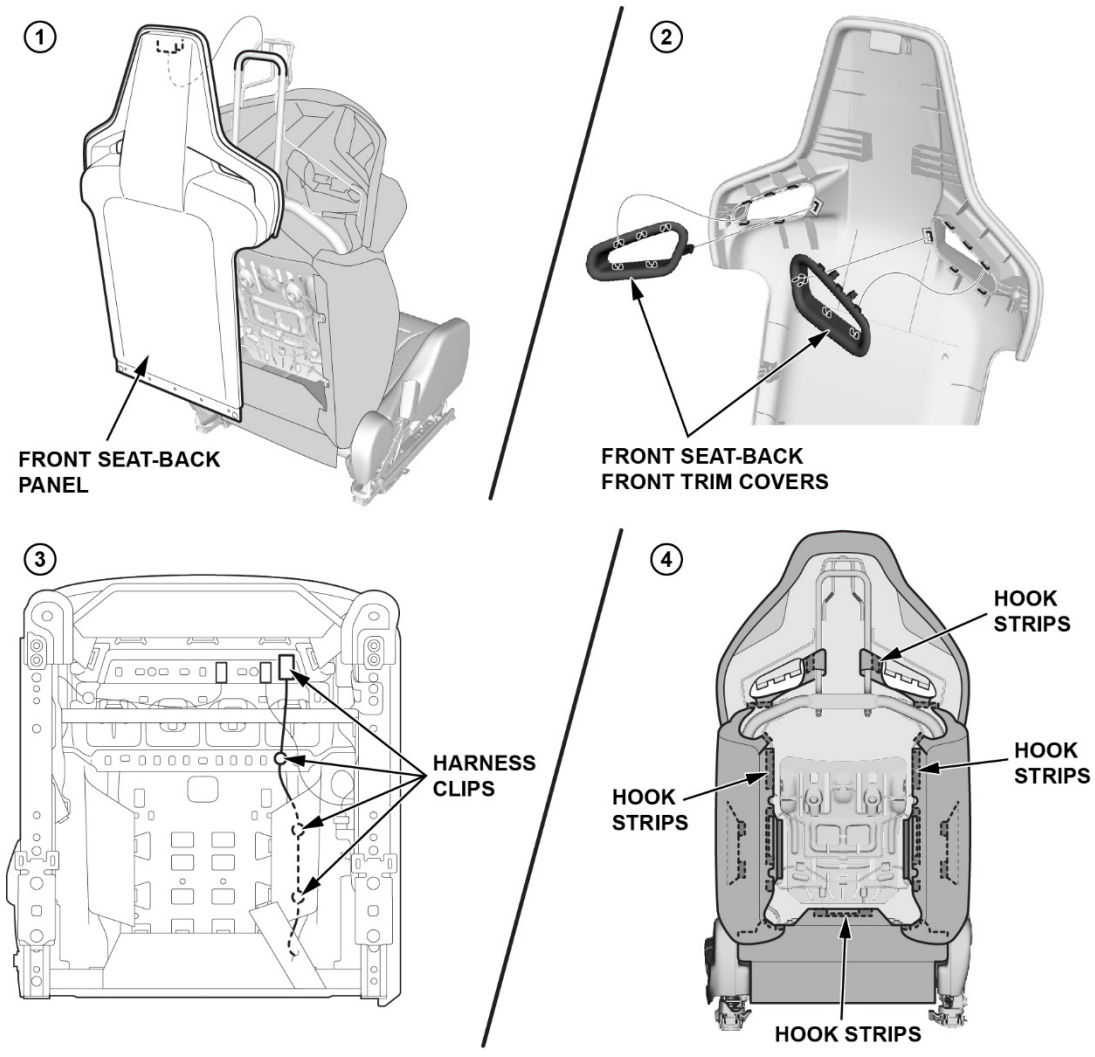
8. Remove and release the following:

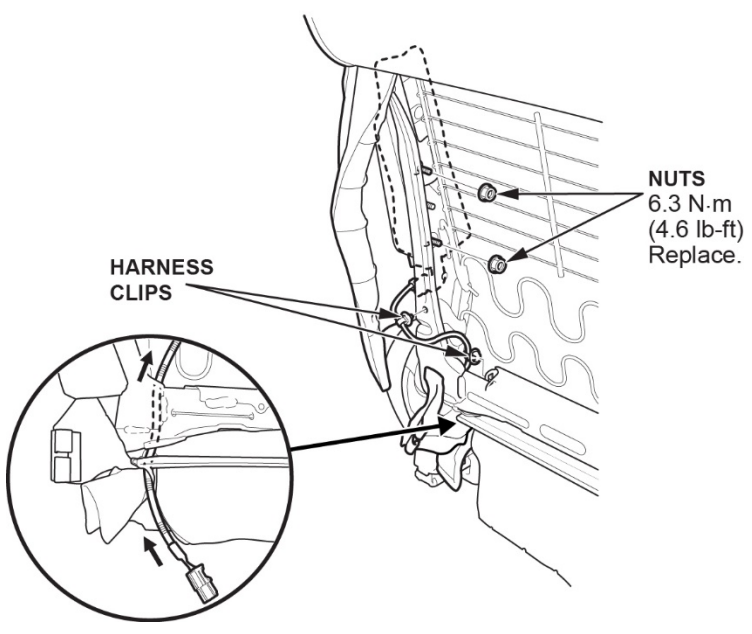
9. Remove the clips and the mounting nuts, pull the harness from the clearance of the seat frame, and then remove the side airbag.

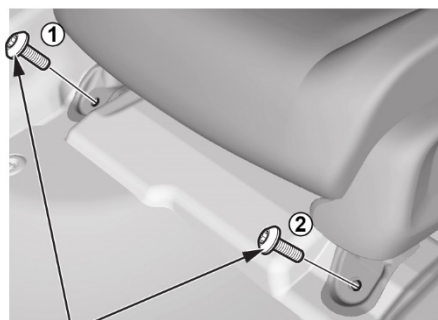
FRONT SIDE

10. Install all removed parts onto the replacement seat frame.
11. Install the bolts to the passenger's seat and tighten them by hand first, then tighten them to the specified torque in the sequence.

BOLTS
43 N·m
(32 lb-ft)

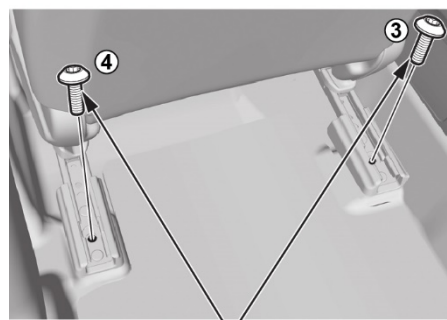
REAR SIDE

BOLTS
43 N·m
(32 lb-ft)

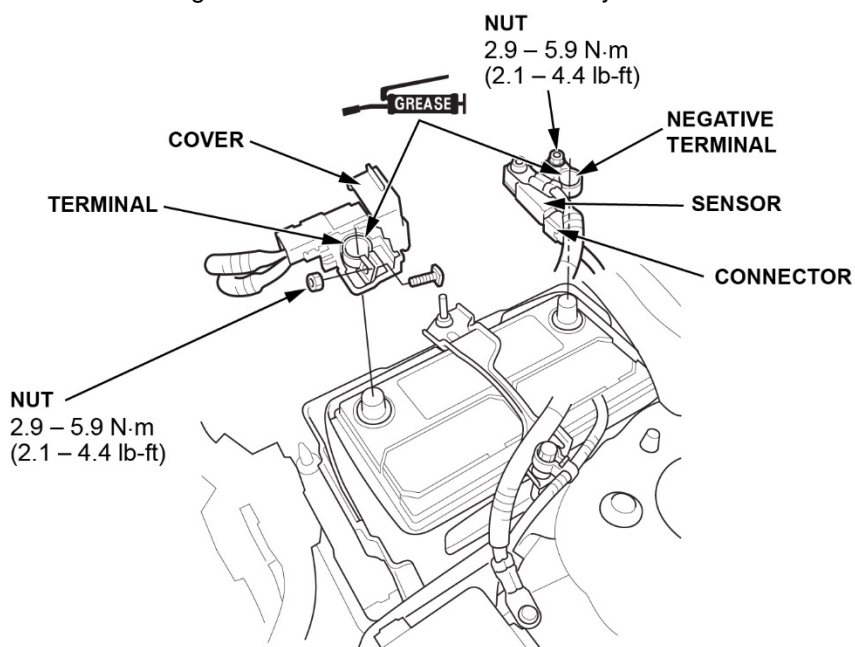
12. Connect the negative terminal of the 12-volt battery.
