Safety Recall: 2021 TLX Seat Weight Sensor (DTC U3000-49)

Affected vehicles may be equipped with seat weight sensors that are not built to proper specifications. Improperly built sensors could lead to cracking and/or a short circuit of the sensor, resulting in the illumination of the SRS warning light and the passenger airbag indicator remaining OFF. In certain collisions, these seat weight sensors may cause improper deployment of the front passenger airbags, increasing the risk of injury.

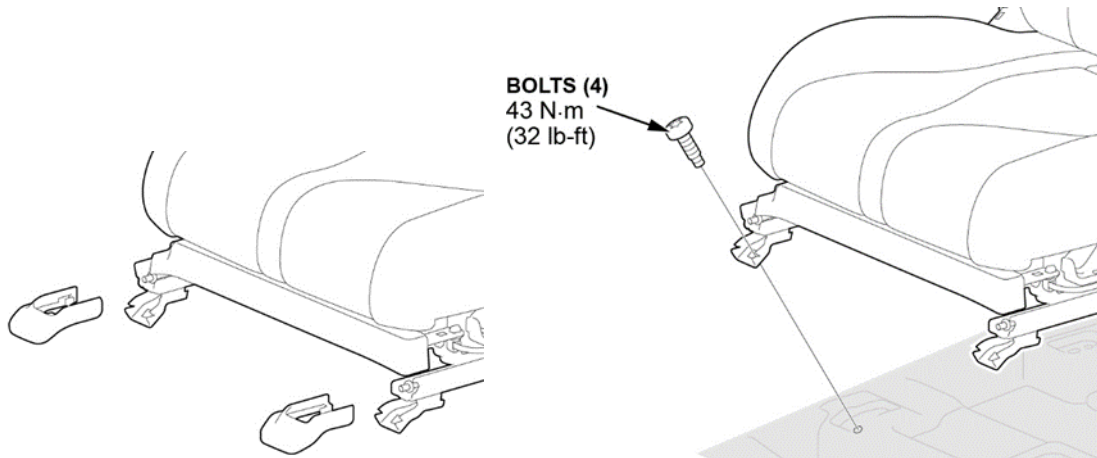
4. Remove passenger seat foot covers and seat mounting bolts.

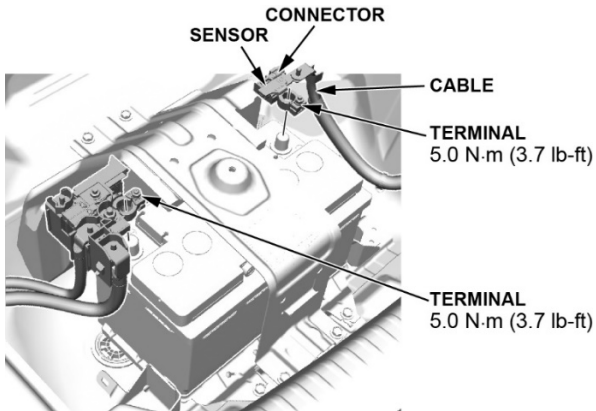
6. Disconnect the negative terminal of the 12-volt battery.

- To protect the 12-volt battery sensor connector from damage, do not hold it when removing the negative terminal.
- Do not disconnect the 12-volt battery sensor from the negative terminal.
- Wait at least **3 minutes** before starting work.

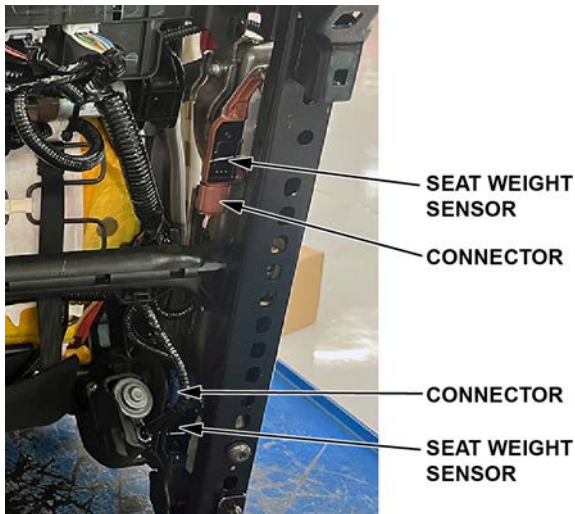
7. Tilt the seat back and disconnect the 2 seat weight sensor connectors from the seat harness.

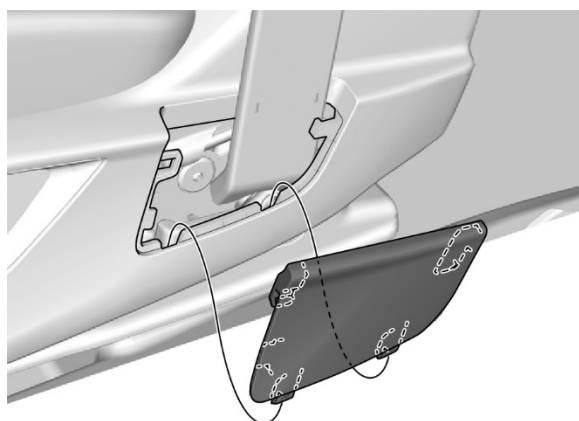
2. Remove the right front seat belt bolt cover and front seat belt anchor bolt. (driver's side is shown).

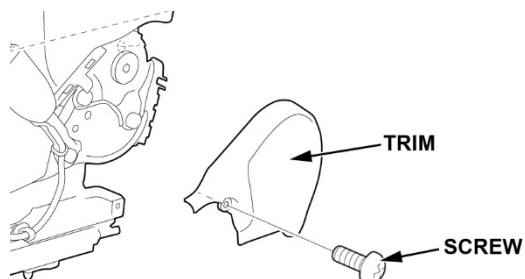
3. Disconnect the floor harness clip and disconnect the connectors underneath the seat.
4. Remove the seat from the vehicle.
5. Remove the screw and the trim on the left side.

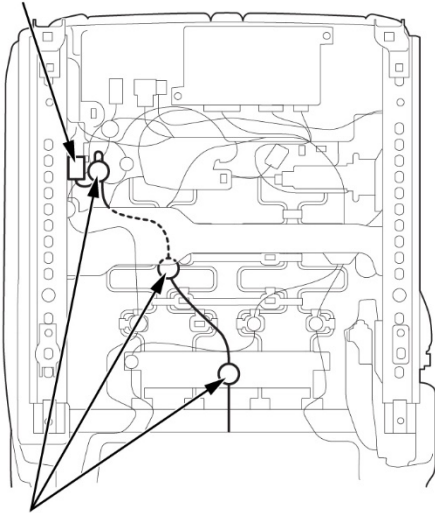
CONNECTOR

10. Disconnect the connectors and remove the harness clips.

NOTE: Take a photo of the of the harness for future reference when installing.

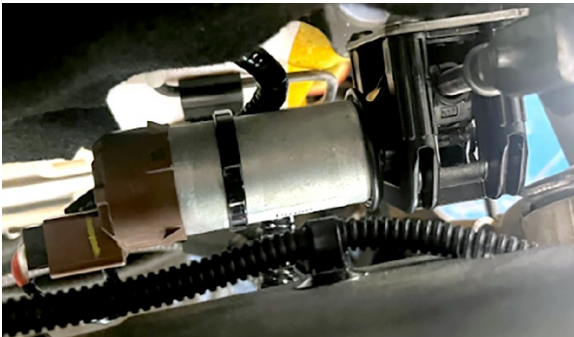
11. Disconnect the connector to the motor and cut the clip (if equipped).

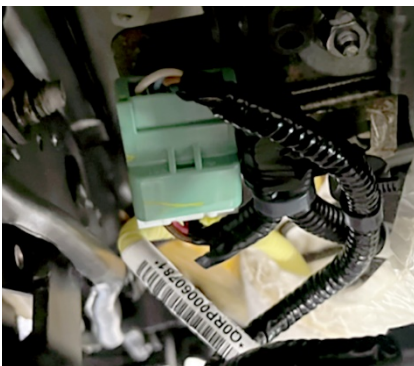
12. Remove the connector and clip (if equipped).

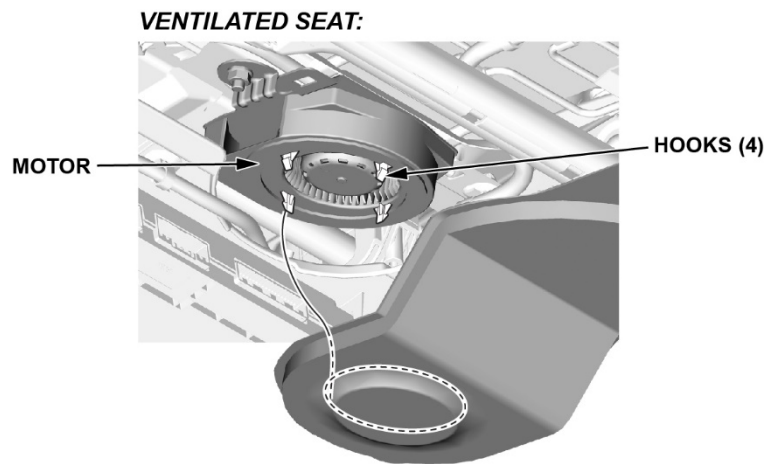
14. Release hooks from the ventilated seat motor (if equipped).

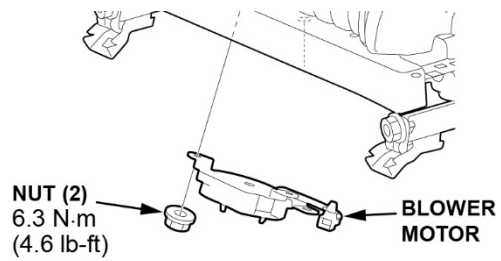
15. Remove the blower motor.

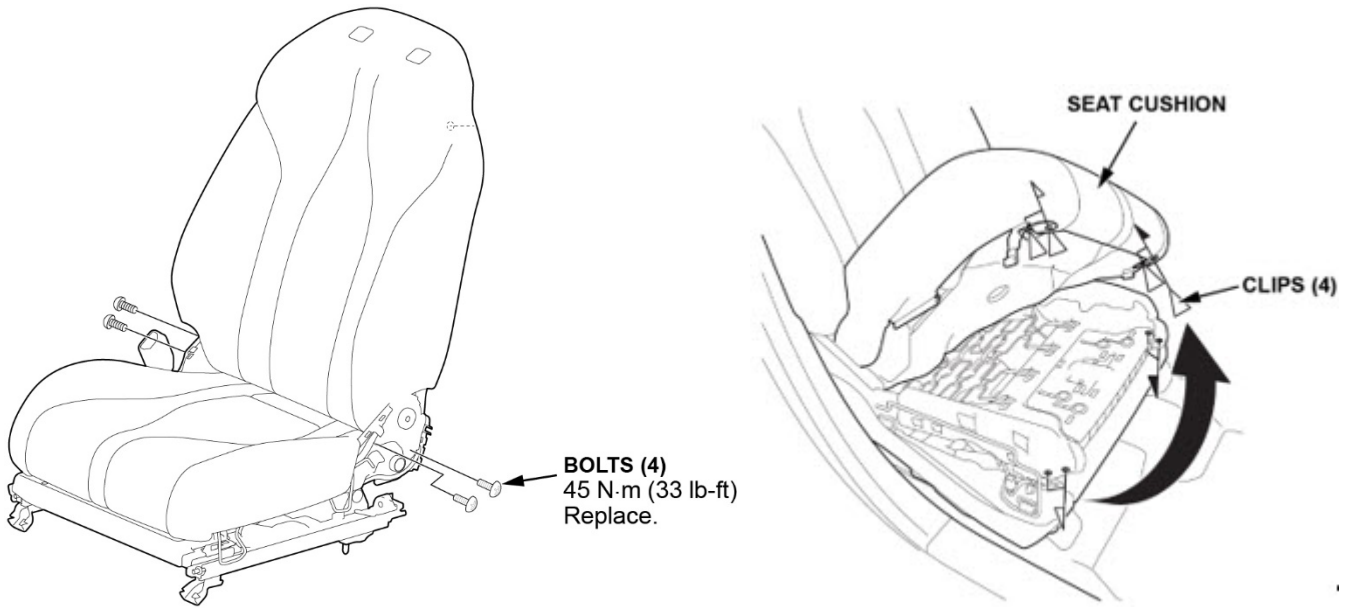
16. Lift off the seat cover and foam from the frame.

17. Remove the 4 bolts holding the seat back, and then remove the seat cushion and cover.

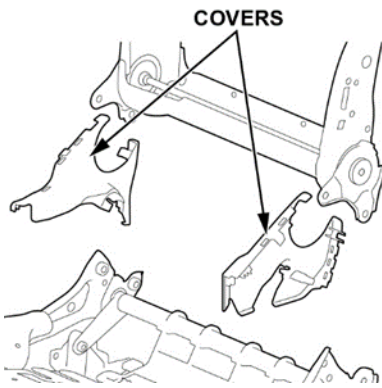
18. Remove the two covers.

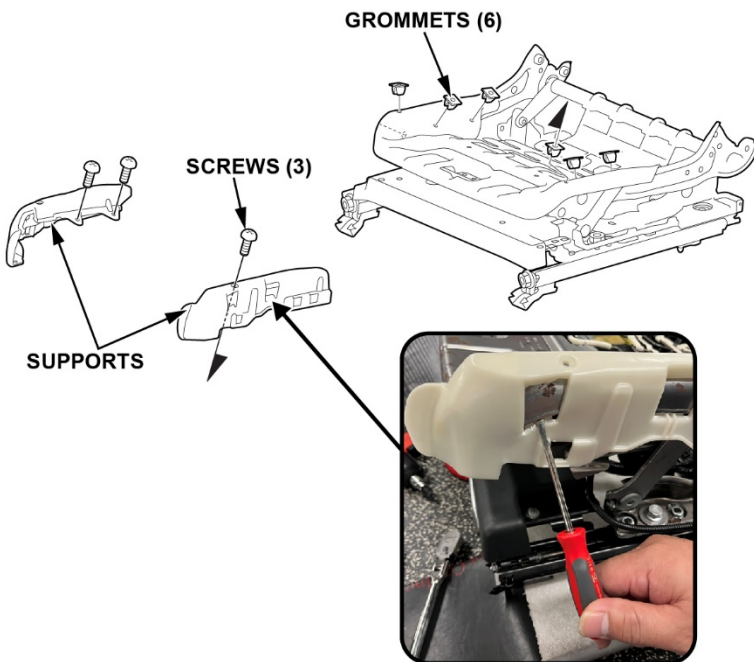
19. Remove the screws from the supports and the 6 grommets in the seat pan.

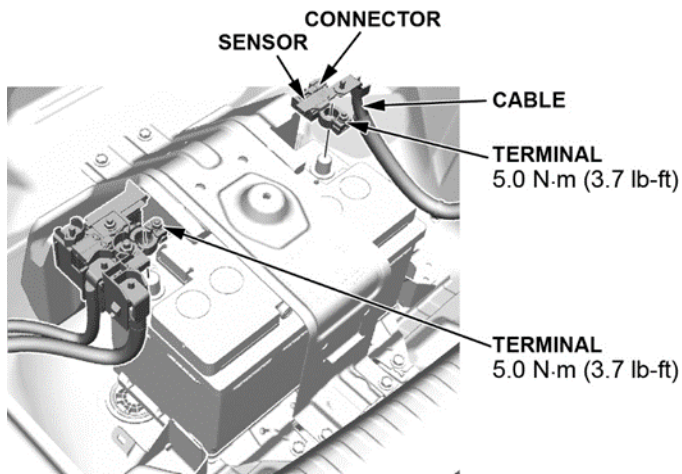
33. Connect the terminal to the 12-volt battery.

NOTE: Do not hold the 12-volt battery sensor connector when installing the terminal to protect it from damage.

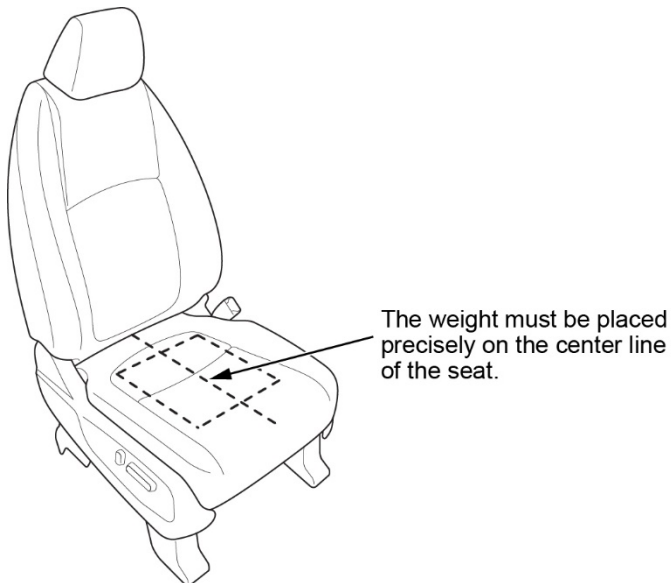
10. Precisely place the prepared weight on the center of the front passenger's seat as shown.
