Safety Recall: 2020–22 RDX Seat Weight Sensor (DTC U3000-49)

BACKGROUND

Affected vehicles may be equipped with seat weight sensors that are not built to proper specifications. Improperly built sensors could lead to cracking and/or a short circuit of the sensor, resulting in the illumination of the SRS warning light and the passenger airbag indicator remaining OFF. In certain collisions, these seat weight sensors may cause improper deployment of the front passenger airbags, increasing the risk of injury.

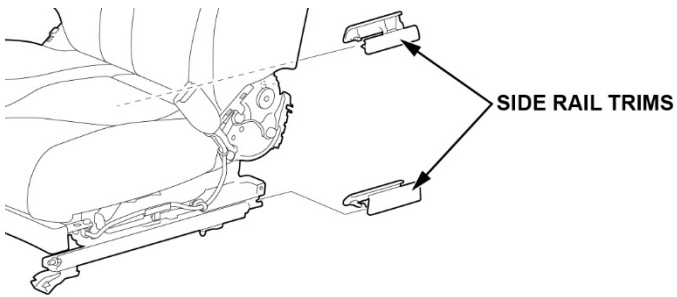
6. Remove the two bottom side rail trims.

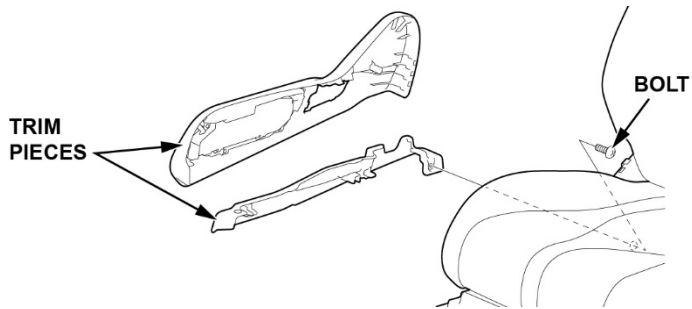
7. Remove the right-side trim pieces.

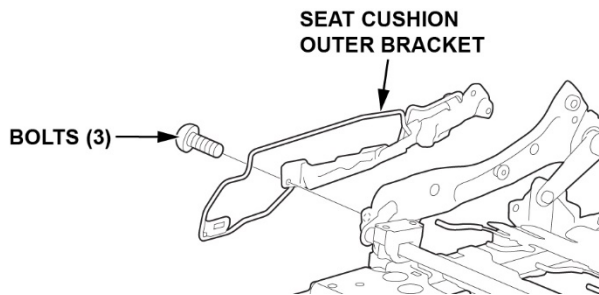
8. Remove the front passenger seat cushion's outer bracket.

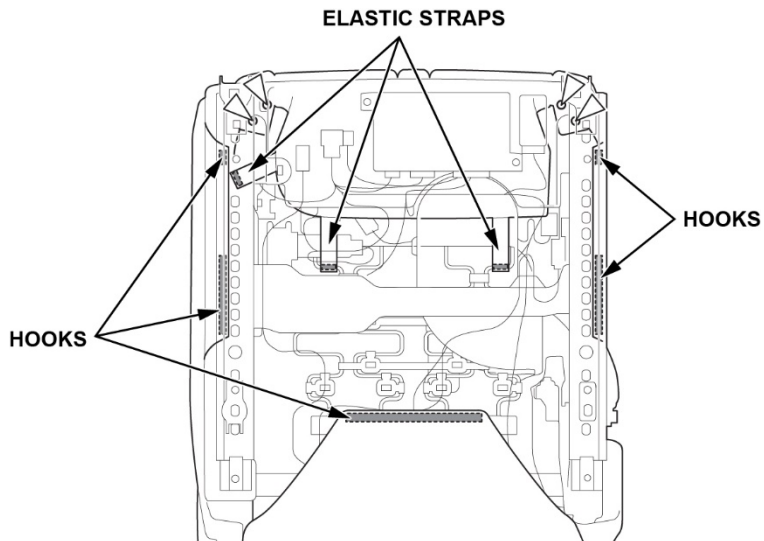
9. Remove the elastic straps and the hooks.

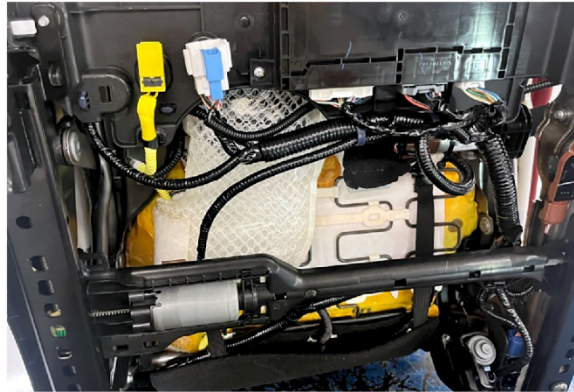
CONNECTOR

10. Disconnect the connectors and remove the harness clips.

NOTE: Take a photo of the of the harness for future reference when installing.

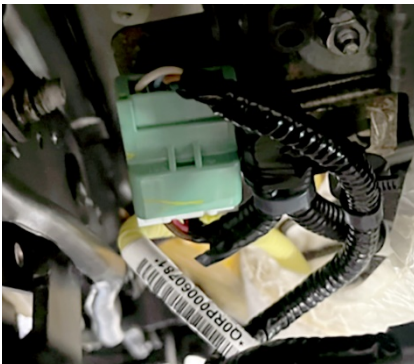
12. Remove the connector and clip (if equipped).

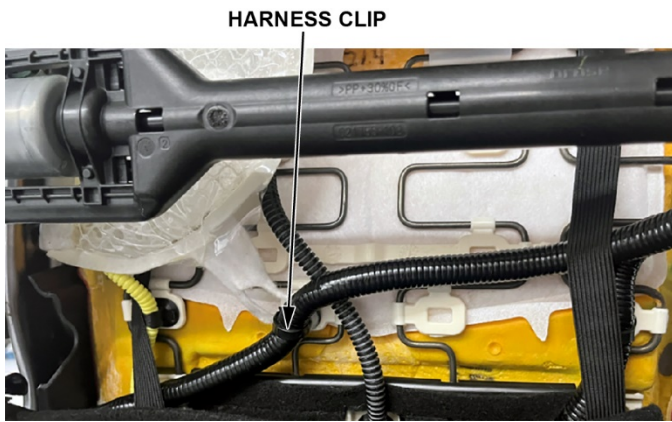
13. Remove the harness clip.

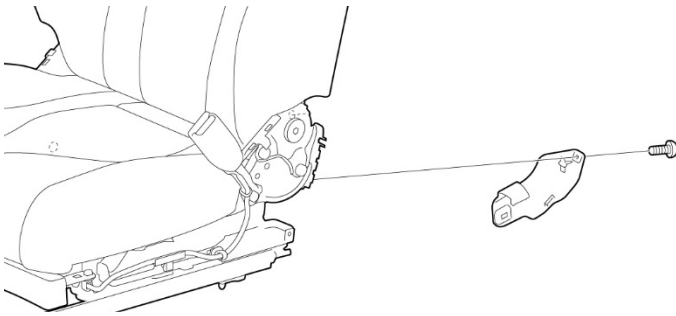
20. Remove the lower trim cover.

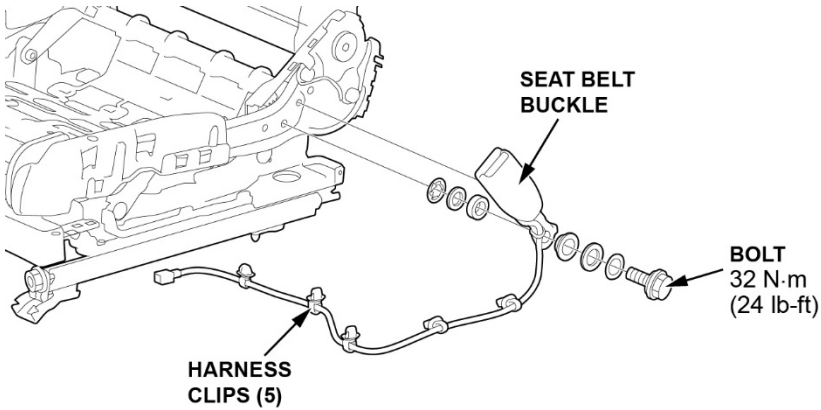
21. Remove the seat belt buckle and harness clips.

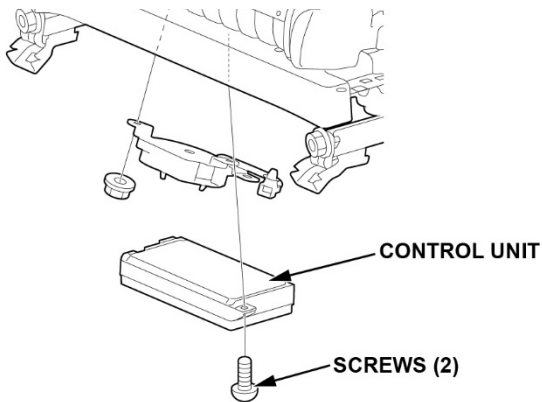
22. Remove the control unit.

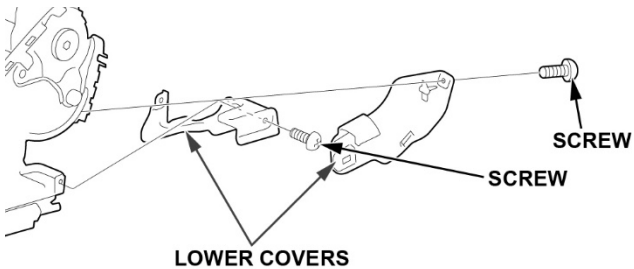
23. Transfer all removed parts to the new lower seat frame, then reassemble following the previous steps in reverse order of removal.

NOTE: Do not install the two lower covers at this time.

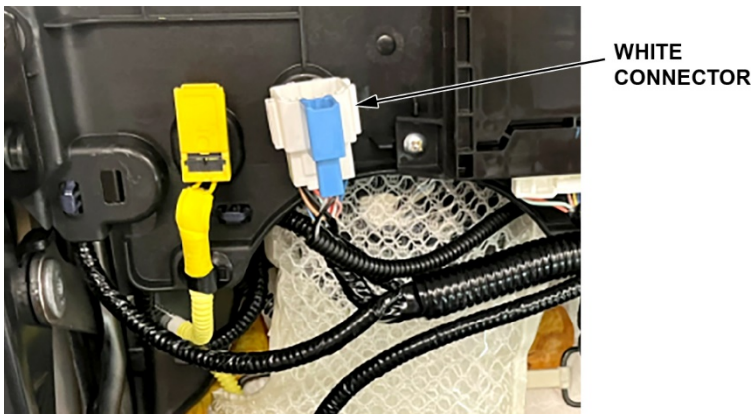
24. Put the seat in the vehicle and connect only the white power seat connector to the floor harness.

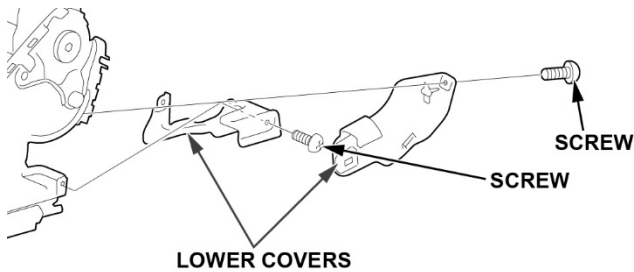
25. Connect the negative cable of the 12-volt battery.
26. Raise the seat to the highest position.
27. Disconnect the negative terminal of the 12-volt battery.
28. Disconnect the white power seat connector.
29. Remove the front passenger seat.
30. Install the two covers.

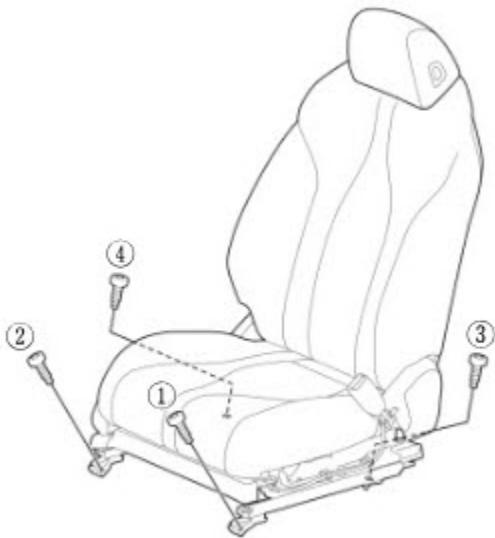
31. Install all remaining parts in the reverse order of removal.
32. Install the seat and hand tighten the bolts first, then torque them in the sequence shown **43 N·m (32 lb-ft)**.
