NAVISTAR, INC

24504
September, 2024

SUBJECT: SAFETY RECALL
Steering gears on certain 2024 IC Bus® CE Series school buses built 07/17/2023 thru 12/14/2023 with R.H. Sheppard M100P model steering gears.

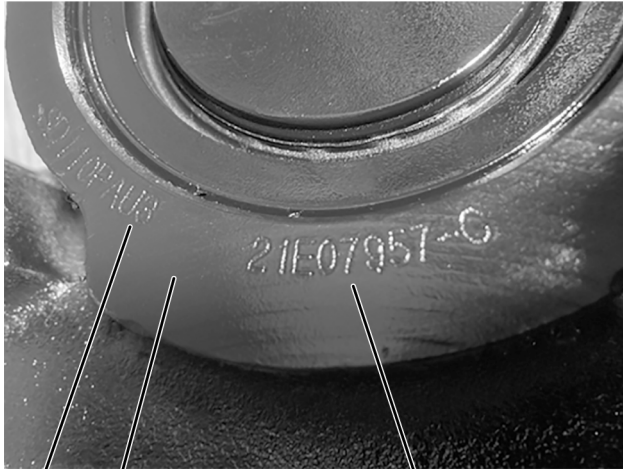
Figure 1. Gear Housing Sector Shaft Output

1. Part number
2. Gear housing sector shaft output
3. Serial number

NOTE: The steering gear serial number is located on the steering gear housing at the bottom of the sector shaft outlet. The wheels may need to be turned for proper viewing. Additionally, a small portion of gears may have the serial number at the top of the sector shaft outlet.

NOTE: The steering gear serial number is a two-digit year followed by an alphanumeric month – Example: 21E (2021 May).

NOTE: If the serial number and / or part number are illegible due to paint, a flat head screwdriver, wire brush, or emery cloth may be used to lightly remove paint where the numbers are located.

6. Record the entire steering gear serial number. Use the R.H. Sheppard link below to determine if the gear needs to be replaced.
