Recall Campaign Bulletin

Campaign No. 2024030001, March 2024

SUBJECT: **Model E-Class, CLS, and AMG GT 4-Door (213, 257, and 290 platform)
Model Year 2021-2023**

Check 48V Ground Connection

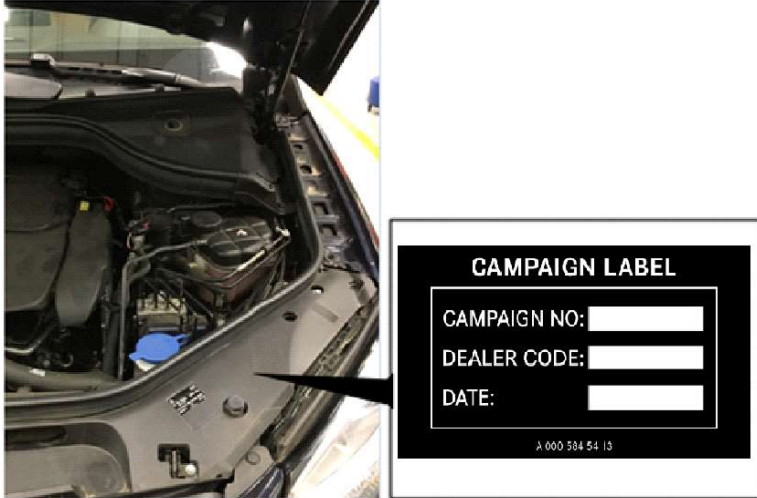
Figure 1

Apply Proof of Correction Label (A 000 584 54 13) to area identified in **Figure 1**. Fill in the blank areas of the label. The campaign number for the California Proof of Correction is unique and must be entered as such (24V100), your dealer code, and the date of the repair, using a black permanent marker.
