RECALL 24V103 / 2024-086 INSPECTION INSTRUCTIONS

Make(s): FR3 & GEORGETOWN
Model(s): ALL MODELS
Model Year(s): 2019 - 2024

Concern:
The two mounting ("L") brackets which the LPG tank is bolted to may fracture within the radius bend, and it is possible there is a lack of weld connecting the L Bracket to the chassis.

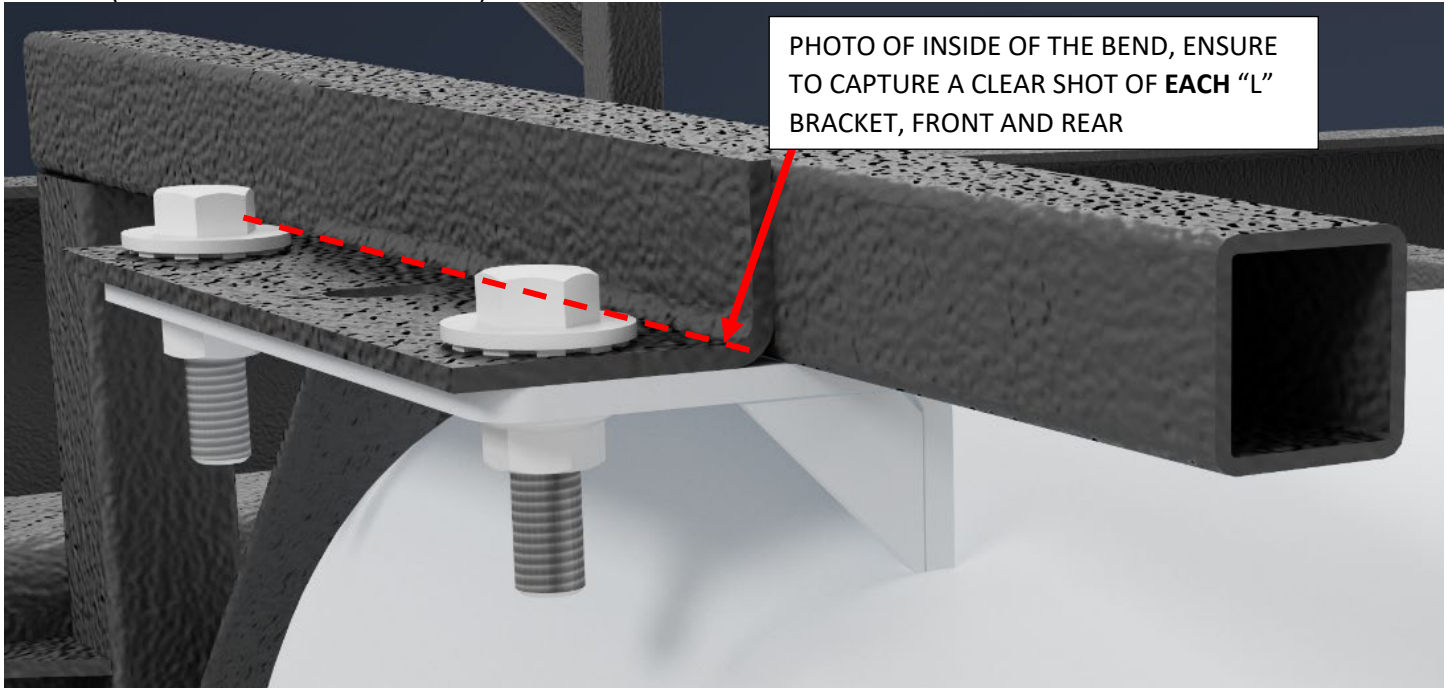
FIGURE 1 (ONLY SHOWING THE FRONT SIDE)

- ENSURE TO CAPTURE THE BRACKET; FIGURE 1
- ENSURE THE FOCUS OF THE PHOTO IS OF THE BEND/RADIUS; FIGURE 1
- THIS SHOULD BE TWO (2) PHOTOS (FRONT BRACKET AND REAR BRACKET);

STEP 3: TAKE A PHOTO OF EACH BRACKET;

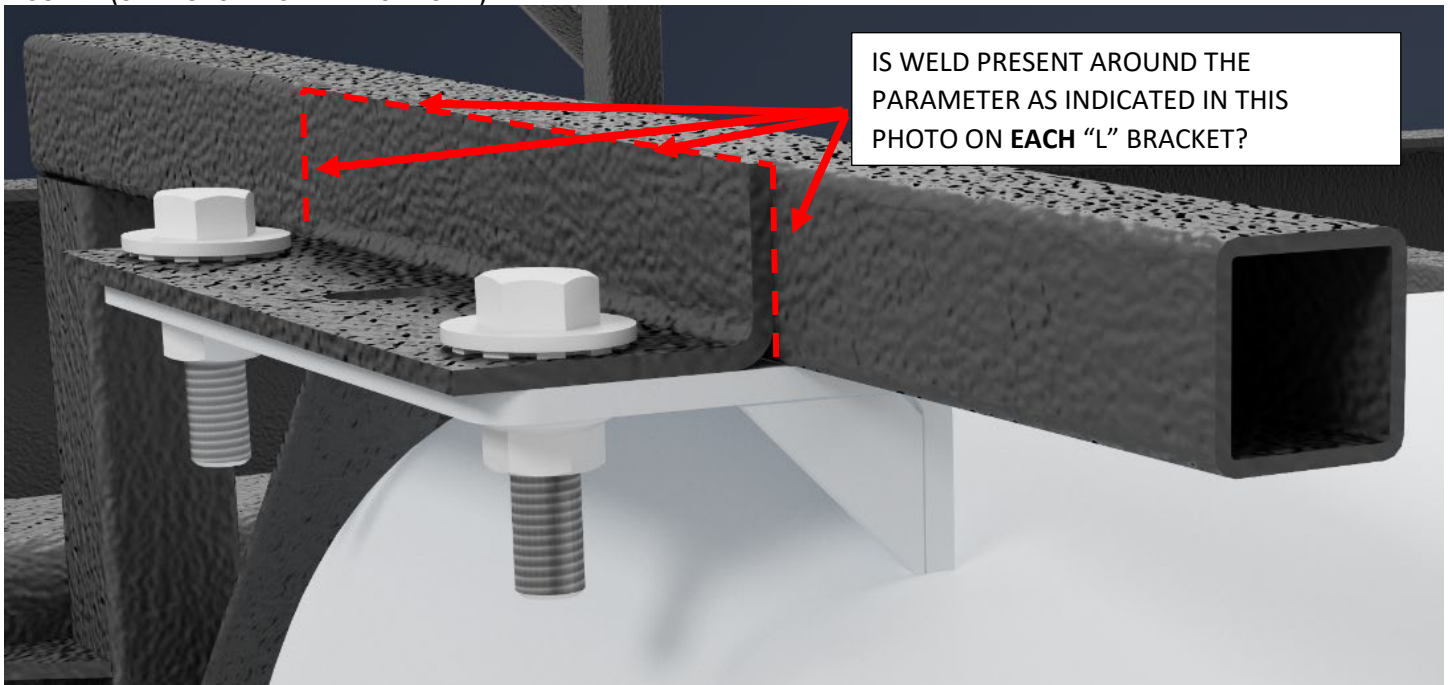
FIGURE 2 (ONLY SHOWING THE FRONT SIDE)

- ENSURE TO CAPTURE THE BRACKET AND WELDS; FIGURE 2
- ENSURE THE FOCUS OF THE PHOTO CAPTURES GOOD VISUALS OF THE BRACKET WELDS; FIGURE 2
- THIS SHOULD BE TWO (2) PHOTOS (FRONT BRACKET AND REAR BRACKET);

STEP 4: TAKE A PHOTO OF EACH BRACKET AND ITS WELDS;
