HYUNDAI Technical Service Bulletin

25-01-004H

GENESIS (DH)

SUBJECT: STARTER RELAY KIT INSTALLATION (RECALL 254)

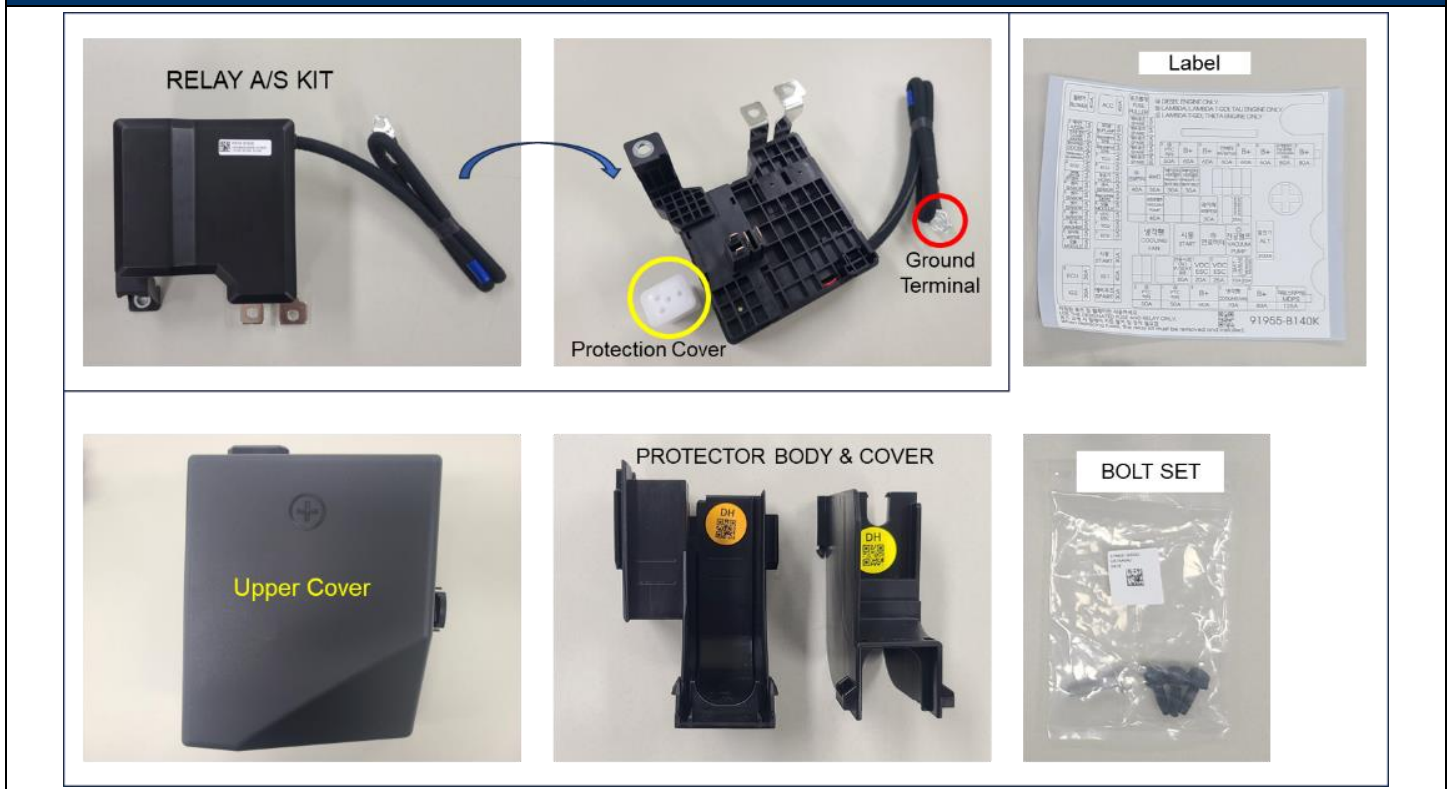
Figure (Samples Shown)

Model	Part Name	Part Number	Kit Contents (1 each)	Remarks
Genesis (DH)	Relay A/S Kit	91950-DH15KQQH	<ul style="list-style-type: none"> Relay Kit Upper Cover (w/Label) Relay A/S Kit Protector Body Relay A/S Kit Protector Cover Bolt Set 	Use Label 91950-B110K
		91950-DH20KQQH	<ul style="list-style-type: none"> Relay Kit Upper Cover (w/Label) Relay A/S Kit Protector Body Relay A/S Kit Protector Cover Bolt Set 	Use Label 91950-B120K

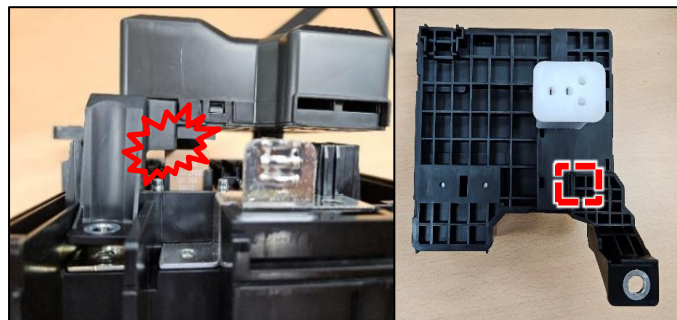
On some vehicles, interference may be found between the new starter relay and the blower RR relay installed in the junction box. This interference may **NOT** allow the new starter relay to seat properly.

If there is interference between the parts, use a pair of diagonal cutters to cut away the area indicated in the photo (I).

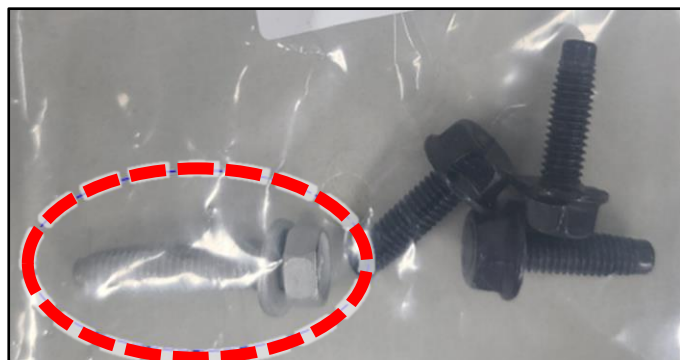
9. Discard the original junction box mounting bolt and use the provided ground bolt (circled right) to install the extension ground terminal (L) from the new relay kit using the existing junction box mounting location (M).

lb-ft	0.9
lb-in	10.8
N.m	1.2

Do **NOT** exceed the tightening torque above. This may damage the part.

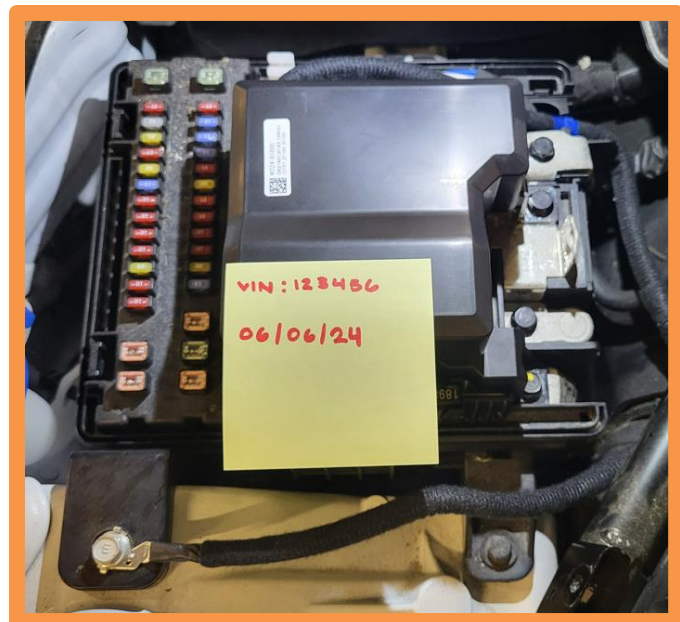
Using STUI, take a clear photo of the new bolts and relay kit installed, and the starter motor power terminal in the proper position, with the last 6 digits of the VIN and the date of repair on a piece of paper.

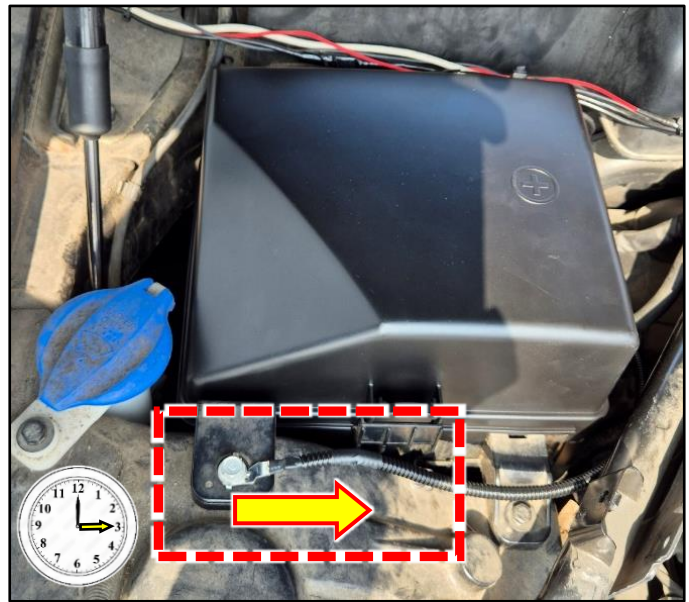
12. Attach the new upper cover to the junction box.

Confirm that the ground harness is installed in the **3 o'clock** position, as shown.
