# HYUNDAI

## Technical Service Bulletin

GROUP <b>RECALL</b>	NUMBER <b>25-01-004HG</b>
DATE <b>JANUARY 2025</b>	MODEL(S) <b>G80 (DH) G90 (HI)</b>

**SUBJECT:** STARTER RELAY KIT INSTALLATION (RECALL 018G)

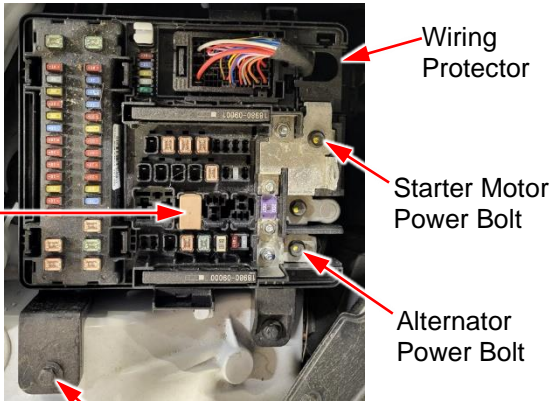
Current Configuration	New Starter Relay Kit Installation

<p>Labels in image:            Starter Relay            Wiring Protector            Starter Motor Power Bolt            Alternator Power Bolt            Junction Box Mounting Bolt</p>

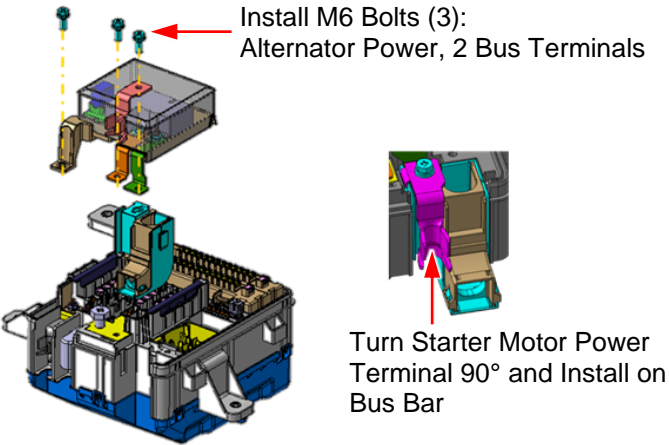
<p>Labels in diagram:            Install M6 Bolts (3):            Alternator Power, 2 Bus Terminals            Turn Starter Motor Power Terminal 90° and Install on Bus Bar</p>

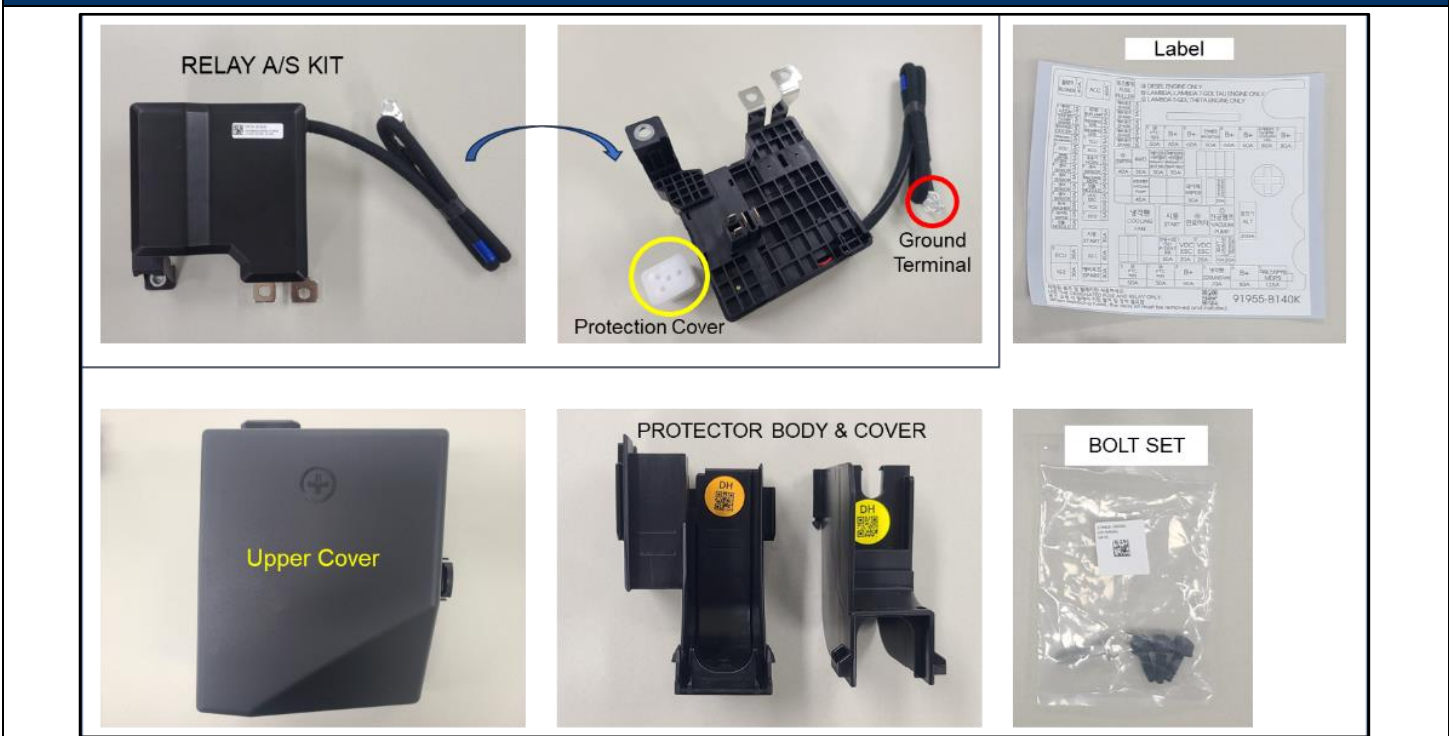
Figure (Samples Shown)

Model	Part Name	Part Number	Kit Contents (1 each)	Remarks
G80 (DH)	Relay A/S Kit	91950-DH15KQQH	<ul style="list-style-type: none"> <li>Relay Kit</li> <li>Upper Cover (w/Label)</li> </ul>	Use Label 91950-B110K
		91955-DH45KQQH	<ul style="list-style-type: none"> <li>Relay A/S Kit Protector Body</li> </ul>	Use Label 91955-B140K
		91955-DH50KQQH	<ul style="list-style-type: none"> <li>Relay A/S Kit Protector Cover</li> </ul>	Use Label 91955-B150K
G90 (HI)		91950-HI20KQQH	<ul style="list-style-type: none"> <li>Bolt Set</li> </ul>

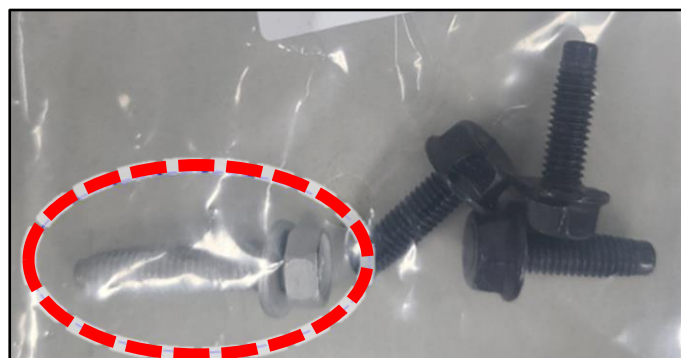
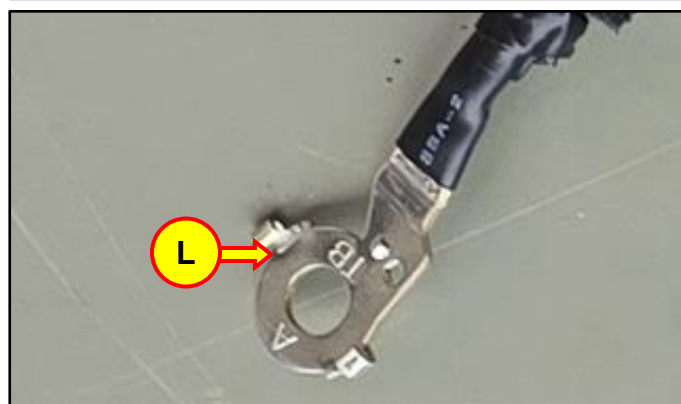
9. Discard the original junction box mounting bolt and use the provided ground bolt (circled right) to install the extension ground terminal (L) from the new relay kit using the existing junction box mounting location (M).

lb-ft	0.9
lb-in	10.8
N.m	1.2

Do **NOT** exceed the tightening torque above. This may damage the part.

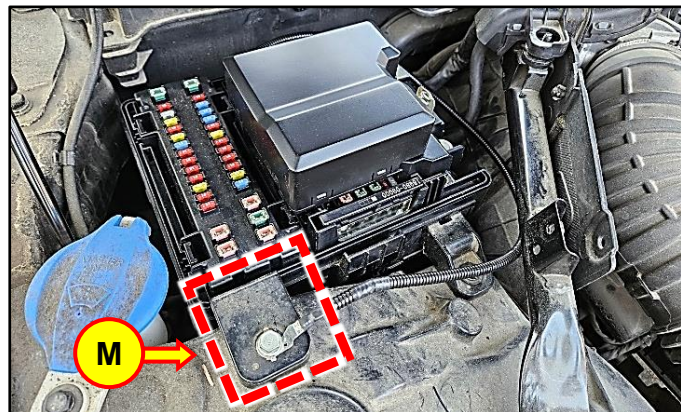
Be sure to install the ground terminal with the protrusion facing up to prevent damaging the terminal.

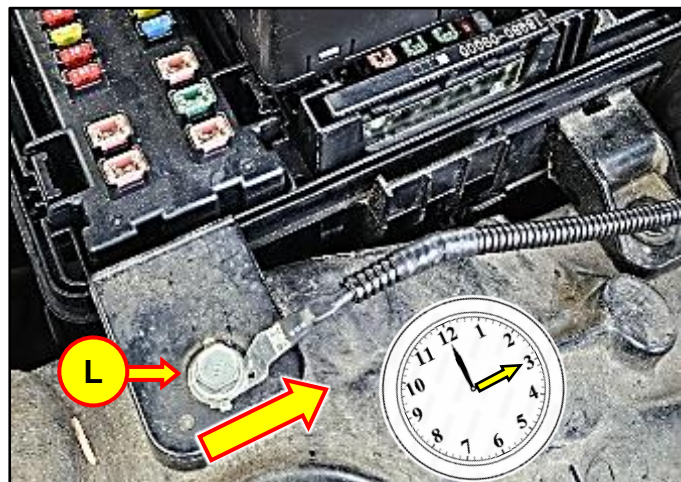
The ground harness should be installed in the **3 o'clock** position, as shown.

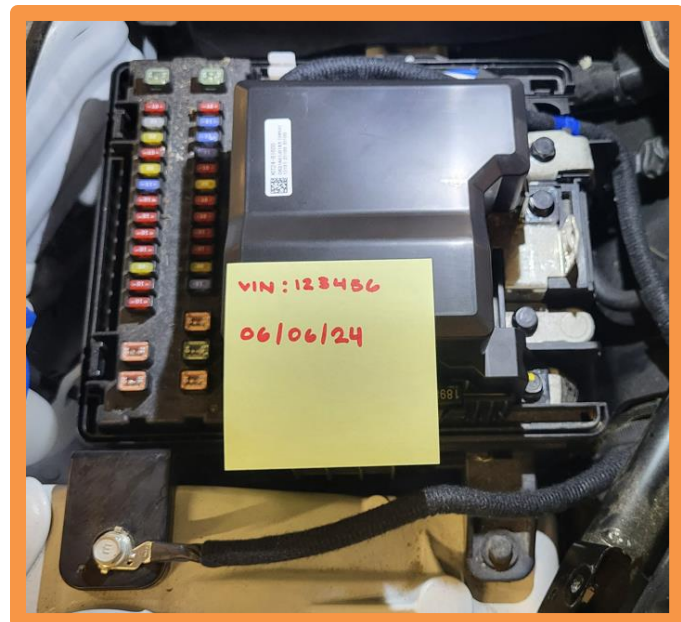
Using STUI, take a clear photo of the new bolts and relay kit installed, and the starter motor power terminal in the proper position, with the last 6 digits of the VIN and the date of repair on a piece of paper.
