Technical Service Bulletin

GROUP	NUMBER
RECALL	24-01-058G
DATE	MODEL(S)
JULY 2024	G70 (IK) G80 (DH) G90 (HI)

SUBJECT: STARTER RELAY KIT INSTALLATION (RECALL 018G)

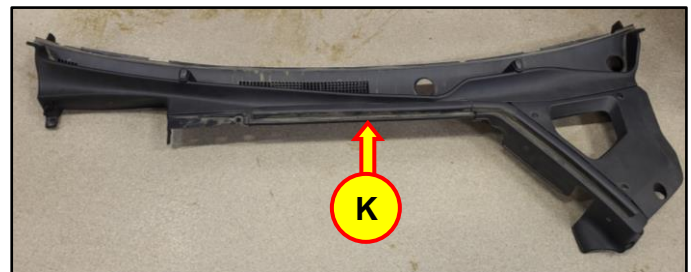
G70 (IK): Remove both wiper arms (J) and lift the entire cowl, driver side bulkhead and brake reservoir cover (K) out of the way and set aside.

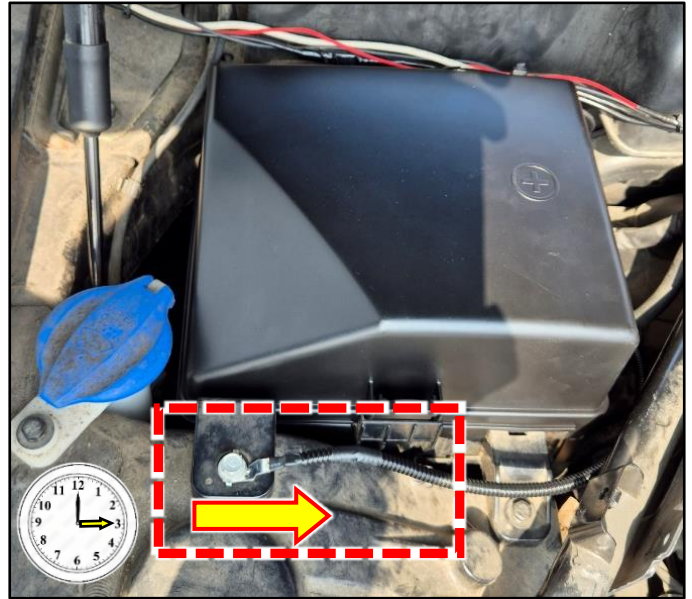
12. Attach the new upper cover to the junction box.

Confirm that the ground harness is installed in the “3 o’clock” position, as shown.
