# Recall Campaign Bulletin

Campaign No. 2024030008, March 2024

## **Replace Fuse Box(es)**

Mercedes-Benz AG, the manufacturer of Mercedes-Benz vehicles, has determined that on certain MY 2023-2024 C-Class, CLE, E-Class, EQE, EQE SUV, EQS, EQS SUV, GLC, S-Class, and SL (206, 214, 223, 232, 236, 254, 294, 295, 296 and 297 platform) vehicles, certain 80A fuses which were installed might not meet production requirements. As a result, a contact interruption or an increased triggering resistance might occur. In this case, systems connected to the fuse might become inoperable. The vehicle might also lose propulsion without warning, and restraint functions or the instrument cluster might be impaired, which could increase the risk of a crash or injuries. In addition, a risk of fire cannot be ruled out. An authorized Mercedes-Benz dealer will replace the respective main fuse box(es) on the affected vehicles.

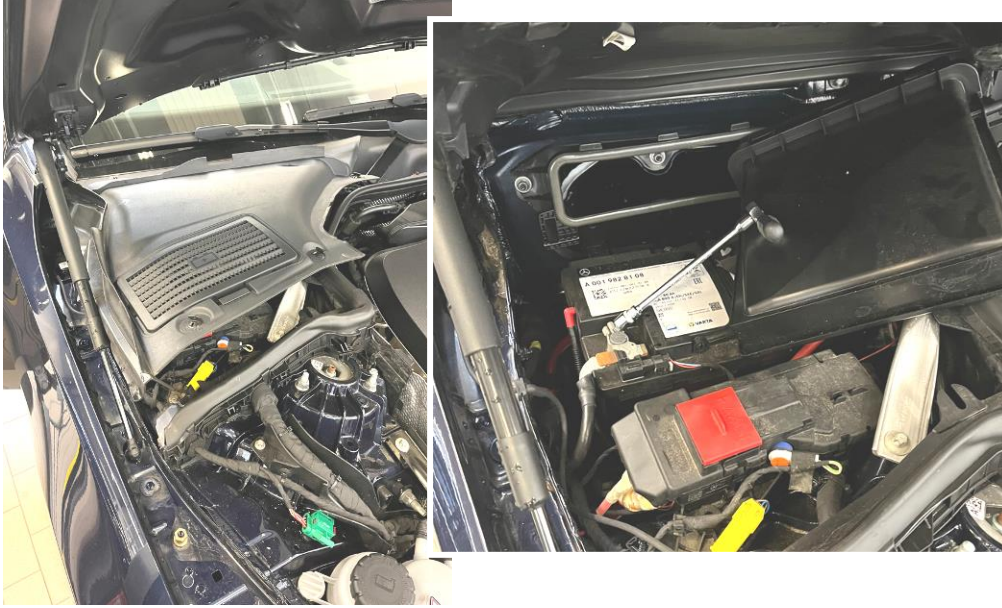
**Figure 1**

1. Disconnect ground line of 12 V battery (**Figure 1**).

**Nm** Screw/nut, electric line to battery terminal of on-board electrical system battery: **6 Nm**.

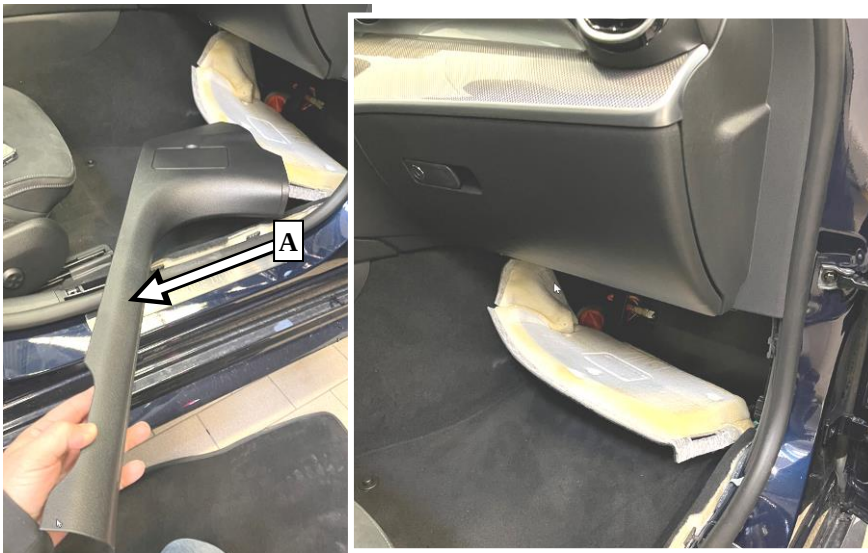
**Figure 2**

2. Remove floor mat, remove trim (**Figure 2, A**) from A-pillar / passenger door sill panel, and fold back floor covering on right front footwell.

**i** **Step 2 is not required for model 232** - Only remove the molded part under the floor mat.

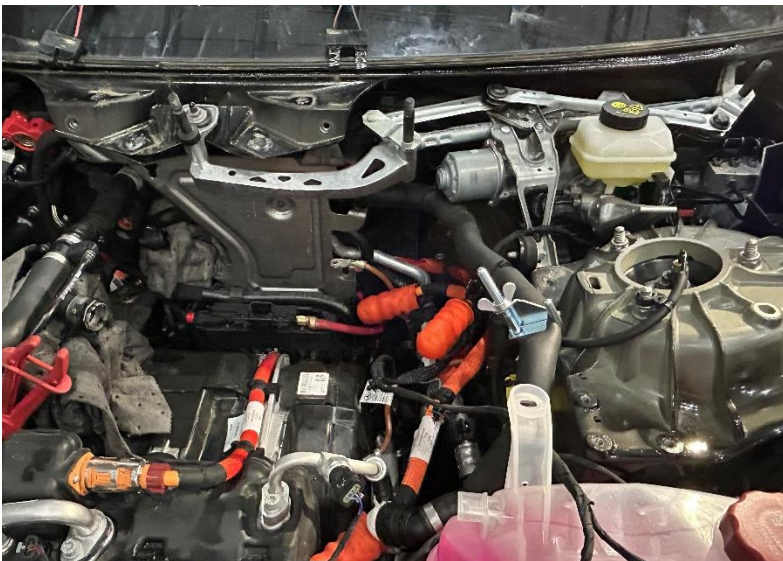
**Figure 7, HV electrical connectors with protective covers (001 589 06 91 00)**

**i** Pay close attention that High Voltage electrical connectors for DC/DC converter are clean and free from coolant.
