SPECIAL SERVICE CAMPAIGN 24TA04

REAR SEAT HEAD REST PERFORMANCE

CERTAIN 2023-2024 MODEL YEAR CAMRY AND CAMRY HV

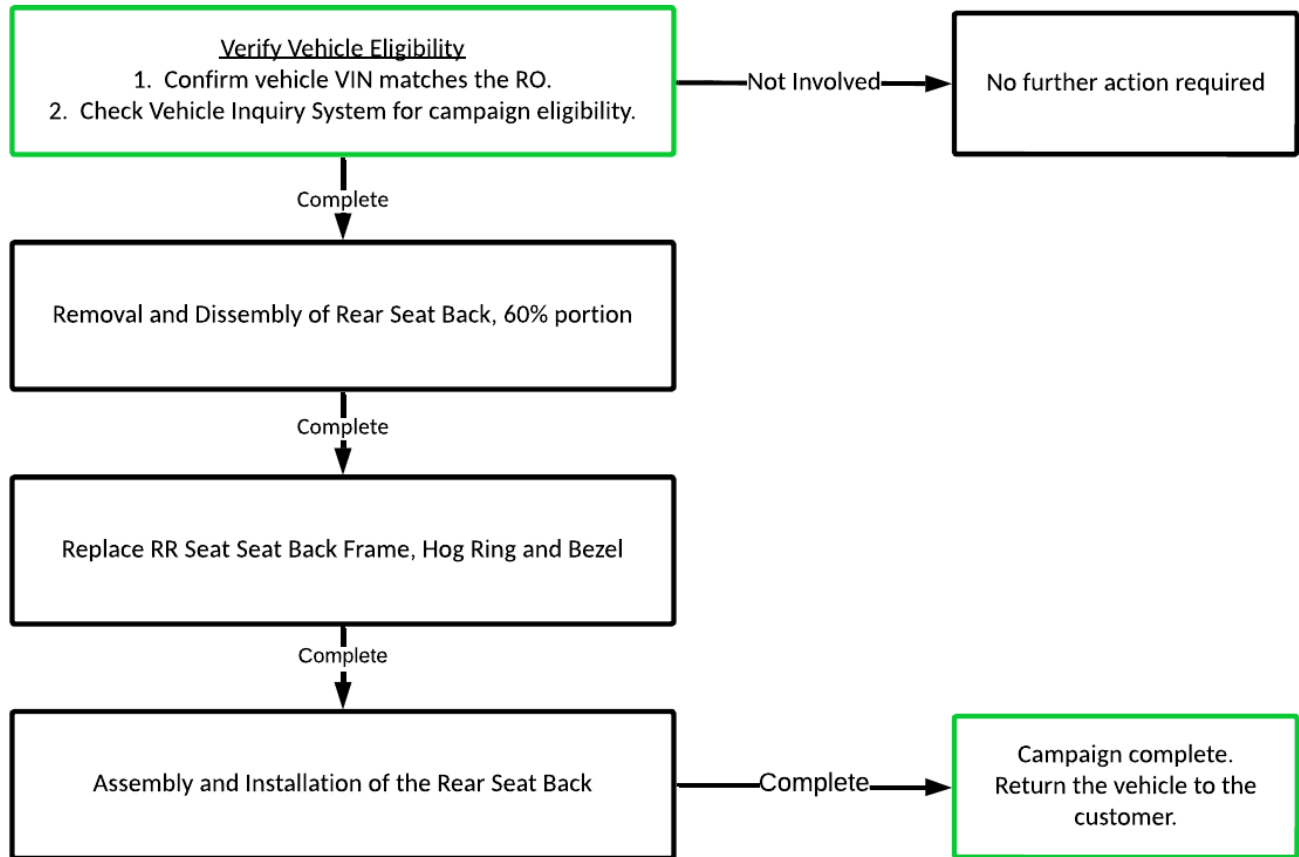
OPERATION FLOW CHART

The flowchart is for reference only. DO NOT use it in place of the full technical instructions. Follow ALL steps as outlined in the full technical instructions to confirm the campaign is completed correctly.

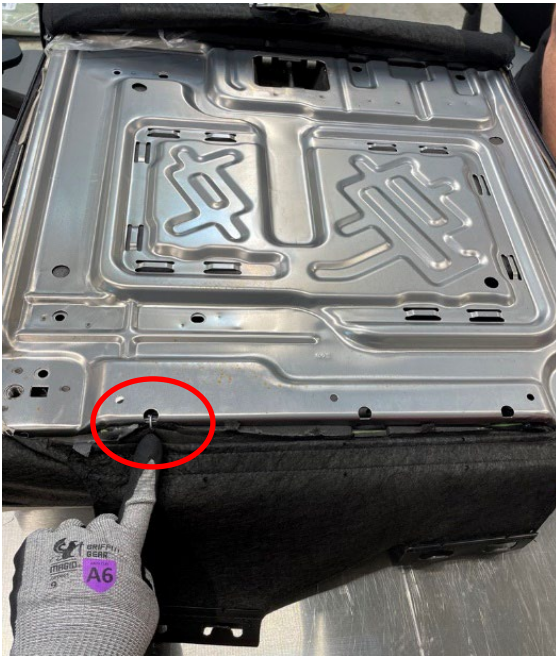
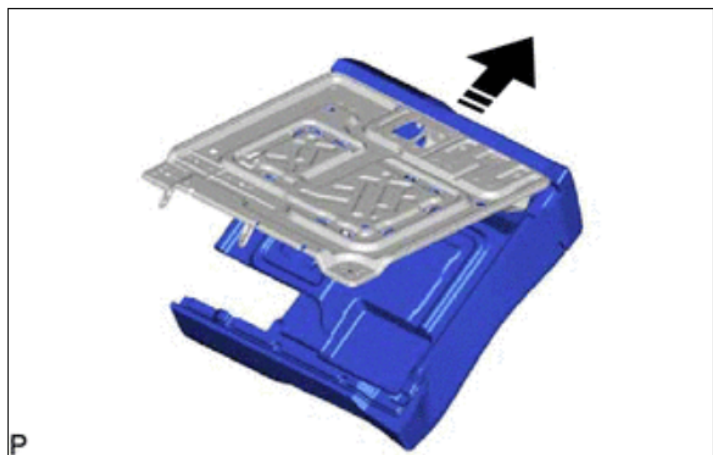
Please note the position of the single hog ring during disassembly. There is only one hog ring on this part of the assembly and is the only hog ring required to be replaced in this procedure.

2. Mark the old seat back frame, (1) hog ring, and bezel so as not to reinstall by accident.
3. Replace RR Seat Back Frame, (1) hog ring, and bezel with new parts.
4. Assembly and Installation of the RR Seat Back, (Camry and Camry HV Repair Manual links)
 - a. [SEAT: REAR SEAT ASSEMBLY \(for Fold Down Seat Type\): REASSEMBLY; 2020 - 2024 MY Camry \[09/2019 - \]](#),
 - b. [SEAT: REAR SEAT ASSEMBLY: REASSEMBLY; 2018 - 2024 MY Camry HV \[07/2017 - \]](#)
 - c. [SEAT: REAR SEAT ASSEMBLY \(for Fold Down Seat Type\): INSTALLATION; 2020 - 2024 MY Camry \[09/2019 - \]](#)
 - d. [SEAT: REAR SEAT ASSEMBLY: INSTALLATION; 2018 - 2024 MY Camry HV \[07/2017 - \]](#)

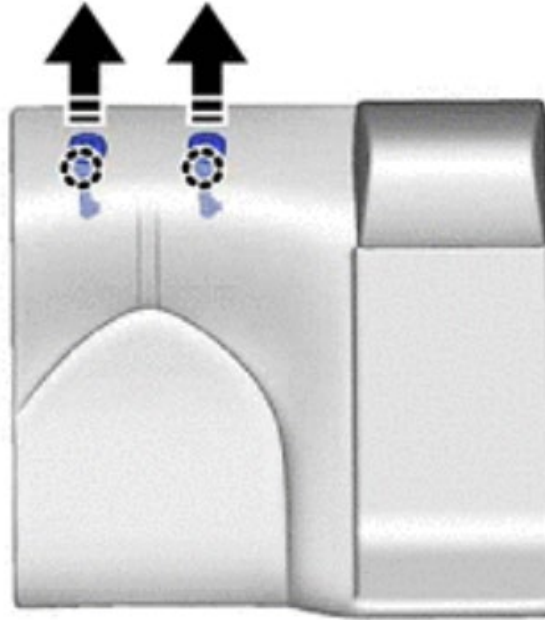
Remove in this Direction

When removing the headrest supports from the adjustable seat, be sure to disengage the two claws to prevent breaking the plastic on these reusable parts.

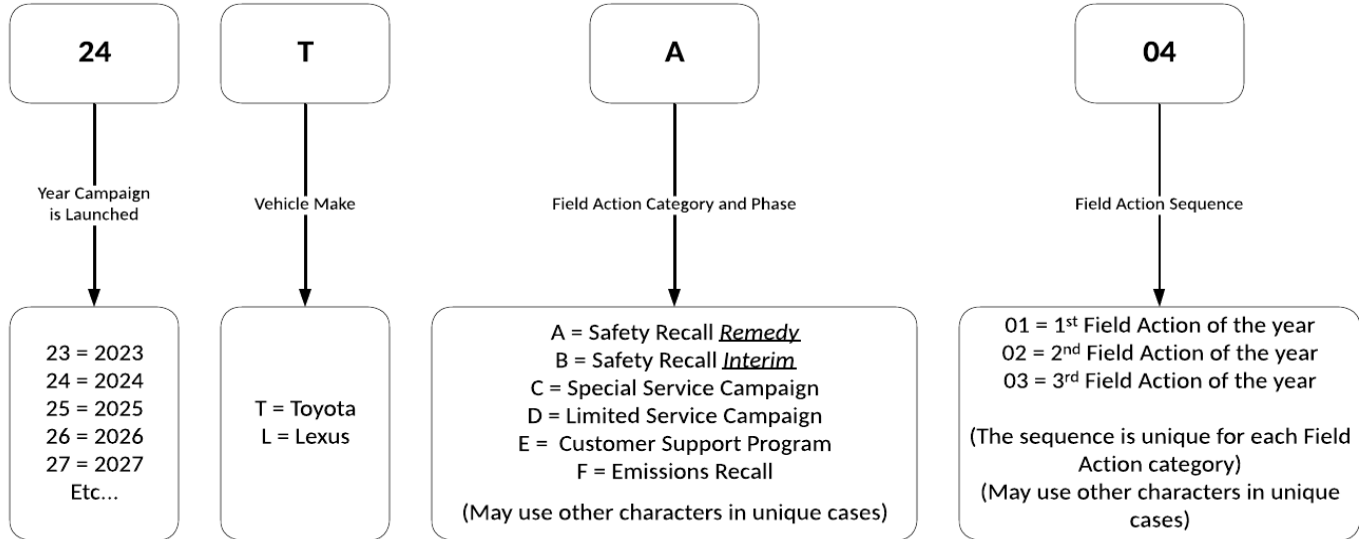
B. CAMPAIGN DESIGNATION DECODER

19TA01 = Launched in 2019, Toyota, Safety Recall Remedy Phase, 1st Safety Recall Launched in 2019

20TC02 = Launched in 2020, Special Service Campaign, 2nd Special Service Campaign Launched in 2020

21TE05 = Launched in 2021, Customer Support Program, 5th Customer Support Program Launched in 2021
