# SAFETY RECALL

## Steering Knuckle

Reference: 07B / NHTSA 24V-131

2024 (WL) Jeep Grand Cherokee

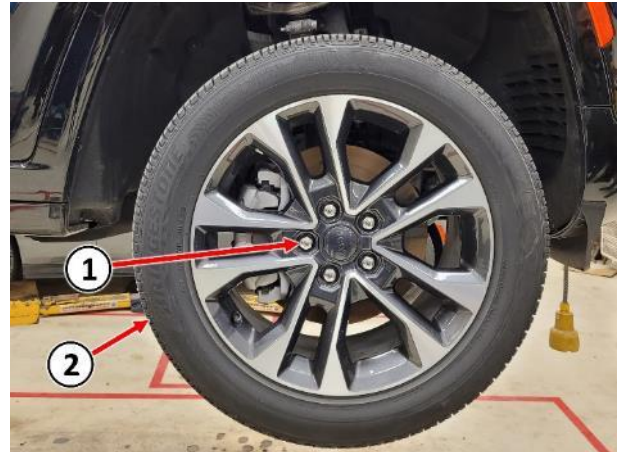
**Figure 1 – Tire and Wheel Assembly**

1 - Lug Nuts

2 - Tire and Wheel Assembly

2. Remove the lug nuts (Figure 1).
3. Remove the front tire and wheel assembly (Figure 1).
4. **If equipped**, have a helper apply brake pressure then remove and **DISCARD** the halfshaft hub and bearing nut (Figure 2).

58. Install the front tire and wheel assembly (Figure 1).
59. Install the lug nuts and Tighten in a star pattern to 176 N·m (130 Ft-Lbs) (Figure 1).
60. **DTC C0050-00 Brake System Hydraulic Leak** may be active after brake caliper was compressed for removal. If this code is set, pump the brake pedal several times to confirm a firm pedal feel (brake pads fully seated) then use the wiTECH scan tool to clear the code.

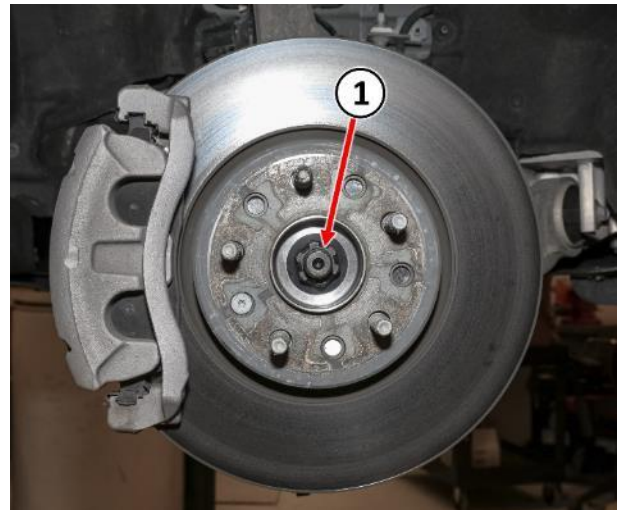
**Figure 2 – Halfshaft Nut**

1 - Halfshaft Hub and Bearing Nut

57. **If equipped**, have a helper apply brake pressure then install a **NEW** halfshaft hub and bearing nut and tighten to 310 N·m (229 Ft. Lbs.) (Figure 2).

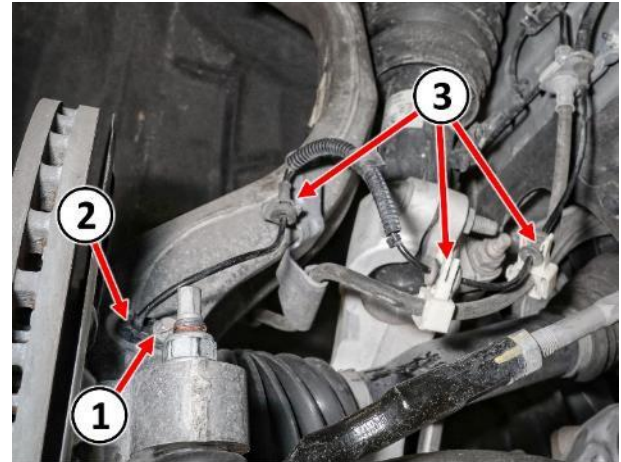
**Figure 3 – Wheel Speed Sensor**

5. Remove the wheel speed sensor bolt (Figure 3).
6. Remove the wheel speed sensor from the steering knuckle (Figure 3).
7. Disengage wheel speed sensor wire harness from the routing clips on the steering knuckle and brake hose (Figure 3).

- 1 - Wheel Speed Sensor
- 2 - Wheel Speed Sensor Bolt
- 3 - Wheel Speed Sensor Wire Harness Retainers

53. Engage wheel speed sensor wire harness routing clips to the steering knuckle (Figure 3).
54. Install the wheel speed sensor to the steering knuckle (Figure 3).

55. Install the wheel speed sensor bolt and tighten to 6 N·m (53 In. Lbs.) (Figure 3).
56. Pump the brake pedal several times to eliminate any excessive gap between brake pads and rotor which may have been caused by brake caliper removal.

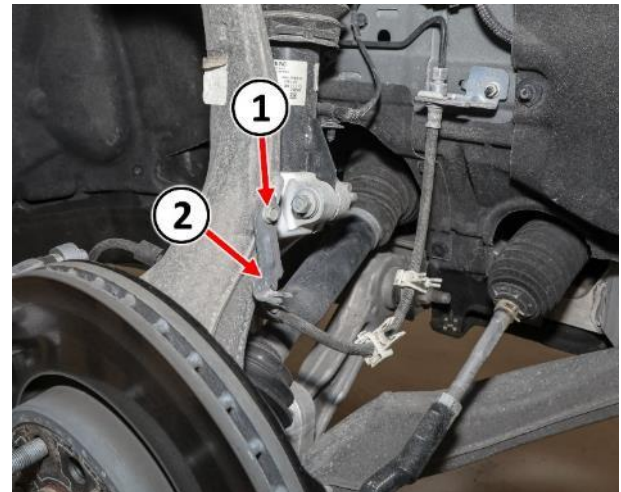
**Figure 4 – Brake Hose Bracket**

8. Remove the front brake hose bracket bolt (Figure 4).

- 1 - Front Brake Hose Bracket Bolt
- 2 - Front Brake Hose Bracket

51. Install the caliper adapter bolts and tighten to 170 N·m (125 Ft. Lbs.) (Figure 5).
52. Install the front brake hose bracket bolt and tighten securely (Figure 4).

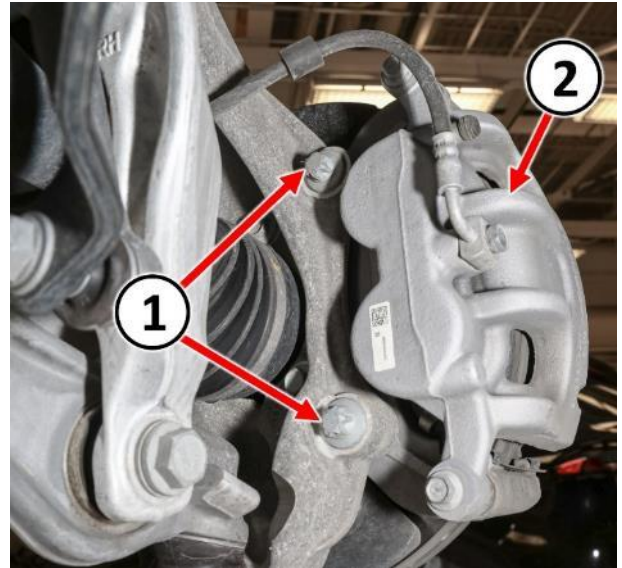
**Figure 5 – Brake Caliper**

9. If necessary, use a large C clamp to compress the brake caliper pistons enough to allow for caliper removal.
10. Remove the brake caliper adapter bolts (Figure 5).
11. Remove the brake caliper assembly (Figure 5).
12. Hang the brake caliper assembly using hook or strap.

**CAUTION:** Never allow the brake caliper assembly to hang from the brake hose. Damage to the brake hose will result. Provide a suitable support to hang the caliper securely.

- 1 - Front Caliper Adapter Bolts
- 2 - Front Brake Caliper Assembly

49. Install the brake rotor bolt and tighten to 20 N·m (15 Ft. Lbs.) (Figure 6).
50. Position the brake caliper assembly to the steering knuckle (Figure 5).

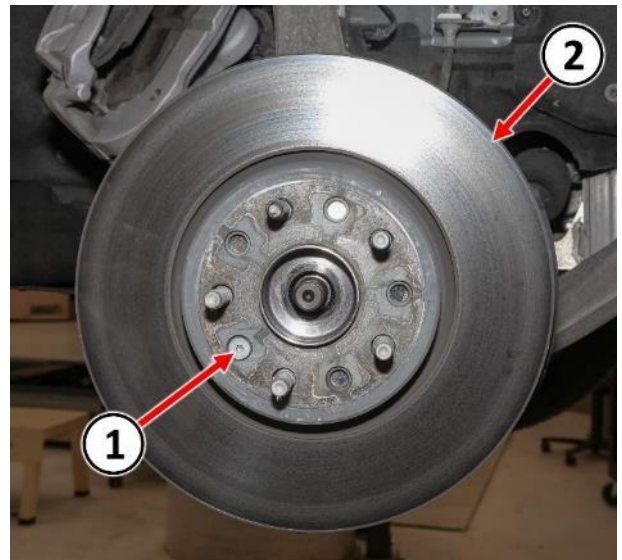
**Figure 6 – Brake Rotor**

13. Remove the brake rotor bolt (Figure 6).
14. Remove the brake rotor (Figure 6).

- 1 - Brake Rotor Bolt
- 2 - Brake Rotor

47. Position the brake rotor splash shield and install the bolts. Tighten the bolts to 11 N·m (8 Ft. Lbs.) (Figure 7).
48. Install the brake rotor (Figure 6).

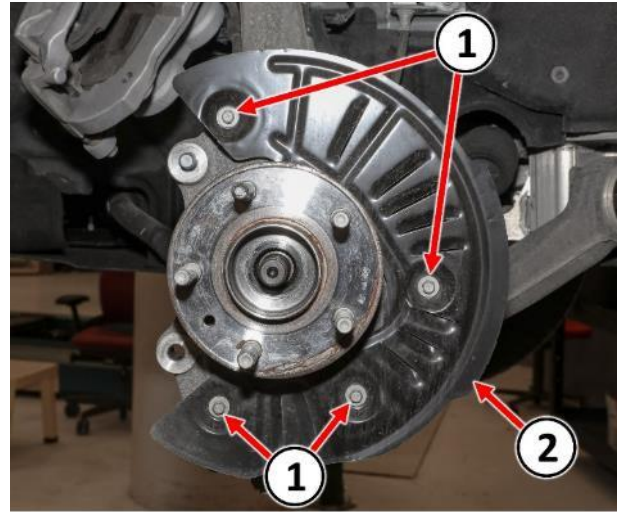
**Figure 7 – Brake Rotor Splash Shield**

15. Remove the brake rotor splash shield bolts and remove brake rotor splash shield (Figure 7).

1 - Brake Rotor Splash Shield Bolts

2 - Brake Rotor Splash Shield

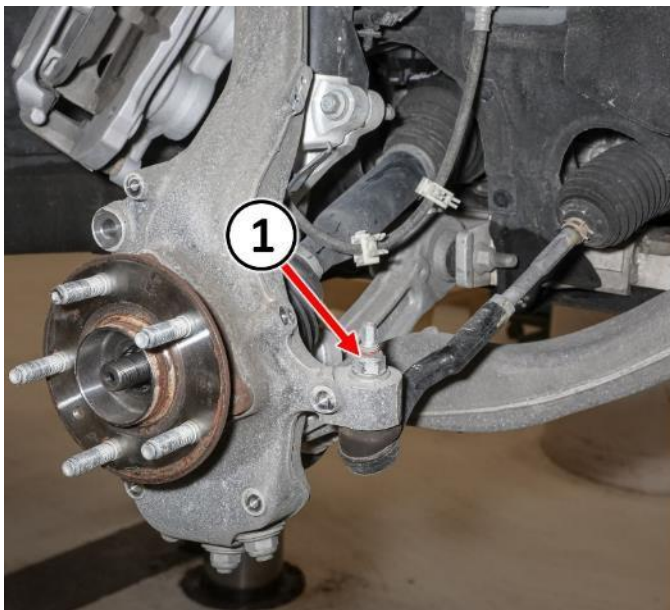
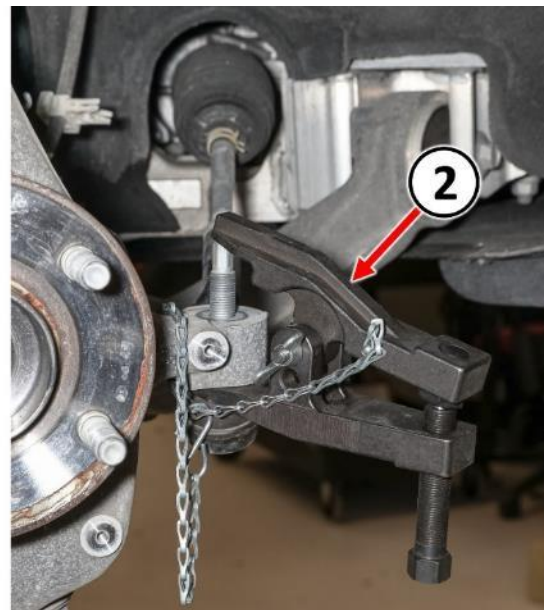
**Figure 8 – Outer Tie Rod End**

16. Hold the stud, then remove and **DISCARD** the tie rod end nut from the ball stud (Figure 8).

17. Separate the tie rod ball stud from the knuckle using Ball Joint Remover 9360.

1 - Tie Rod End Nut

2 - Ball Joint Remover 9360

45. Remove the jack stand from under the lower control arm spring handling link.
46. Install the tie rod ball stud to the steering knuckle. Hold the tie rod ball stud, then install a **NEW** nut and tighten to 54 + 110° N·m (40 + 110° Ft. Lbs.) (Figure 8).

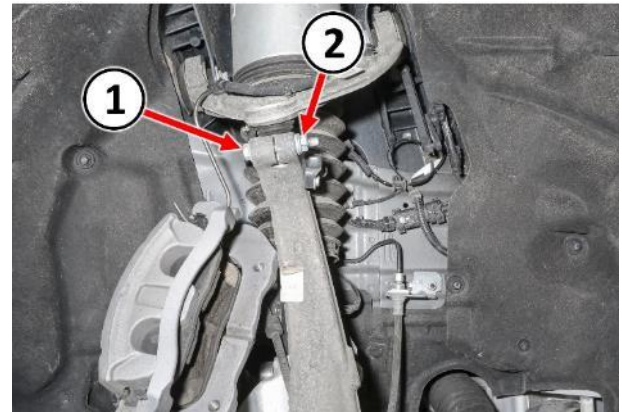
**Figure 9 – Upper Ball Joint**

**CAUTION:** The upper control arm must be pulled down slightly so there is no tension drawing the ball joint stud out of the steering knuckle when loosening or tightening the steering knuckle pinch bolt. Steering knuckle pinch bolt damage may occur if the ball joint stud notch is not centered to the steering knuckle pinch bolt.

18. Support the lower control arm spring handling link with a jack stand near the curb height position to avoid steering knuckle pinch bolt damage. Hold the bolt while loosening and removing the nut. **DISCARD** the nut (Figure 9).
19. Apply downward pressure to upper control arm with prybar to remove the steering knuckle pinch bolt then **DISCARD** the bolt (Figure 9).
20. Disengage the upper ball joint stud from the steering knuckle (Figure 9).
21. Remove the jack stand from under the lower control arm spring handling link.
22. Remove and **DISCARD** the tension link bolt (Figure 10).

- 1 - Steering Knuckle Pinch Bolt
- 2 - Steering Knuckle Pinch Bolt Nut

41. Support the lower control arm spring handling link with a jack stand near the curb height position to avoid steering knuckle pinch bolt damage. Insert the upper ball joint stud into the steering knuckle (Figure 9).

**CAUTION: The upper control arm must be pulled down slightly so there is no tension drawing the ball joint stud out of the steering knuckle when loosening or tightening the steering knuckle pinch bolt. Steering knuckle pinch bolt damage may occur if the ball joint stud notch is not centered to the steering knuckle pinch bolt.**

42. Apply downward pressure to upper control arm with prybar to install the **NEW** pinch bolt to the steering knuckle. Bolt must be installed from rear towards front of vehicle (Figure 9).

43. Install a **NEW** nut on the upper control arm pinch bolt, **do not tighten at this time** (Figure 9).
44. With suspension supported with a jack stand near the curb height position, tighten the following suspension components:

- Steering knuckle to upper control arm pinch bolt. Hold bolt and tighten the nut to 40 N·m (30 Ft. Lbs.) (Figure 9).
  - Align the mark on the adjustment bolt or eccentric if equipped to the subframe, then tighten the lower control arm spring handling link bolt and nut to 180 N·m (133 Ft. Lbs.) (Figure 14).

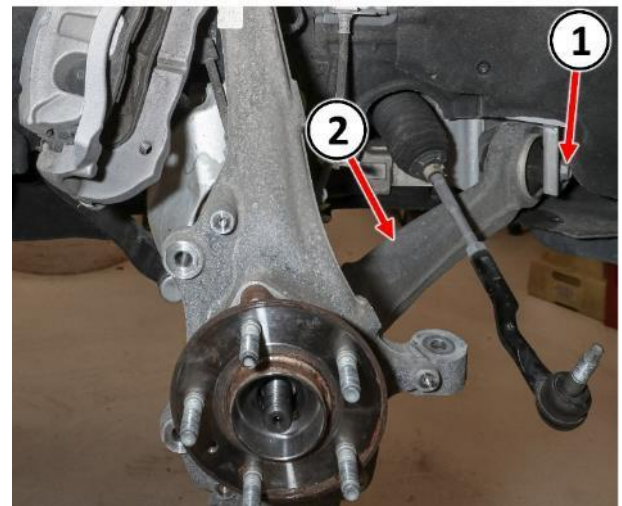
**Figure 10 – Tension Link**

- 1 - Tension Link Bolt
- 2 - Tension Link

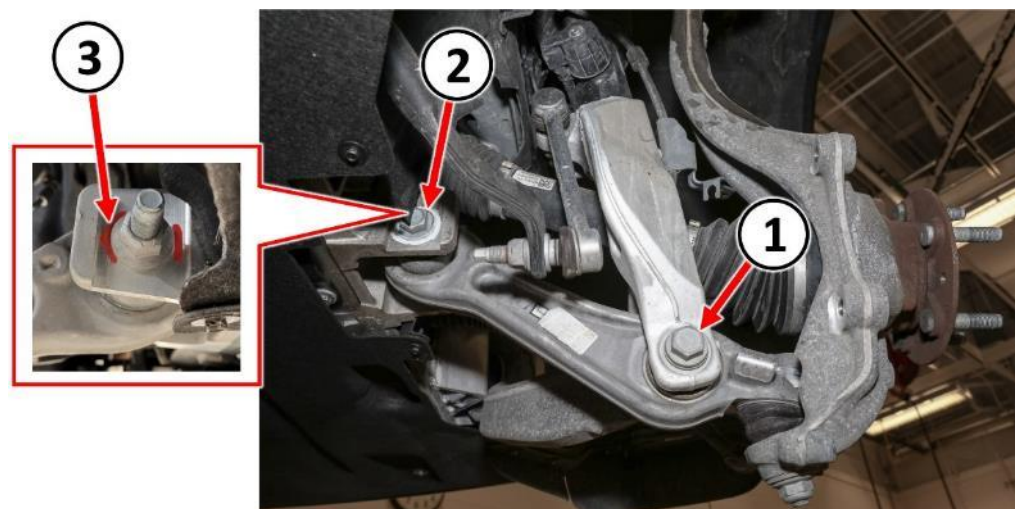
**Figure 11 – Spring Handling Link**

**CAUTION: DO NOT attempt to rotate the clevis lower nut. The clevis lower nut is pressed in the clevis bracket and damage will occur if the nut is rotated.**

23. Hold the clevis lower nut and remove and **DISCARD** the clevis lower bolt (Figure 11).
24. Mark the relation of the adjustment bolt and nut or eccentric if equipped to the subframe (Figure 11).
25. Remove and **DISCARD** the lower control arm spring handling link adjustment bolt and nut (Figure 11).

- 1 - Clevis Lower Bolt
- 2 - Spring Handling Link Adjustment Bolt
- 3 - Mark Adjustment Bolt/Nut to Subframe Relationship.

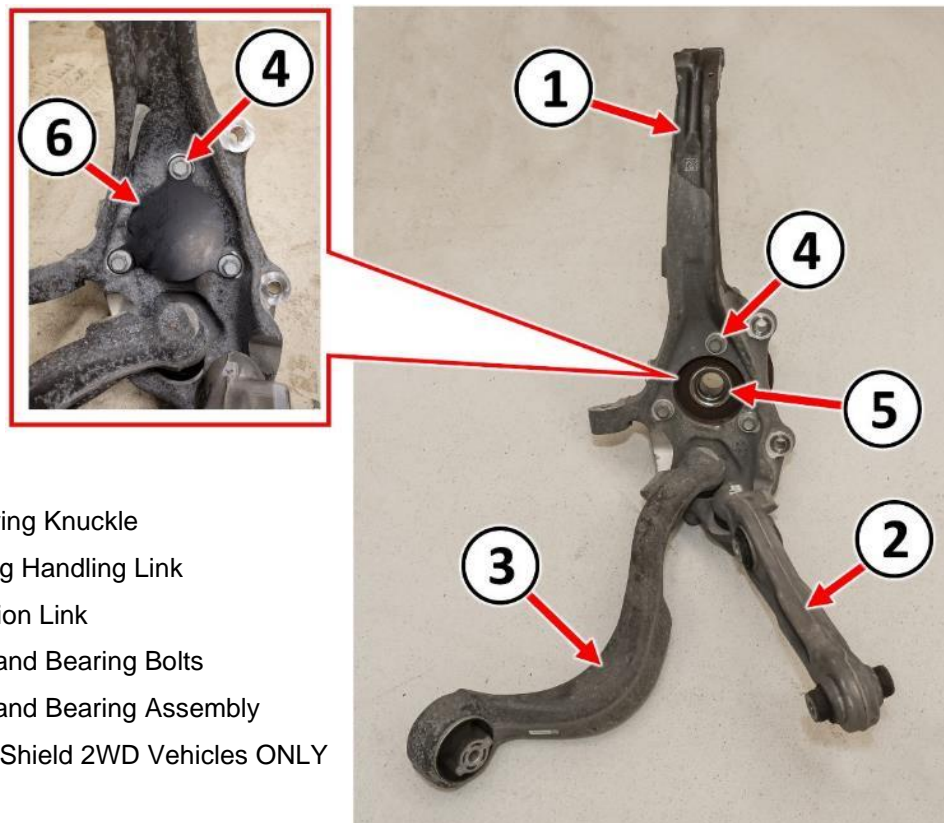
**Figure 12 – Steering Knuckle, Suspension Links, Hub and Bearing Assembly**

26. Remove the steering knuckle, spring handling link, tension link, hub and bearing as an assembly (Figure 12).

27. Remove the hub and bearing bolts (Figure 12).

**NOTE: 2WD vehicles will also have a dust shield retained by the hub and bearing bolts which will need to be removed (Figure 12).**

28. Remove the hub and bearing assembly from the steering knuckle (Figure 12).

29. **DISCARD** the steering knuckle, spring handling link, tension link assembly (Figure 12).

- 1 - Steering Knuckle
- 2 - Spring Handling Link
- 3 - Tension Link
- 4 - Hub and Bearing Bolts
- 5 - Hub and Bearing Assembly
- 6 - Dust Shield 2WD Vehicles ONLY

30. Install the hub and bearing into the **NEW** steering knuckle then install the bolts. Tighten the bolts to 116 N·m (86 Ft. Lbs.) (Figure 12).

**NOTE: 2WD vehicles will also have a dust shield retained by the hub and bearing bolts which will need to be installed (Figure 12).**

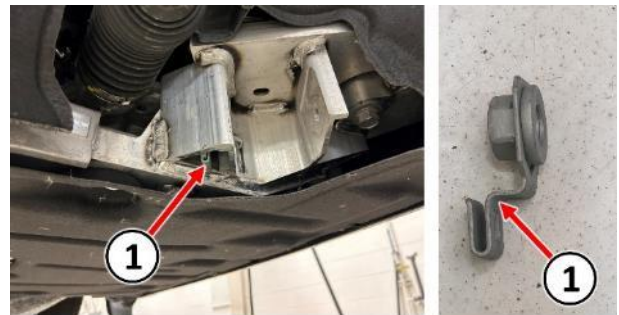
**Figure 13 – Tension Link Nut**

31. Remove and **DISCARD** the tension link nut then install a **NEW** tension Link nut (Figure 13).

**NOTE: In any instance where a bolt is through a rubber bushing, the bolt must be torqued with the vehicle at normal ride height.**

1 - Tension Link Nut

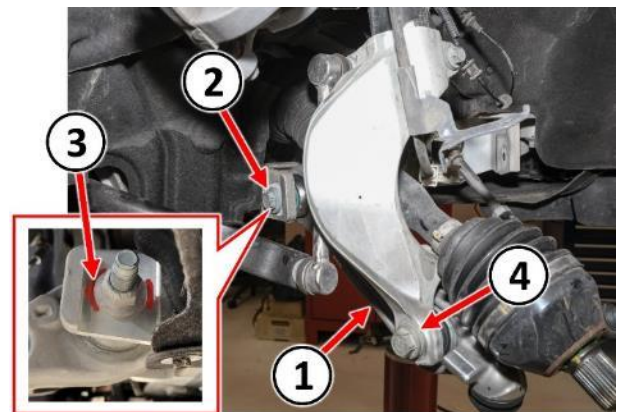
**Figure 14 – Spring Handling Link**

32. Install the **NEW** lower control arm spring handling link (Figure 14).

33. Install the **NEW** lower control arm spring handling link adjustment bolt, **do not tighten at this time** (Figure 14).

34. Install the **NEW** clevis lower bolt while holding the nut, **do not tighten at this time** (Figure 14).

1 - Spring Handling Link

2 - Spring Handling Link Adjustment Bolt

3 - Bolt/Nut to Subframe Relationship Mark.

4 - Clevis Lower Bolt

- Hold the clevis lower nut and tighten the clevis lower bolt to 308 N·m (227 Ft. Lbs.) (Figure 14).
  - Tighten the tension link bolt to 145 N·m (107 Ft. Lbs.) (Figure 15).

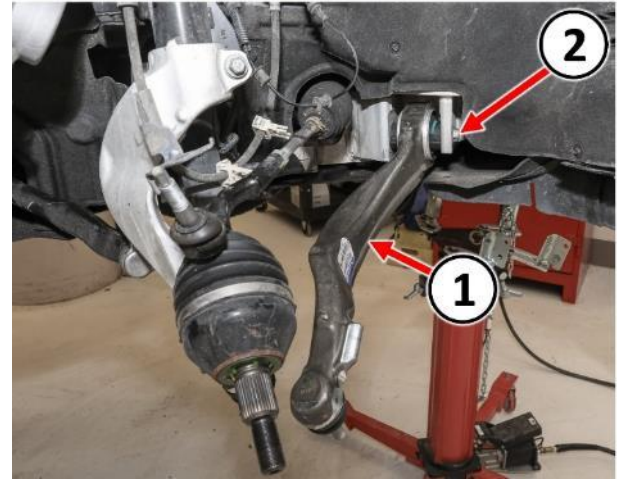
**Figure 15 – Tension Link**

35. Install the **NEW** tension link (Figure 15).
36. Install the **NEW** tension link bolt, **do not tighten at this time** (Figure 15).
37. Support the lower control arm spring handling link with a jack stand near the curb height position.
38. Position the **NEW** steering knuckle to the vehicle.

- 1 – Tension Link
- 2 – Tension Link Bolt

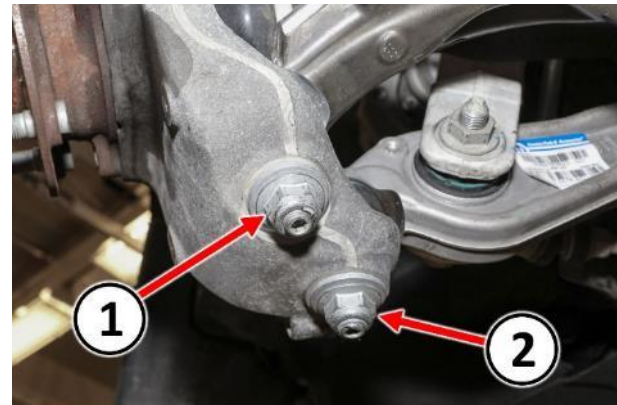
**Figure 16 – Lower Ball Joints**

39. Install the lower control arm spring handling link ball joint into the **NEW** steering knuckle. Hold the stud while installing the **NEW** nut. Tighten the nut to 70 + 85° N·m (52 + 85° Ft. Lbs.) (Figure 16).
40. Install the tension link ball joint into the **NEW** steering knuckle. Hold the stud while installing the **NEW** nut. Tighten the nut to 70 + 85° N·m (52 + 85° Ft. Lbs.) (Figure 16).

- 1 - Tension Link Ball Joint Nut
- 2 - Spring Handling Link Ball Joint Nut
