TSB Number:	164-001-2024
Product:	Brakes
Date:	February 27, 2024

Purpose

This document outlines repairing a specific list of units that may have brake lines unsecured to the chassis. The fix includes attaching P-clamps to secure brake lines to the chassis.

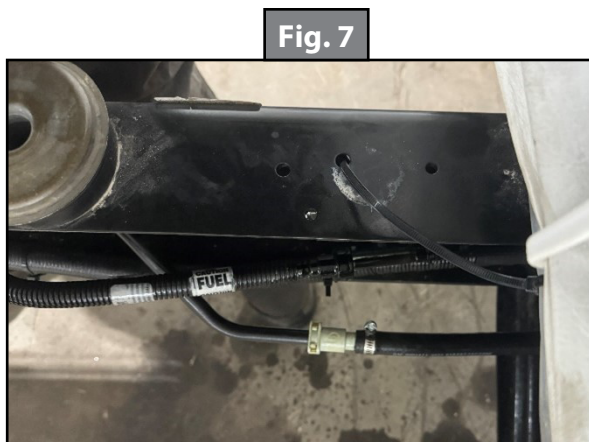
NOTE: Fig. 7 shows the finished repair.

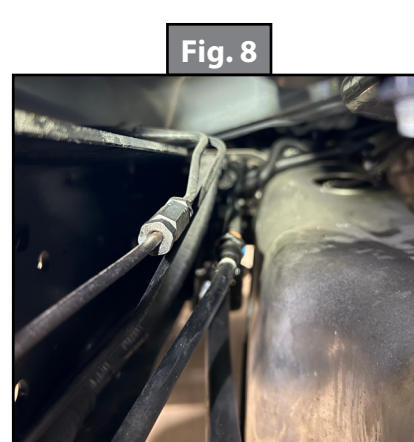
NOTE: Make sure the brake lines that run over the driver's side frame rail are not touching the frame rail. Fig. 8 shows the correct placement of the brake lines. If the brake lines touch the frame rail, the lines could develop a hole causing loss of brake pressure.
