**TECHNICAL INSTRUCTIONS**

**SAFETY RECALL - 24TA05**

**POTENTIAL AXLE SHAFT SEPARATION**

**CERTAIN 2022-2023 TACOMA**

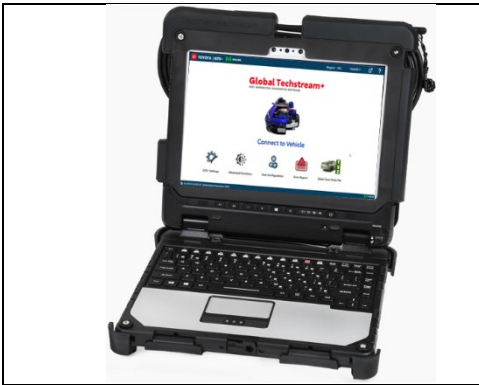
## VII. WELD SPATTER - AXLE NUT INSPECTION AND REPAIR PROCEDURE

### 1. CHECK FOR DTCs

- a. Using Techstream /GTS+, check for Diagnostic Trouble Codes.

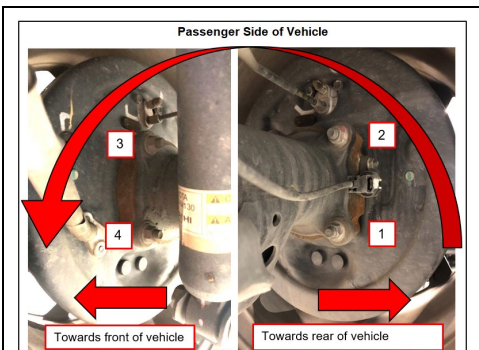
- b. Inspection and repair of passenger side rear axle housing nuts.

- i. Passenger side axle nuts are identified in the corresponding illustration (1 – 4).

**HINT:** When inspecting the passenger side, the rear shock absorber is on the axle tube's front side.

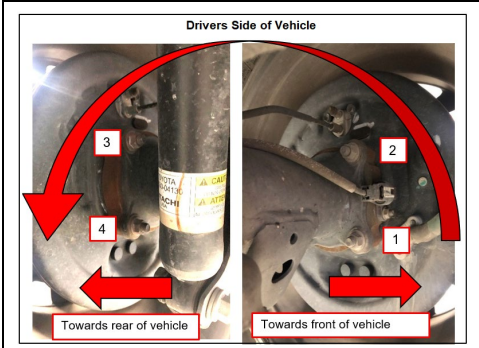
- c. Inspection and repair of driver side rear axle housing nuts.

- i. Driver side axle nuts are identified in the corresponding illustration (1 – 4).

**HINT:** When inspecting the driver side, the rear shock absorber is on the axle tube's rearward side.

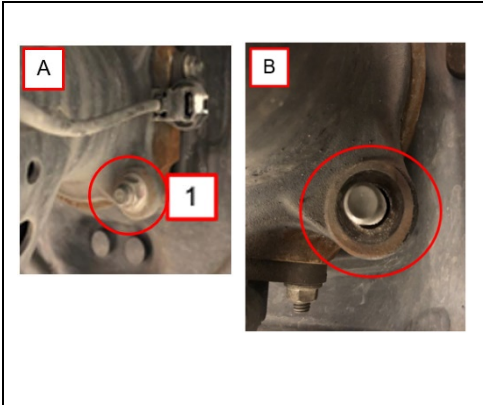
a. Remove and inspect nut #1.

- A.** Locate the passenger side nut #1 as shown in the illustration.
- B.** Remove the passenger side #1 nut.

**NOTE:** The area to inspect is the axle nut contact surface on the axle flange.

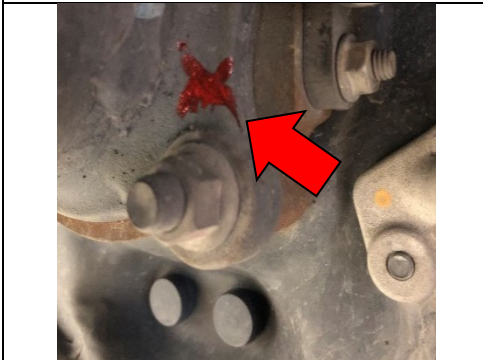
c. Carefully inspect the flat surface behind the axle nut to ensure the area is free of any weld spatter.

HINT: See examples of the "OK" condition vs. "NG" weld spatter condition in the corresponding illustration.

**Does any weld spatter exist?**

OK: Re-install axle nut and torque to specification.

NG: Proceed to Step 4.

**Torque:**

**55 N·m {41 ft·lbf}**

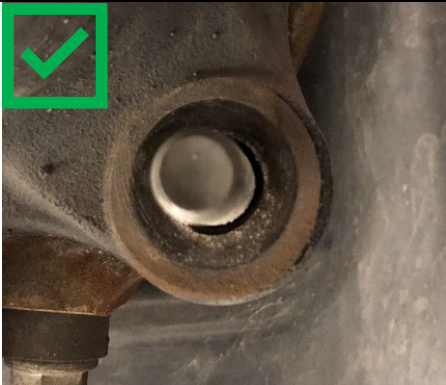
#### 5. VERIFY REAR AXLE HOUSING BOLT FLANGE IS CLEAR OF WELD SPATTER

- a. Check the surface for smoothness (any abnormalities/bumps should be removed using a chisel/file).
- b. Check visually for surface gouges.
- c. Assure a flat surface is maintained.

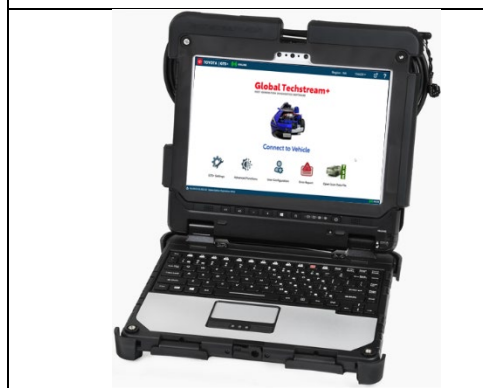
### 2. CHECK FOR DTCs

- Using Techstream / GTS+, check for Diagnostic Trouble Codes.
