VOLUNTARY RECALL CAMPAIGN

| Classification: RS24-004 | Reference: ITB24-004 | Date: March 5, 2024 |

VOLUNTARY SAFETY RECALL CAMPAIGN 2024 QX60; DRIVER SEATBELT PRETENSIONER

CAMPAIGN ID #: PD107
APPLIED VEHICLES: 2024 QX60 (L51)

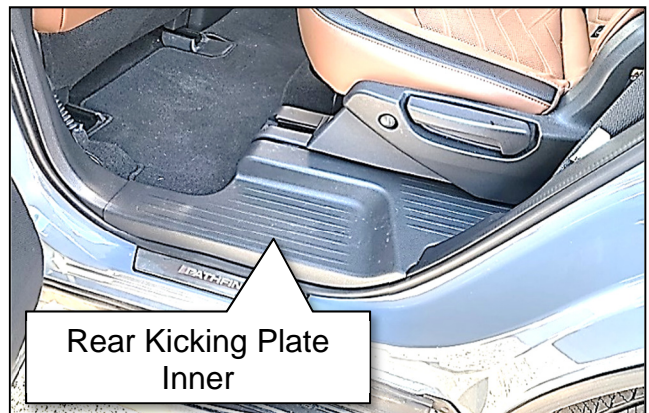
Figure 1

1. Remove the driver (LH) side Rear Kicking Plate Inner.
 - Refer to the ESM: **BODY INTERIOR > INTERIOR > REMOVAL AND INSTALLATION > BODY SIDE TRIM > KICKING PLATE > Removal and Installation > Rear Kicking Plate**

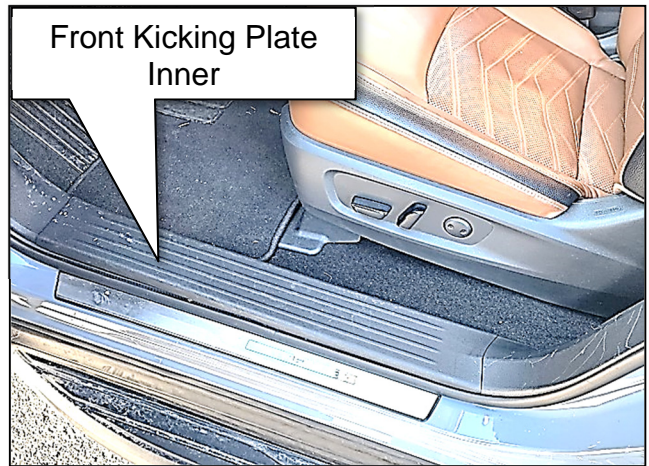
Figure 2

2. Remove the driver Front Kicking Plate Inner.
 - Refer to the ESM: **BODY INTERIOR > INTERIOR > REMOVAL AND INSTALLATION > BODY SIDE TRIM > KICKING PLATE > Removal and Installation > Front Kicking Plate**

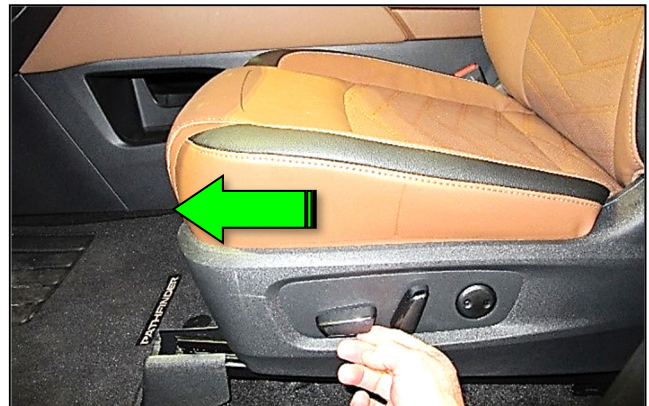
Figure 3

3. Move the driver seat all the way forward.

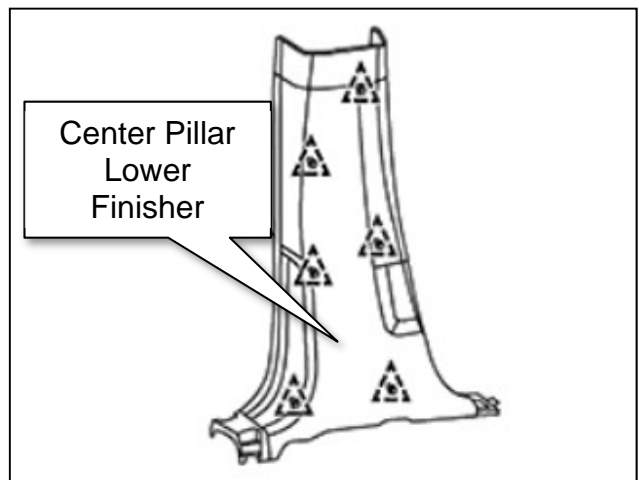
Figure 4

4. Remove the Center Pillar Lower Finisher.
 - Refer to the ESM: **BODY INTERIOR > INTERIOR > REMOVAL AND INSTALLATION > BODY SIDE TRIM > CENTER PILLAR LOWER FINISHER > Removal and Installation**

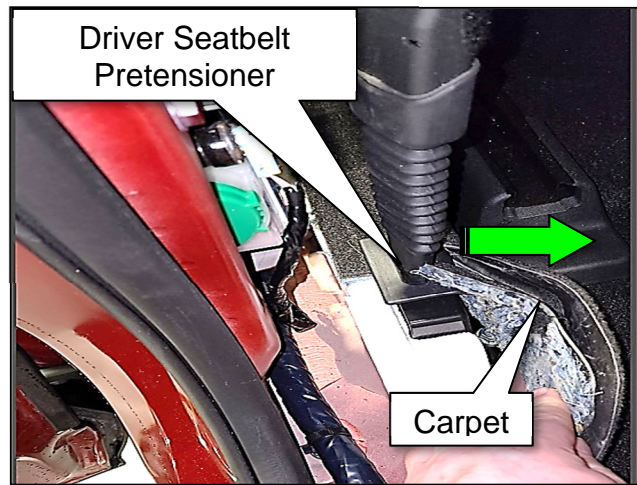
Figure 5

5. Position the carpet away from the Driver Seatbelt Pretensioner.

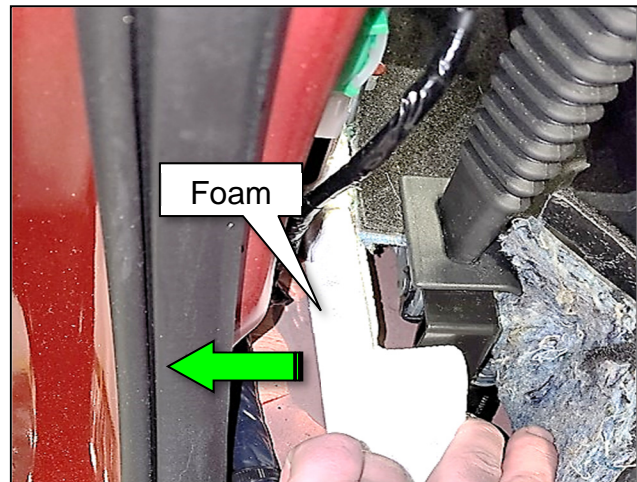
Figure 6

6. Carefully move the foam away from the Driver Seatbelt Pretensioner lower anchor.

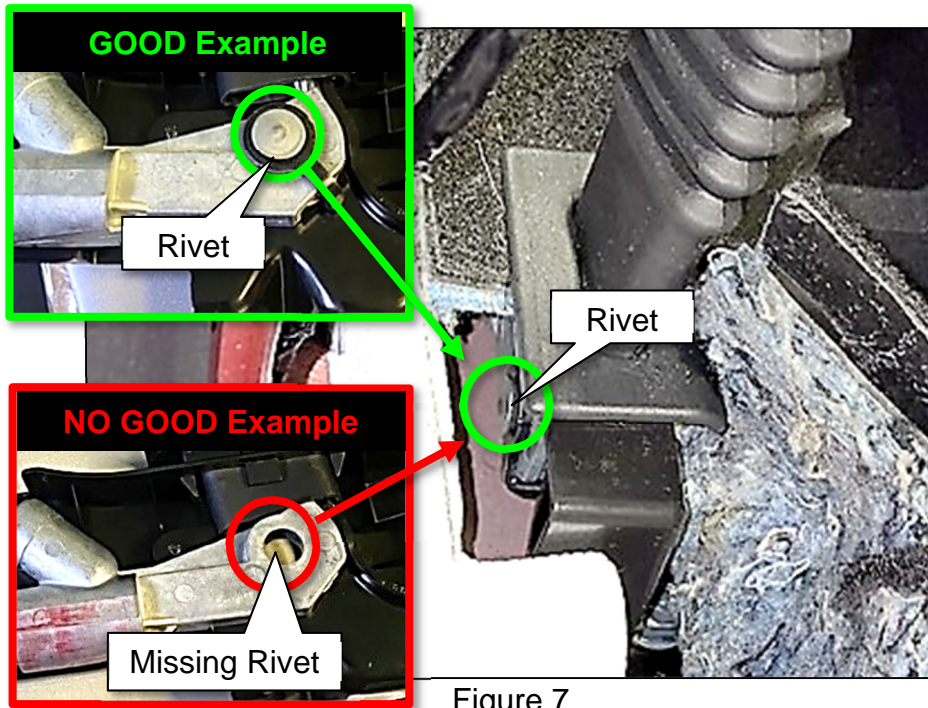
7. Inspect the Driver Seatbelt Pretensioner for the presence of a rivet, as shown in Figure 7.
- If the rivet is present on the Driver Seatbelt Pretensioner, no further action is needed. Continue to step 8 to reassemble the vehicle.
 - If the rivet is missing from the Driver Seatbelt Pretensioner, replace the Driver Seatbelt Pretensioner, and then continue to step 8 to reassemble the vehicle.
 - Refer to the **ESM: RESTRAINTS > SEAT BELT > REMOVAL AND INSTALLATION > FRONT SEAT BELT > SEAT BELT RETRACTOR > FOR USA AND CANADA > Removal and Installation**

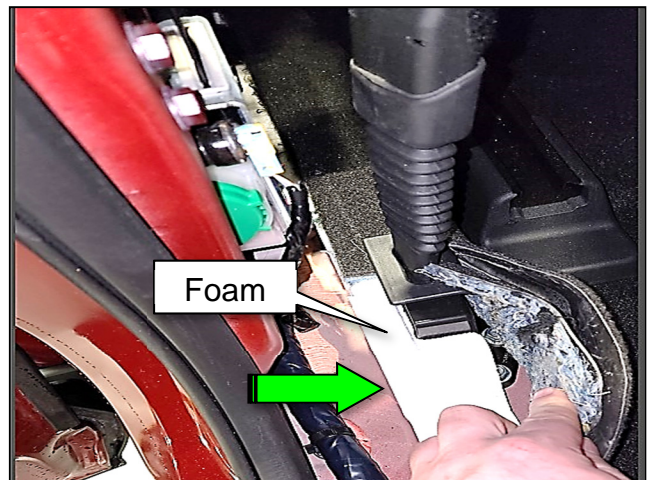
8. Reposition the foam against the Driver Seatbelt Pretensioner lower anchor.

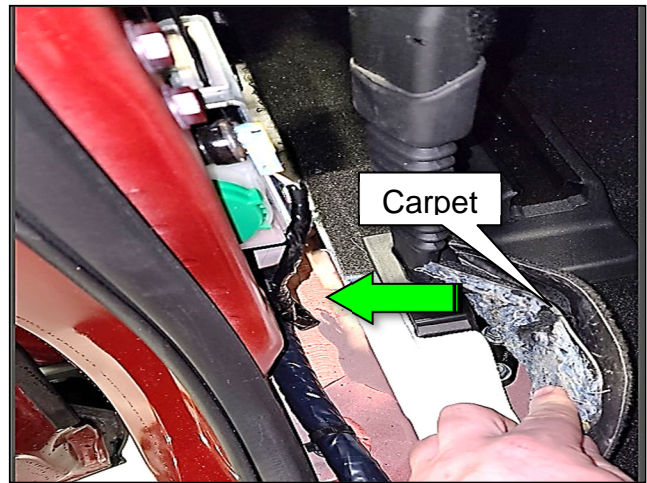
Figure 9

9. Reposition the carpet back to its original location.
