March 8, 2024

Safety Recall: 2023 Passport, Ridgeline EPS Gearbox Inspection

Due to a manufacturing error, two vehicles may have been produced with an improperly fastened inner ball joint housing and rack end in the steering gearbox assembly. Improperly manufactured electronic power steering (EPS) gearbox assemblies can affect steering function, potentially increasing the risk of a crash or injury.

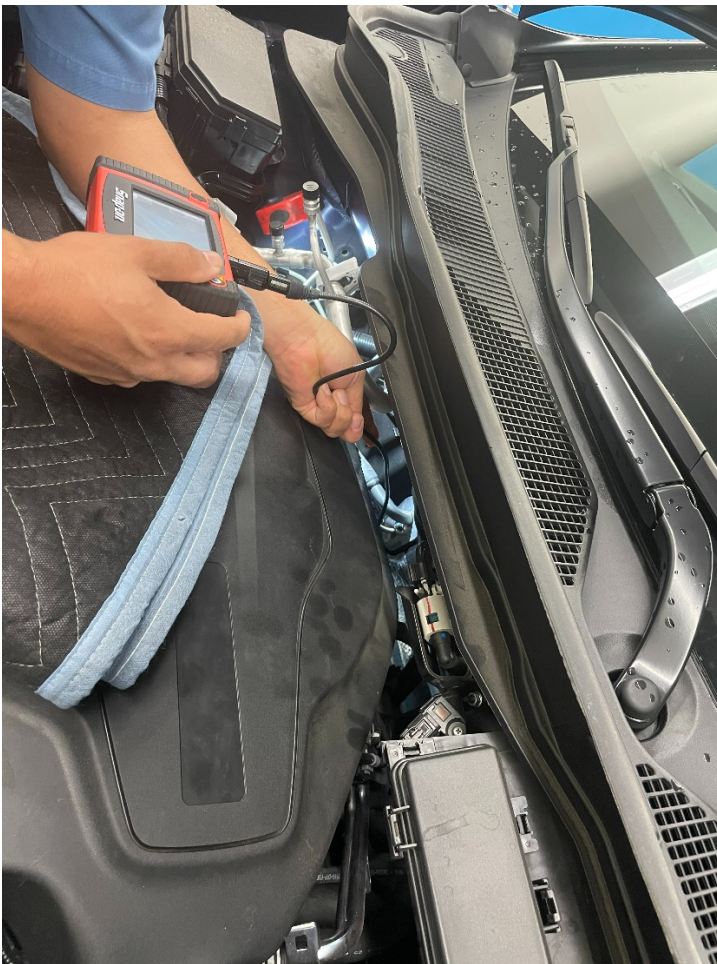
1. Open the hood and wait for the engine to cool down.
2. Using a borescope, locate the label on the EPS gearbox.

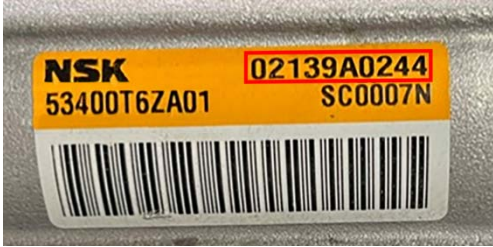
3. Inspect the label on the EPS gearbox and check the serial number on the label.

- If the EPS serial number is **012138T0167** or **012138T0126**, take a picture of the label, as you will need it to submit your warranty claim. Then go to REPAIR PROCEDURE.

Inspect the serial number, and if there is a match, replace the EPS gearbox assembly.

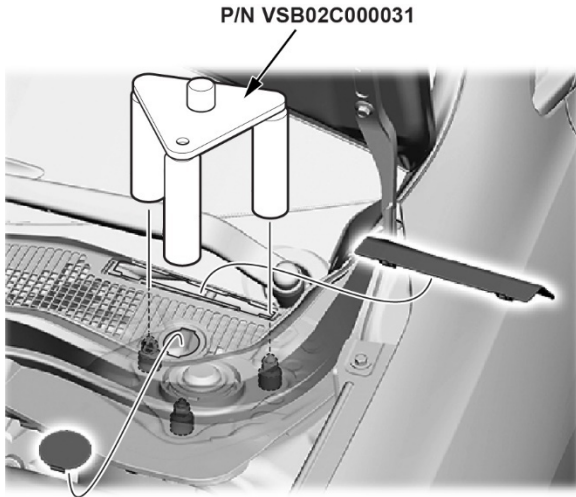
7. Install the engine support hanger.
 - Install engine hanger adapters (T/N: VSB02C000031)

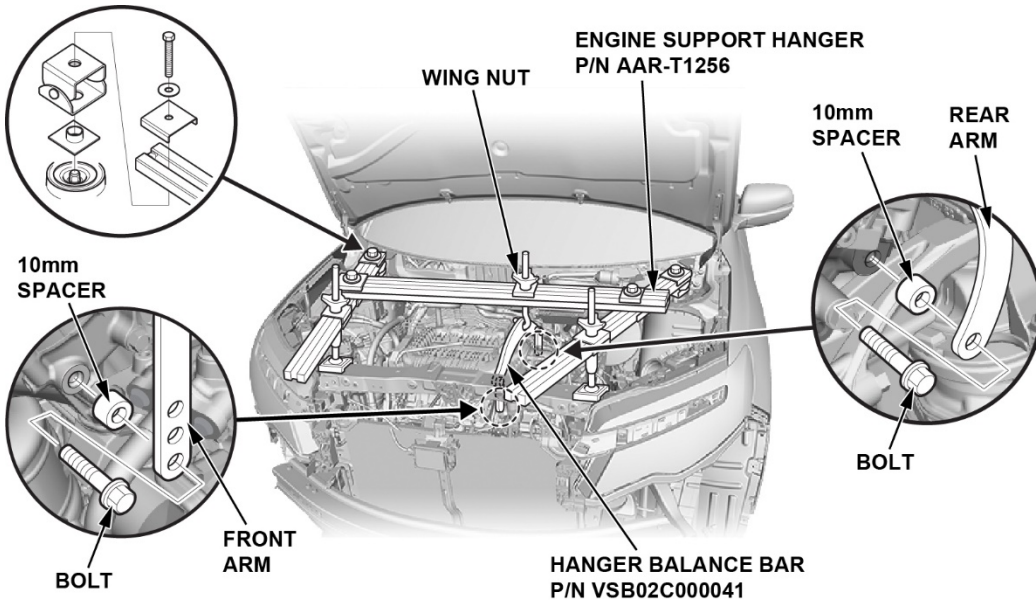
8. Install the engine hanger balance bar. (T/N: VSB02C000041).

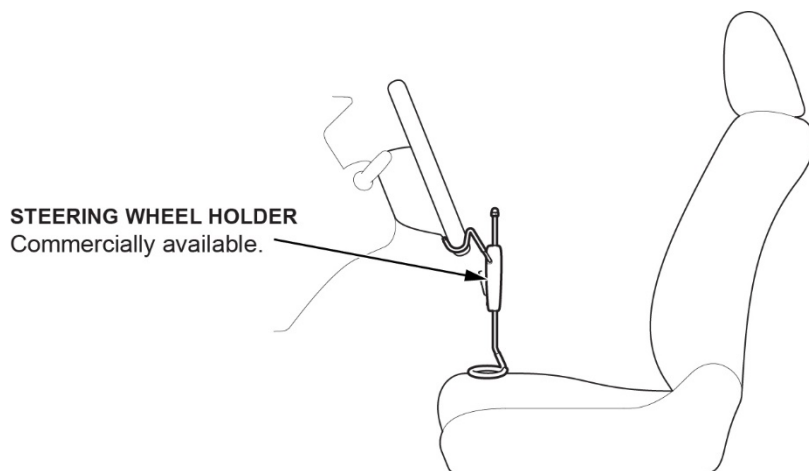
11. Set the steering column to the center tilt position and to the center telescope position and install the steering wheel holder tool.

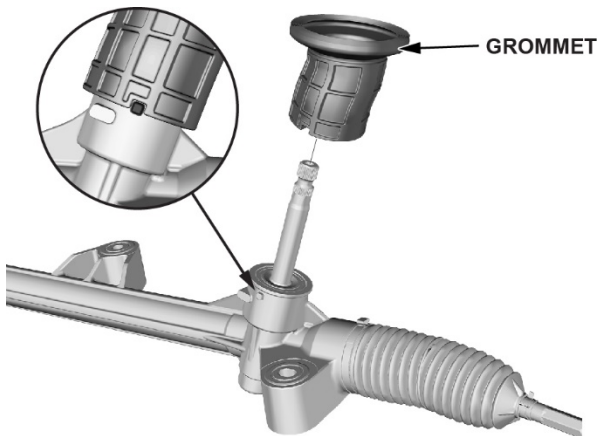
1. Install the pinion shaft grommet.

- Align the cutout portion with the tab portion.
- The grommet must not have a gap at the mating surface of the grommet and steering gearbox.

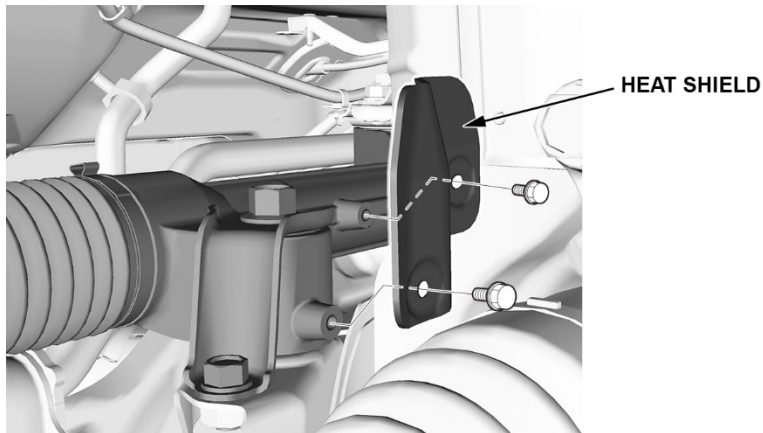
2. Install the gearbox heat shield **9.5 N·m (7 lb-ft)**.

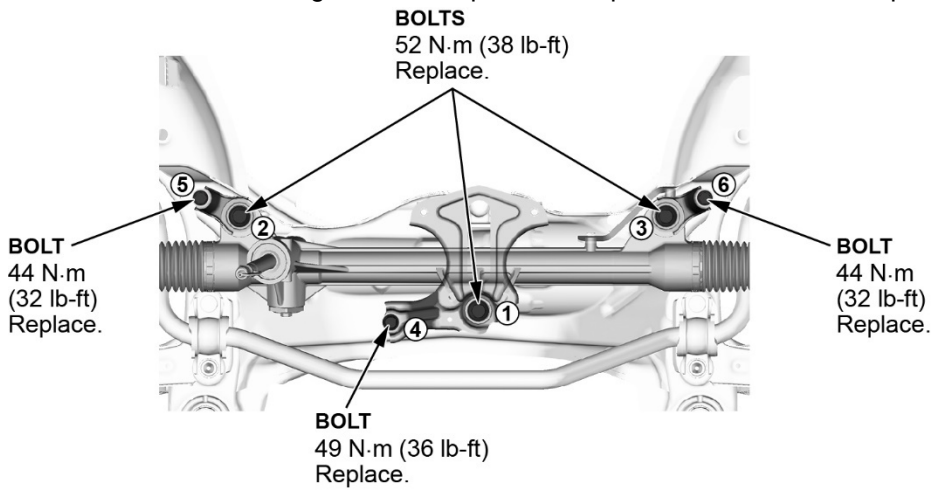
4. Install the steering gearbox on the front subframe.

- Tighten the steering gearbox mounting bolt, Install the stiffener mounting bolts, and Install the rear engine mount base bracket mounting bolt to the specified torque in the numbered sequence below.

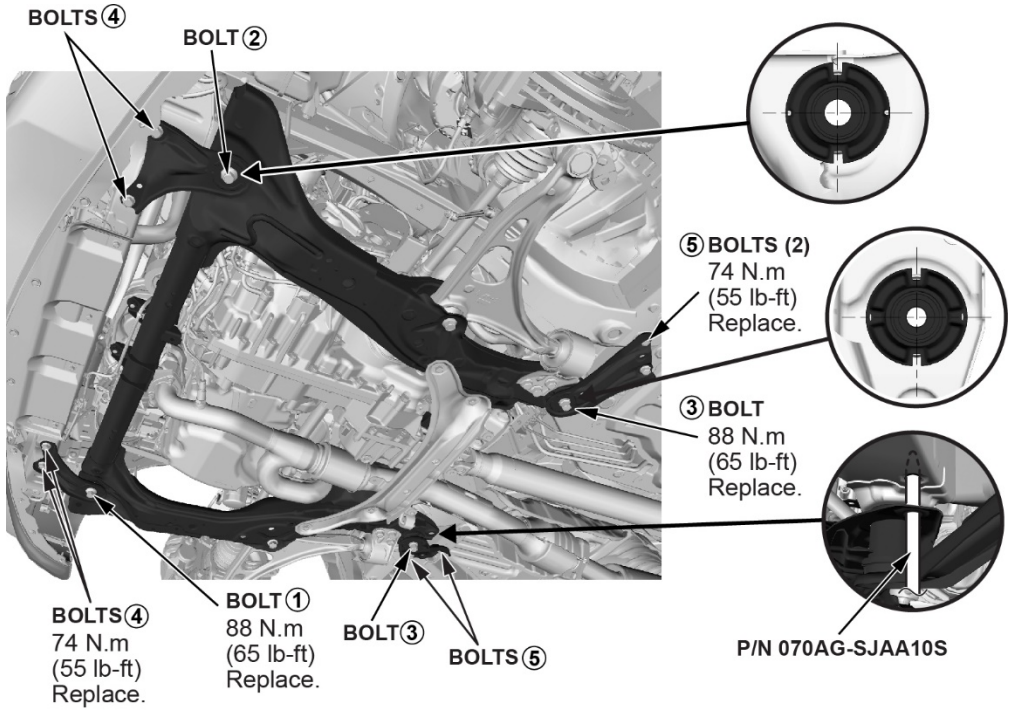
6. Raise the subframe and align the front subframe with the subframe alignment pin.
 - Tighten the mounting bolts to the specified torque in the numbering sequence shown.

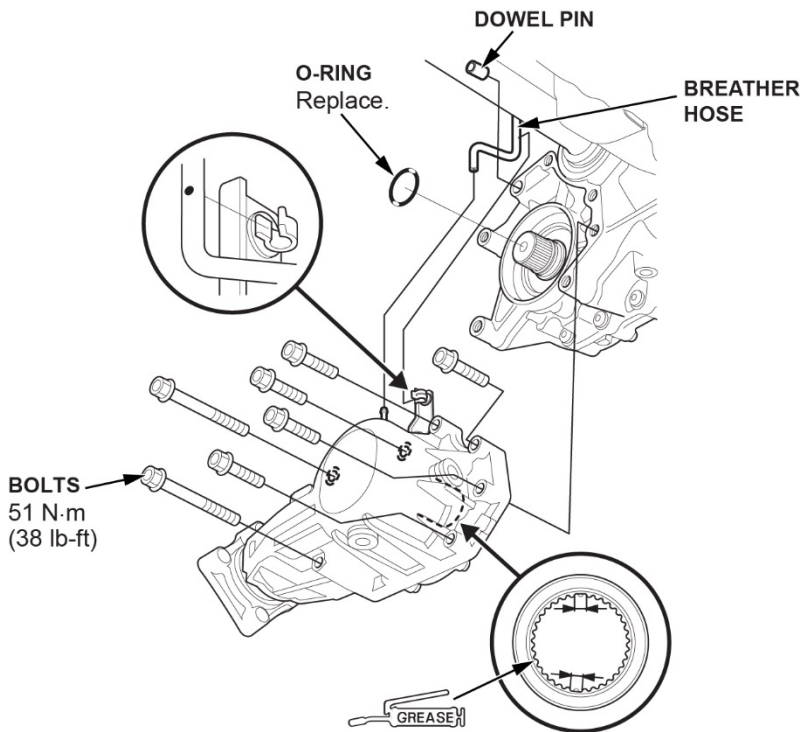
8. Install the transfer case.

- Clean the areas where the transfer assembly contacts the transmission with solvent and dry with compressed air.
- Install a new O-ring.
- Apply grease to the transfer shaft spines. (P/N: 04360-5P8-305).
- Install the transfer assembly with the dowel pin.
- Connect the breather hose by aligning the paint mark to the bracket.

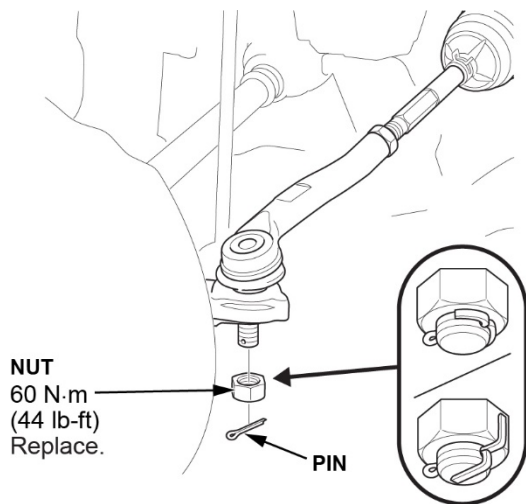
13. Connect the tie rod end ball joint.

- Wipe off grease contamination from the tapered ball joint section and threads.
- Connect the tie rod ball joint to the knuckle.
- Install a new nut and tighten to the specified torque.
- Install a new cotter pin.

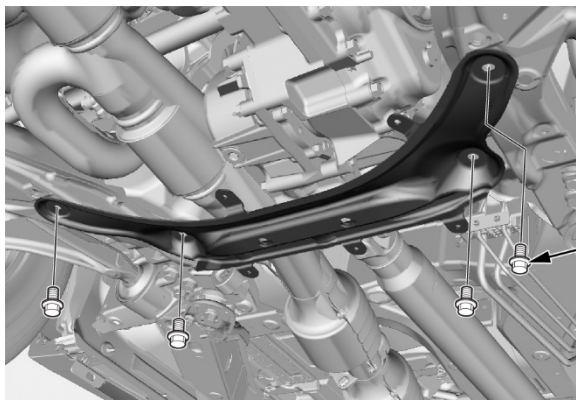
16. Install the front subframe stiffener plate.

BOLTS (4)
54 N.m
(40 lb-ft)
Replace.

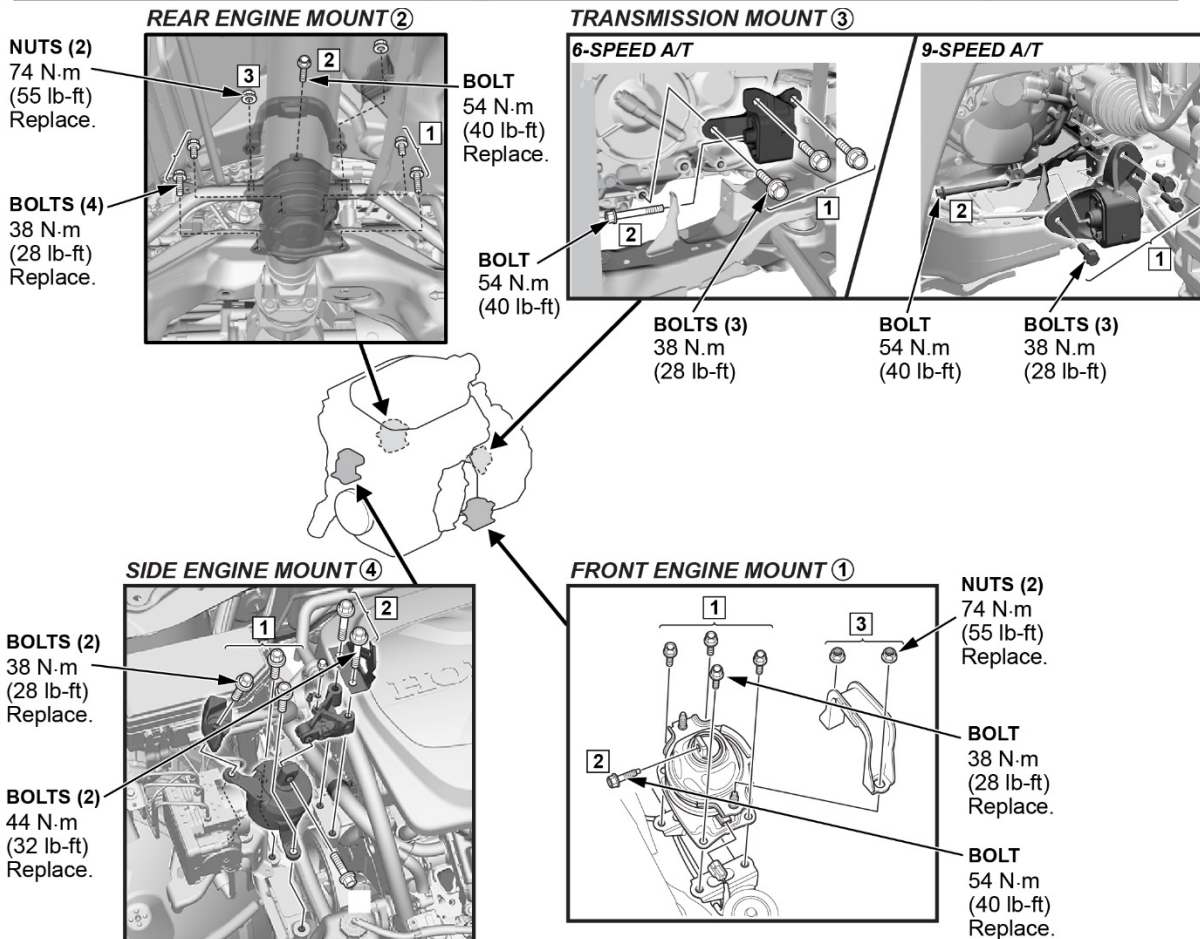
18. Install the engine and transmission mounts.

- When the front or rear engine mount is removed, loosen all bolts and nuts of ② and ③ first before tightening. Then tightening all bolts and nuts in the sequence as ①'s ② and ③, ②'s ② and ③, ③'s ②, and then ④'s ② and ③.
- When any mounts other than the front and the rear engine mounts are removed, only tighten the mount you just removed in the sequence listed below.
- Install the VSA modulator-control unit with bracket after tightening the side engine mount mounting bolts.

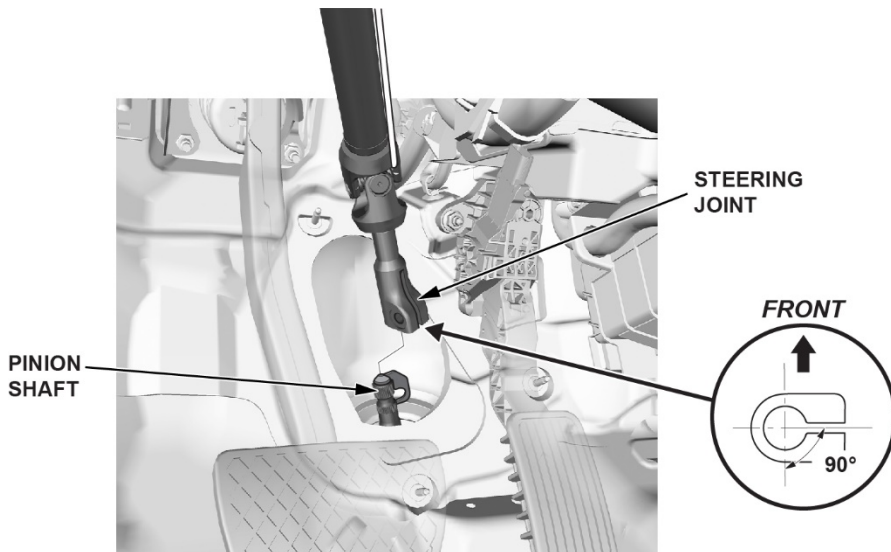
22. Install the air intake tube.
23. Install the front bulkhead cover.
24. Install the splash shield.
25. Install the engine undercover.
26. Install the front wheel and torque the nuts to **127 N·m (94 lb-ft)**.
27. Release the steering wheel.
28. Connect the steering joint.

- Align the bolt hole on the steering joint with the groove around the pinion shaft.
- Loosely install the steering joint bolt.
- Be sure that the joint bolt is securely in the groove in the pinion shaft.
- Pull on the steering joint to make sure that the steering joint is fully seated.
- Tighten the steering joint bolt to the specified torque.

NOTE: Install the steering joint bolt and tighten it within 5 minutes using the specified tightening torque.

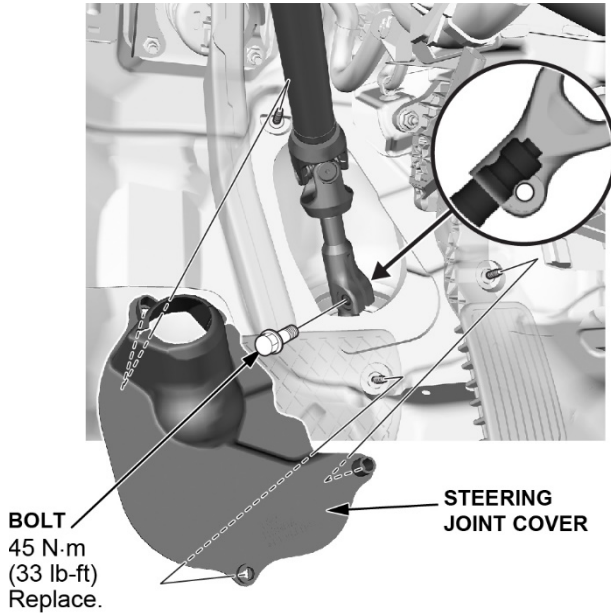
- Install the steering joint cover.

NOTE: Check the steering joint cover for damage and cracks. If the steering joint cover is cracked, replace the steering joint cover.
