## Technical Service Bulletin

<b>GROUP</b>	<b>NUMBER</b>
<b>RECALL</b>	<b>24-01-032G</b>
<b>DATE</b>	<b>MODEL(S)</b>
<b>APRIL 2024</b>	<b>G70 (IK), G80 (DH), G90 (HI)</b>

**SUBJECT:** TURBO OIL FEED PIPE REPLACEMENT (RECALL 019G)

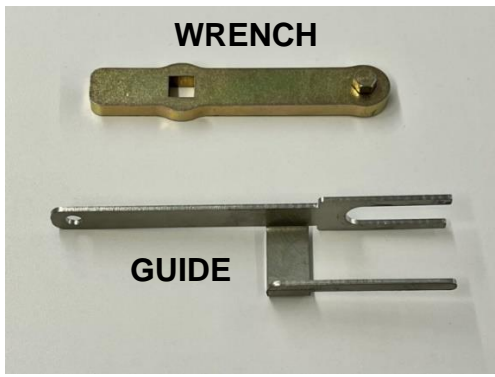
Tool Name	Tool #	Figure	Remarks
COOLING PIPE EYE BOLT REMOVAL WRENCH AND GUIDE	0K282-CK001QQH

<ul style="list-style-type: none"> <li>- Use the newly supplied tool set to remove and reinstall the turbocharger water pipe and hose.</li> <li>- Each retailer has been provided 1 tool set at the start of the recall.</li> </ul>

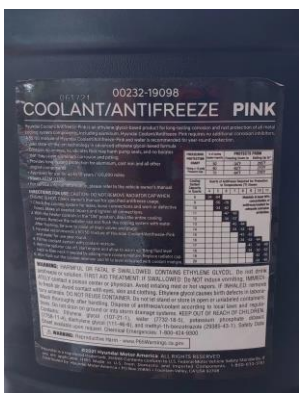
Description	Supply #	Figure	Remarks
PINK, ANTIFREEZE/ COOLANT	00232-19098

<ul style="list-style-type: none"> <li>- Allowance of 1 gallon (3.78L) has been included for this procedure.</li> <li>- Do not use 100% full strength. Prepare coolant mixed with distilled/filtered water to refill the cooling system. (35 to 50% antifreeze, diluted with water)</li> </ul>

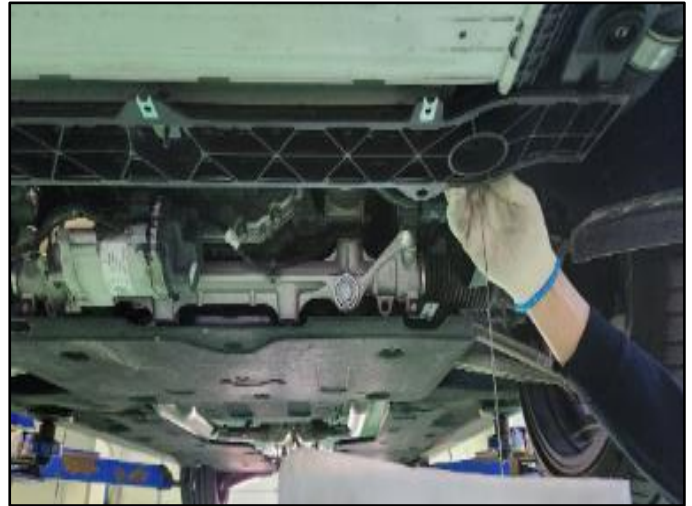
## 3. Drain the coolant.

- Do not reuse drained engine coolant.
- Disconnect the coolant vent hose to allow initial air bleeding when refilling the cooling system.
- Afterwards perform the “Electric Thermostat Engine Coolant Filling Mode” using the GDS to complete the final air bleeding process.

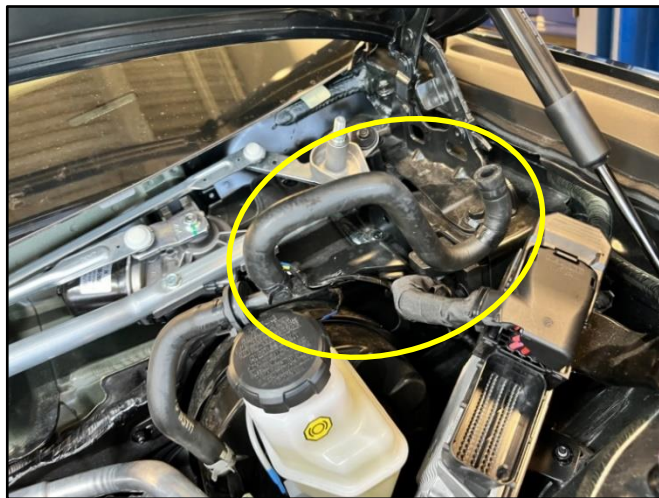
13. Unclamp and disconnect the brake booster hose end (L) from the intensifier and then move it aside (as shown below).

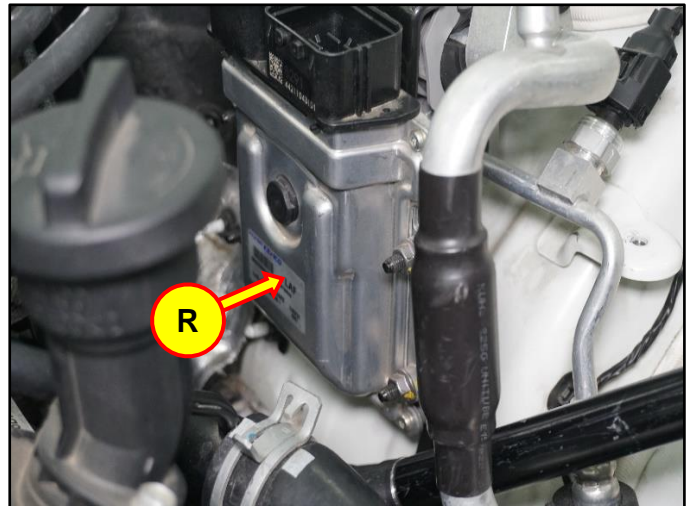
**Tightening Torque:**

lb-ft	8
N.m	10.8
