# SAFETY RECALL

## Flashers and Turn Signals

Reference: 21B / NHTSA 24V-197

Remedy available for  
2021-2022 (VF) RAM ProMaster

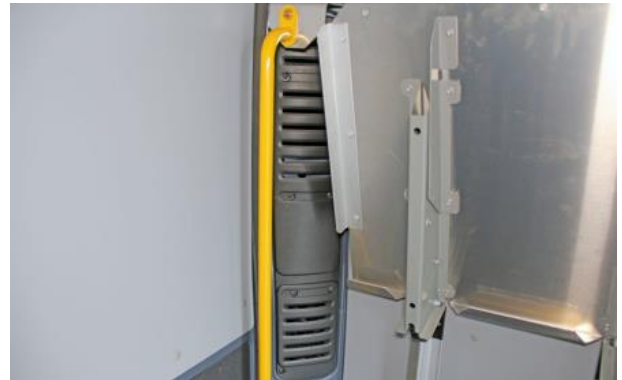
**Figure 1 – D-pillar Trim Panel**

1. Remove the trim panel from the LH rear door D-pillar by removing seven screws. Set aside fasteners (Figure 1).
2. From outside of the vehicle, visually inspect that the rear sensor harness routed from the LH D-pillar to the rear bumper is free from damage, remains intact, and is secured.

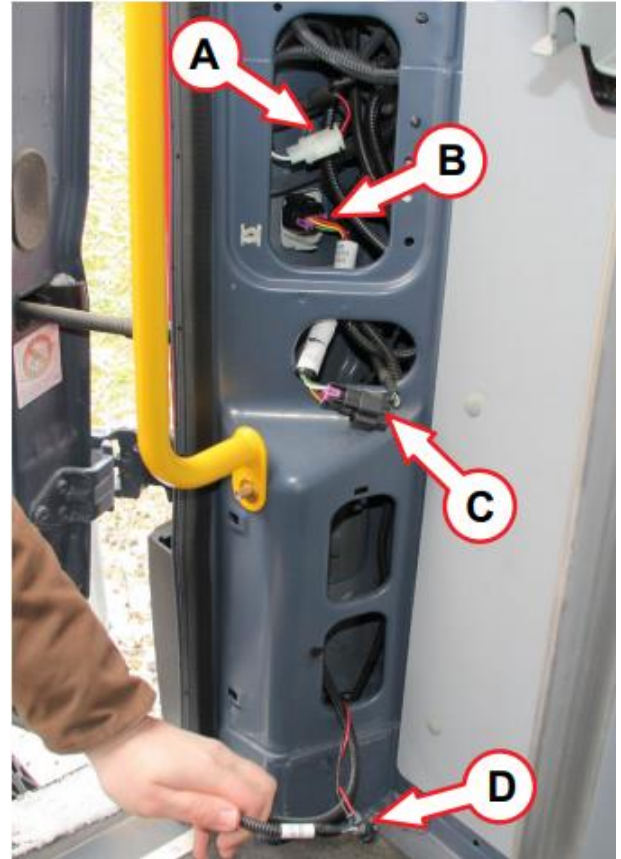
Figure 2 – D-pillar Connectors

3. With the ignition “ON”, visually inspect the LH and RH turn signal lamps for functionality, using the turn signal lever and hazard switch.
  - If either turn signal lamp does NOT work, proceed with Step 4.
  - If both turn signal lamps work, activate the hazard switch, unravel the rear sensor harness from within the D-pillar.
  - Manually manipulate the rear sensor harness (at and between B and C in Figure 2) to confirm proper function remains stable.
  - If no issues are noted, no further repair is necessary. Claim the Inspect LOP.
  - If functionality does not remain stable, order a replacement harness as described in the Parts Information section. Once parts are received, proceed to B. Harness Replacement.

4. Using wiTECH, identify and record Diagnostic Trouble Codes (DTCs) for any tail-lamp/turn signal faults.
5. If related DTCs are identified, disconnect the chassis interface 8-pin connector (B) (Figure 3). Disconnect the 8-pin taillight connector (C) (Figure 2). Plug in the chassis tail light connector to the chassis interface (Figure 2).
  - If DTC codes remain, harness replacement is NOT necessary, and the fault is related to chassis lighting system. Reassemble the vehicle.
  - If no related DTCs are identified, and the taillights operate normally with rear sensor harness removed from the system, or if the harness is damaged, replace the harness.

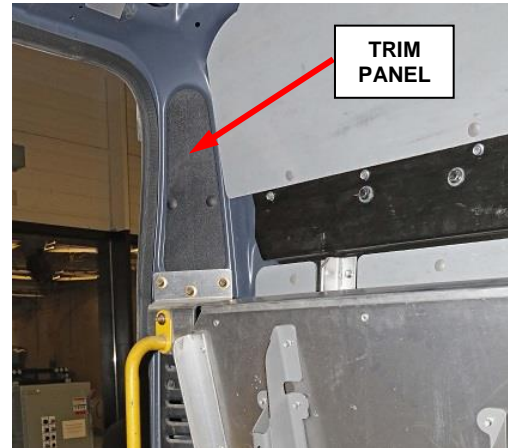
**Figure 3 – D-pillar Upper Trim Panel**

1. Remove the upper D-pillar trim (Figure 3).
2. From the top of the LH D-pillar, disconnect the 2-pin back-up alarm connector (A). Disconnect the chassis interface 8-pin connector (B). Disconnect the 8-pin taillight connector (C). Disconnect the 2-pin back-up sensor connector (D) (Figure 2).
3. Remove the back-up sensor harness from the D-pillar and discard.

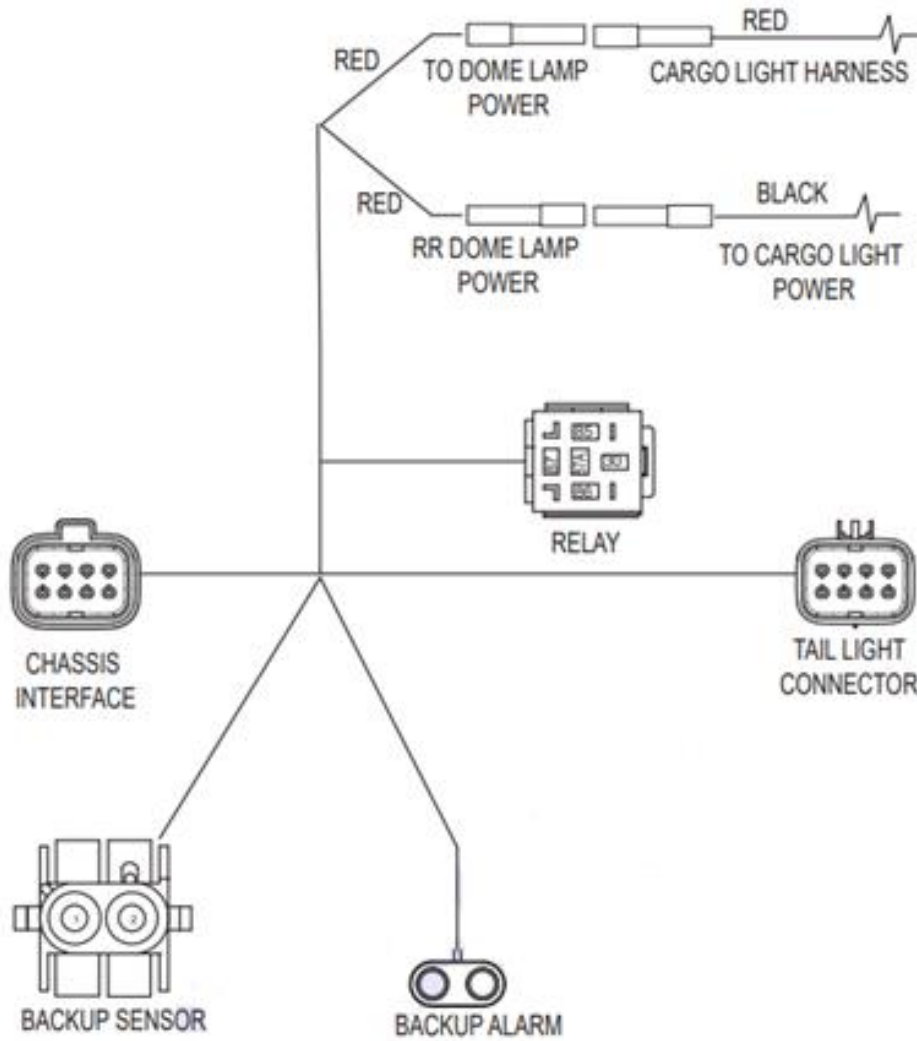
**Figure 4 – Backup Harness**

- 4. Isolate the two dome light power bullet connectors from the rest of the replacement harness. Insert the remaining harness connectors and relay block into the D-pillar (Figure 4).

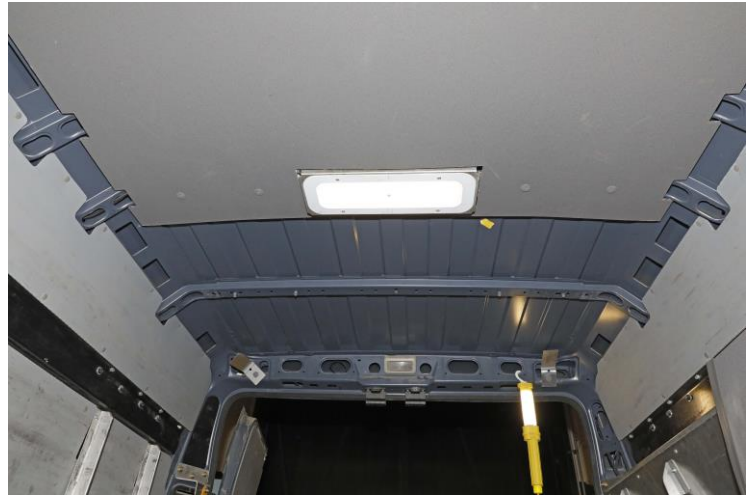
**Figure 5 – Rear Ceiling Panels Removed**

5. Remove the most rearward roof panel and one row of pushpins from the second panel, to gain access to the rear dome light (if applicable) (Figure 5).

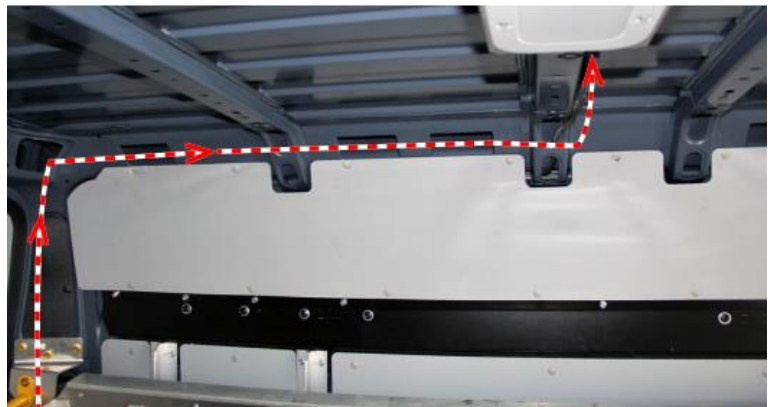
**Figure 6 – Dome Light Power Wires Routed Up D-pillar to Dome Light**

6. Route the dome light power connectors to the LH harness channel and pull wiring through to the dome light crossmember (Figure 6).

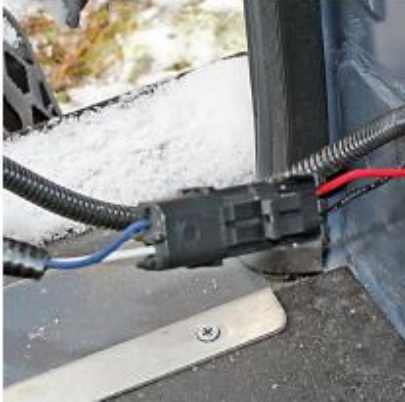
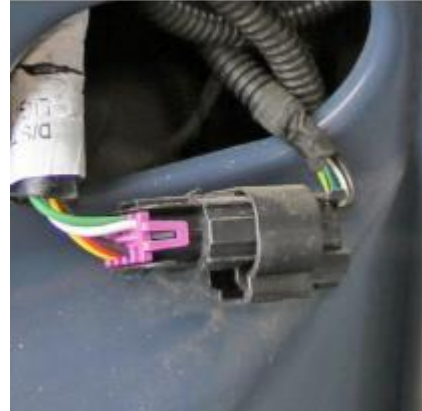
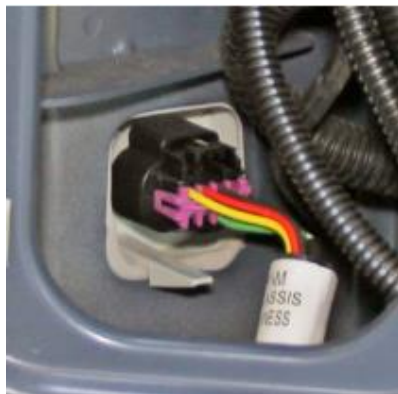
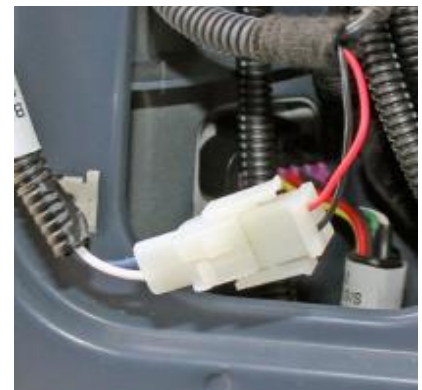
7. Starting from the bottom of the D-pillar, connect the 2-pin back-up alarm connector. Connect the 8-pin taillight connectors to the taillight harness. Connect the 8-pin connector into the chassis interface. Connect the back-up sensor connector (Figure 7-10).

**Figure 7 – Backup Alarm Connector**

**Figure 8 – Taillight Connector**

**Figure 9 – Chassis Interface Connector**

**Figure 10 – Backup Sensor**

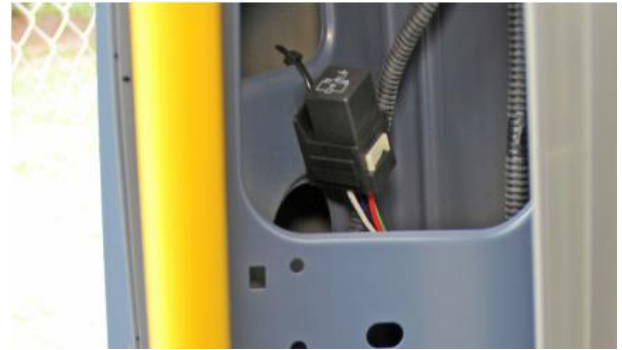
**Figure 11 – Relay to D-pillar**

- 8. Use a wire tie to secure the relay to D-pillar frame (Figure 11).

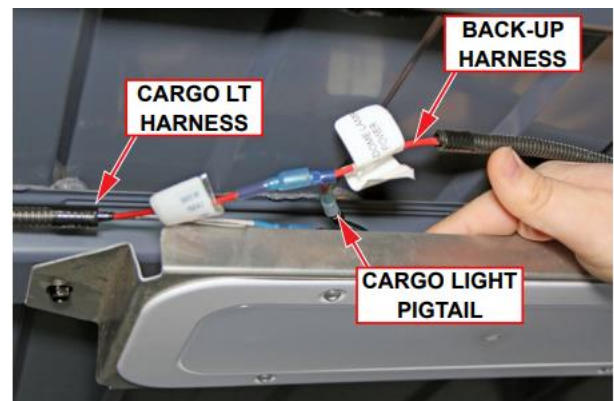
**Figure 12 – Cargo Light Power**

- 9. Disconnect the Red dome light harness wire from the male Black dome lamp pigtail.
- 10. Connect the Red dome light harness wire from the back-up harness to the male Black cargo light pigtail.
- 11. Connect the Red female dome light harness wire to the Red male back-up harness wire (Figure 12).

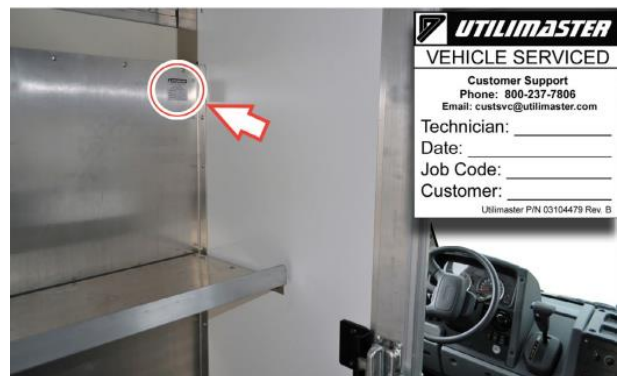
**Figure 13 – Service Decal on Driver's Door Pocket (Cargo Side)**

- 12. Wire tie connector wires to the roof bow.
- 13. Secure the harness in D-pillar.
- 14. Secure D-pillar covers using existing screws and small fir tree fasteners.
- 15. Install the rear roof panels with the new large fir tree fasteners provided.
- 16. Adhere the decal to the upper right-hand corner of the driver's door pocket panel or sidewall next to the bulkhead wall. Do NOT cover any previously applied decals (Figure 13).
