# SAFETY RECALL

## SABIC Inflator

Reference: 19B / NHTSA 24V-198

FCA US LLC

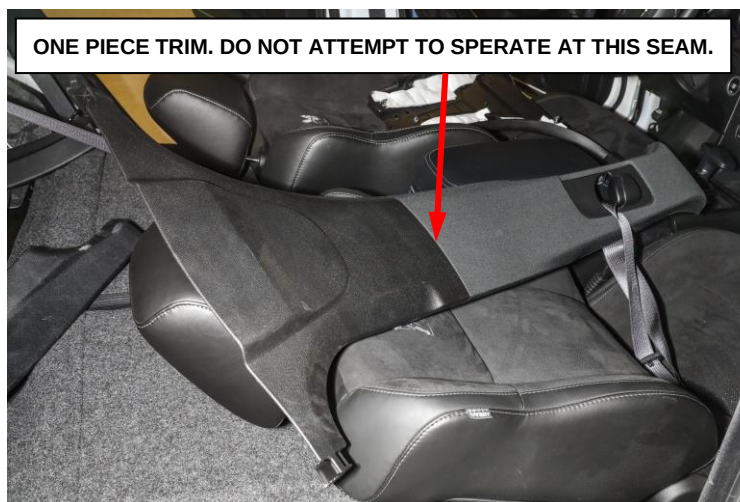
Figure 1 – B-Pillar Trim

**NOTE:** B-Pillar trim is ONE PIECE. Do not try to separate the upper from the lower (Figure 1).
