# Recall Campaign Bulletin

Campaign No. 2024040002, April 2024

SUBJECT: **Model GLE/GLS (167 platform)**  
**Model Year 2019 – 2024**

## **Check 48V Ground Connection on Passenger Seat**

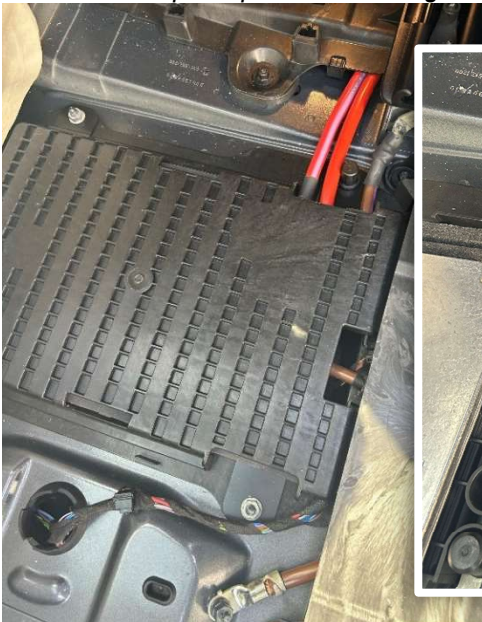
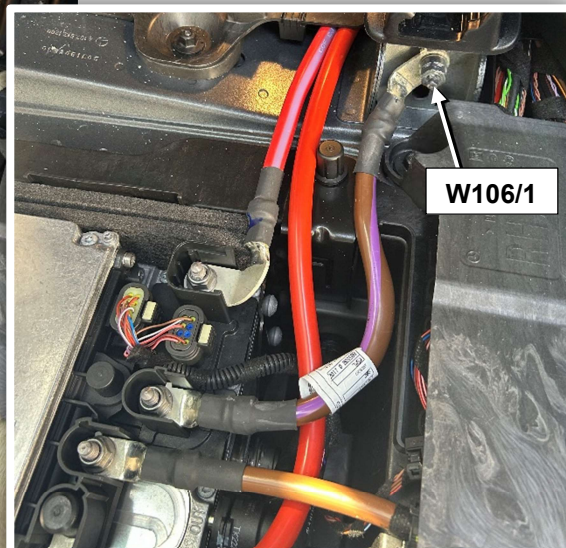
Figure 5

1. Replace electrical wiring harness from "W106/1" ground point to 48 V on-board electrical system battery (**Figure 5**).

Thoroughly clean area affected by thermal overload or damage.

If the ground bolt also displays traces of thermal overload or damage, the ground bolt must be replaced.

See **AR60.00-P-0100A** "Attach ground point to body" (please take the bolt part number from here).

If traces of thermal overload or damage are present on the surrounding component parts, such as the floor covering, these component parts must be replaced.

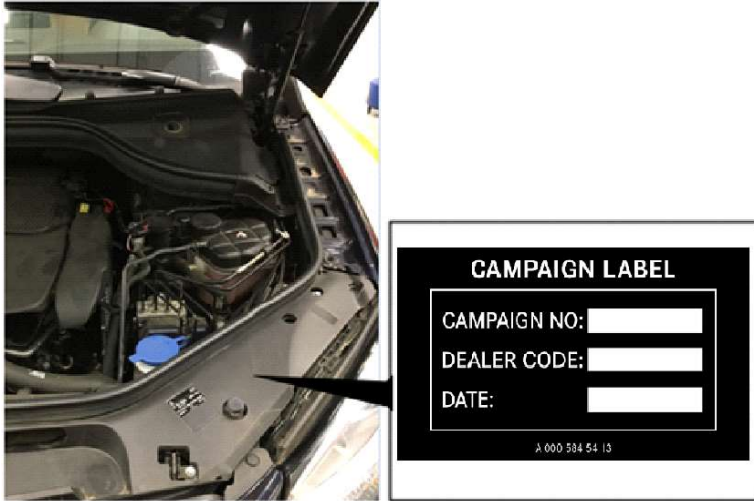
**Figure 1**

Apply Proof of Correction Label (**A 000 584 54 13**) to area identified in **Figure 1**. Fill in the blank areas of the label. The “**Campaign No.**” for the California Proof of Correction is unique and must be entered as such (**24V207**), your “**Dealer Code**”, and the “**Date**” of the repair, using a black permanent marker.
