TECHNICAL INSTRUCTIONS
FOR
SAFETY (NONCOMPLIANCE) RECALL 24LA03

Airbag May Not Deploy Properly

Certain 2018-2021 LS500 and Certain 2018-2020 LS500h

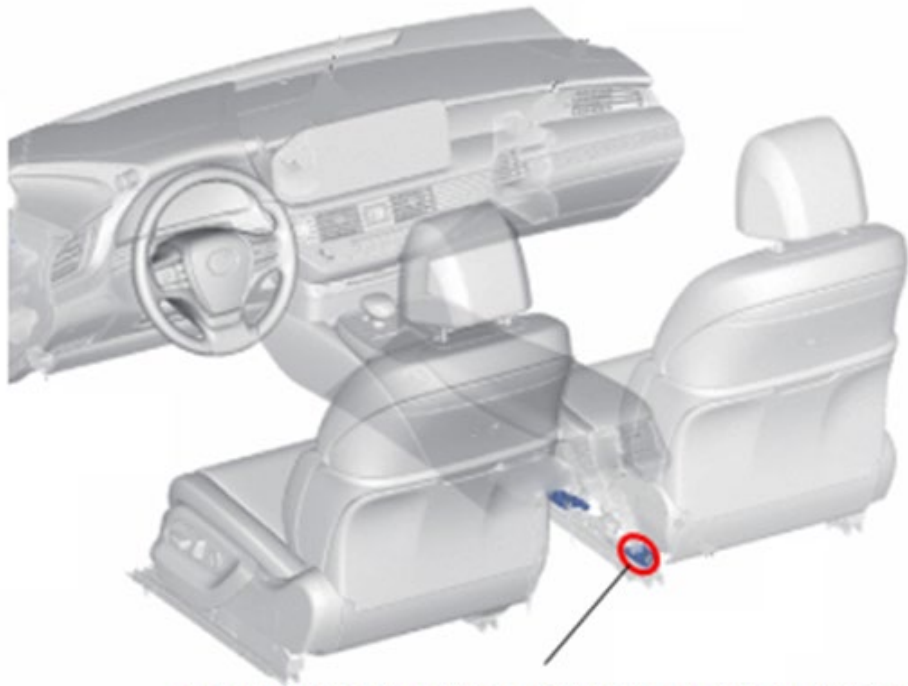
REAR OCCUPANT CLASSIFICATION SENSOR

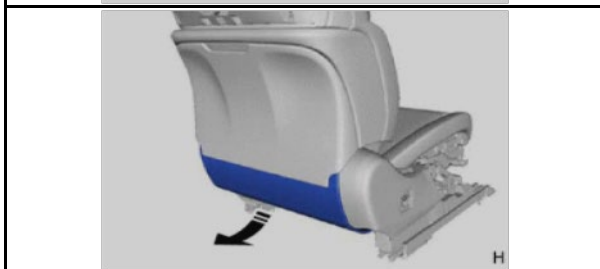
- b) Fold back the front seatback board sub-assembly in the direction of the arrow shown in the illustration.

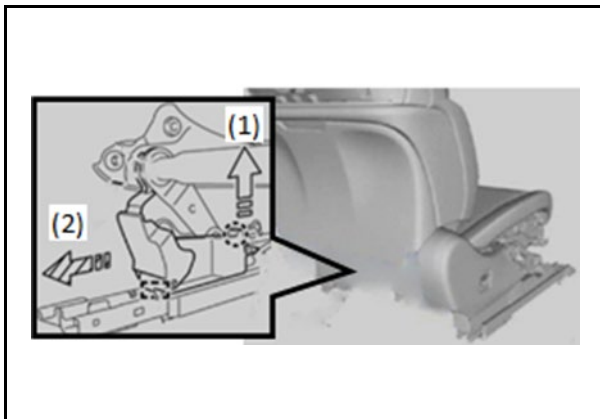
4. DISCONNECT FRONT SEAT LOWER CUSHION SHIELD

STOP DO NOT disengage the front seat lower cushion shield forcefully to avoid breakage.

- a) Detach the claw and move the front lower seat cushion shield in the direction of (1).
- b) Slide the front lower cushion shield in the direction of (2) and detach the guide.
- c) Hold the front seat cushion shield with protective tape.

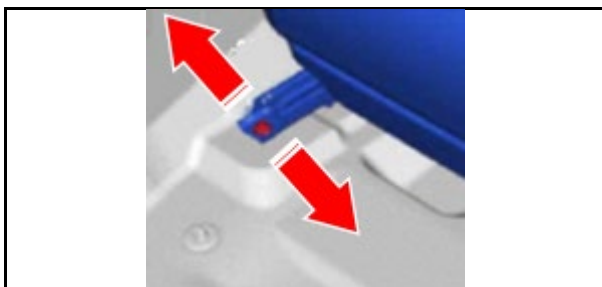
4. ADJUST INNER SEAT RAIL

- Move the inner seat rail towards the direction of the arrows to remove the interference at the stopper.

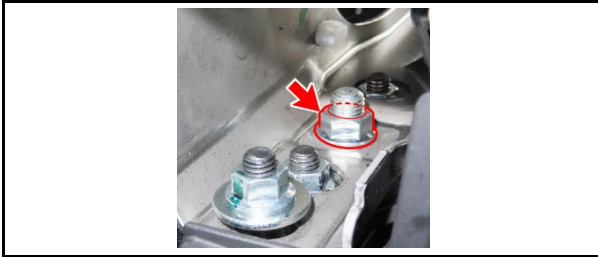
5. TIGHTEN THE REAR OCS SENSOR NUT

- a) Tighten the rear OCS sensor nut.

Torque: 37 N*m (377 kgf*cm, 27 ft.*lbf)

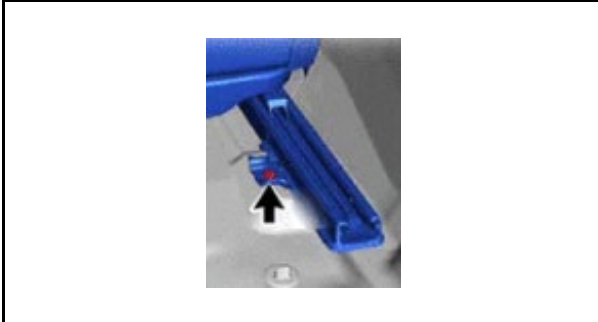
6. TIGHTEN FRONT SIDE BOLT OF FRONT PASSENGER SEAT INNER SEAT RAIL

- a) Operate the slide and vertical power seat switch knob and move the passenger seat assembly to the rearmost position.
- b) Using a T50 "TORX" socket wrench, tighten the front side bolt of the inner seat rail.

Torque: 37 N*m (377 kgf*cm, 27 ft.*lbf)
