Recall Bulletin 240416REV

RECALL BULLETIN: 240416REV	<p>The purpose of this Recall Service Bulletin is to inform REV Recreation Group dealers of the need to repair the water pump circuitry on certain 2022-2024 Fleetwood Discovery and Holiday Rambler Endeavor 38N model motorhomes. No other floor plans are involved. A list of affected motorhome serial numbers appears at the end of this bulletin. There are a total of 79 motorhomes affected by this recall.</p>
YEAR(S) AFFECTED: 2022-2024	
PRODUCT(S) AFFECTED: <u>FLEETWOOD DISCOVERY</u> <u>HOLIDAY RAMBLER ENDEAVOR</u>	<p><u>CONDITION:</u> On motorhomes affected by this recall campaign, the larger capacity water pump should be protected by a 15-amp fuse. A production schematic was found to have incorrectly designed water pump circuit fuse protection with a 50-amp fuse. The 50-amp fuse is too high for the wire size.</p> <p><u>DEALER CORRECTIVE ACTION:</u> Follow the attached repair bulletin to repair the water pump circuitry used on vehicles built between Dec 02, 2021, and March 14, 2024.</p>

MONTHS OF MANUFACTURE: DEC 02, 2021 - MARCH 14, 2024	<p>ATTENTION SERVICE, WARRANTY AND PARTS MANAGERS: All prior Authorization Approvals must go

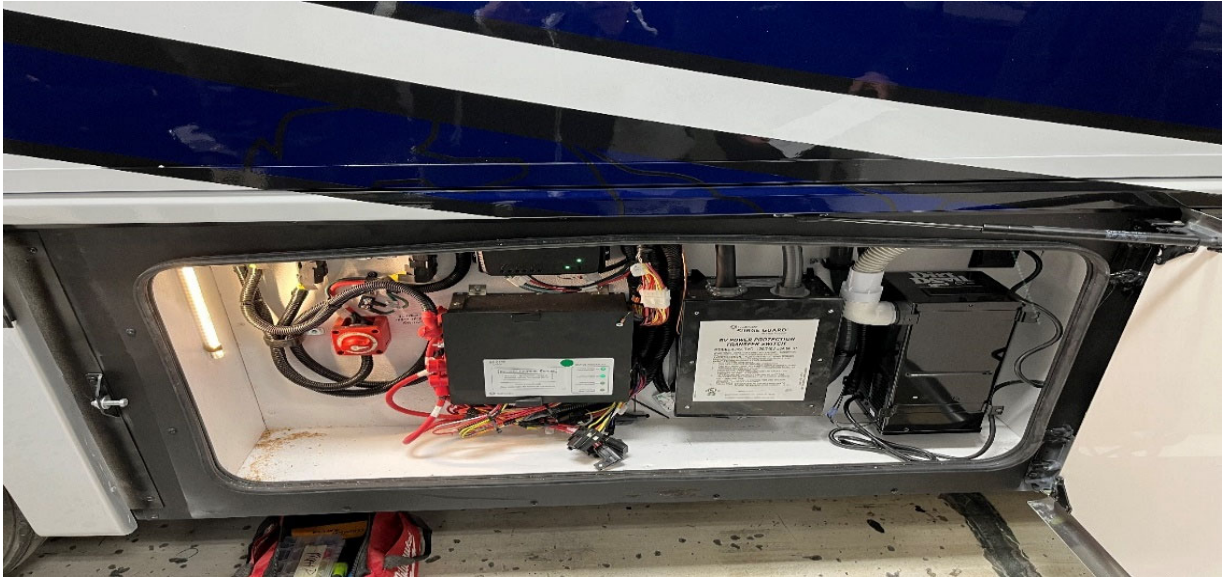
Figure 1

1. Turn off the battery disconnects inside of unit.
2. Go to the door side luggage compartment (forward of the rear axle) of the motor home to locate the battery control center. **(see figure 1)**

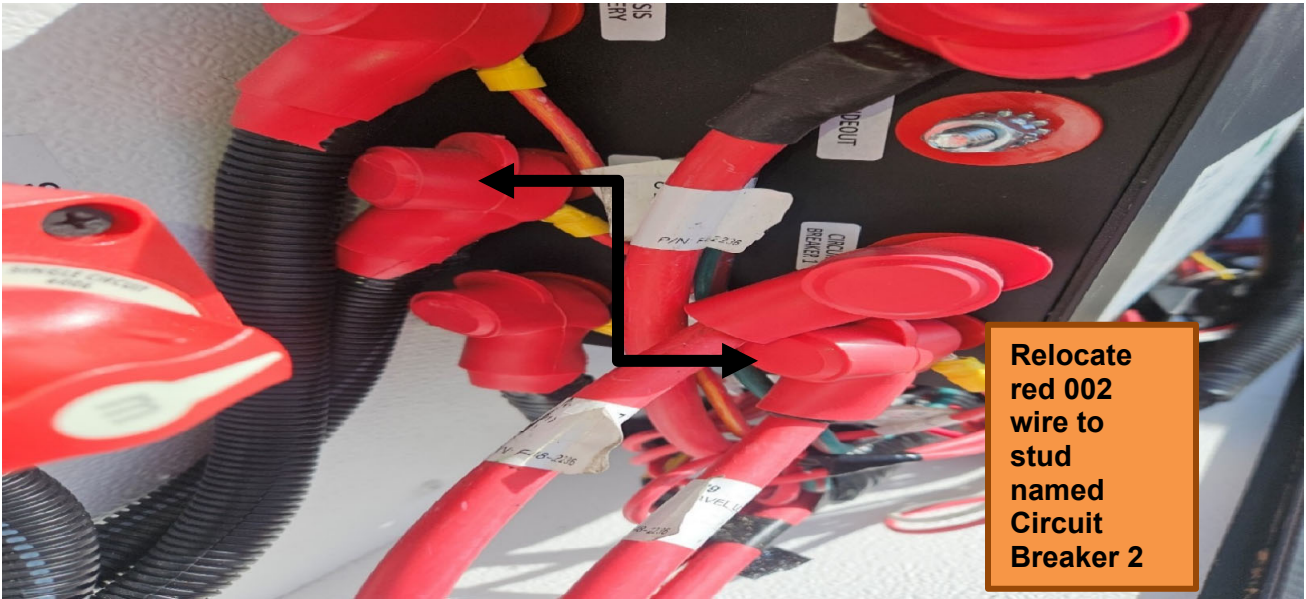
Figure 4

4. **Caution:** The red 10-gauge wire stamped with circuit 002 will be moved to the **“CIRCUIT BREAKER 2”** stud on side of the BBC. **(see figure 4) (tighten nut to 50-inch pounds using a torque wrench).**

5. NOTE: Wire 002 PWR must remain on the GENERATOR stud along with the generator cable. (tighten nut to 55-inch pounds using a torque wrench)
