Recall Campaign Bulletin

Campaign No. 2024050001, May 2024

SUBJECT: **Model GL-Class, ML-Class, and R-Class (X164, W164 and 251 platform)
Model Year 2006 – 2012**

Inspect Brake Booster – without Pedal Rework

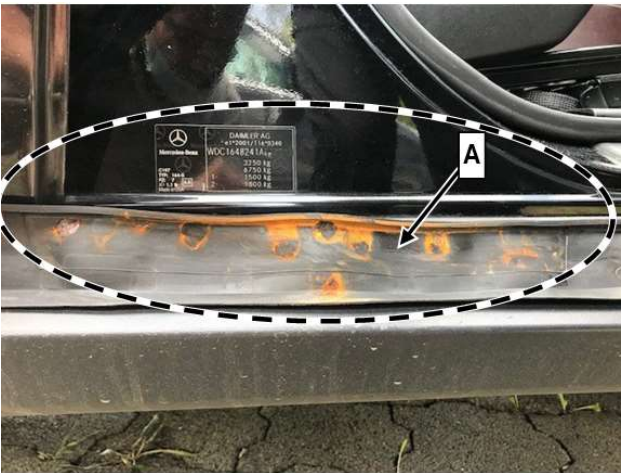
3. Take a photo of the rubber sleeve with the VIN label of the B-pillar (**Figures 3 and 4, A**) and store to a local HDD/computer storage location with the vehicle service file and attach it to the warranty claim in EVA.
 - i** These pictures serve as documentation of the current condition of the brake booster.

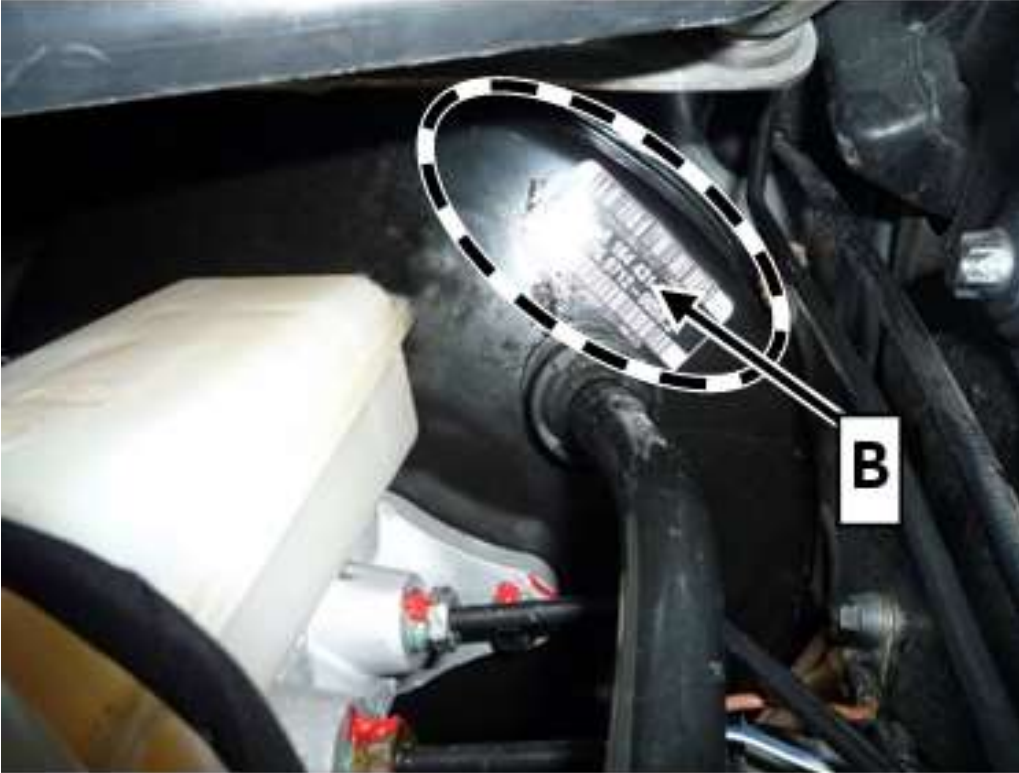
Figure 8

1. Take a photo of the barcode label (**Figure 8, B**) on the brake booster and store to a local HDD/computer storage location with the vehicle service file and attach to the warranty claim in EVA.

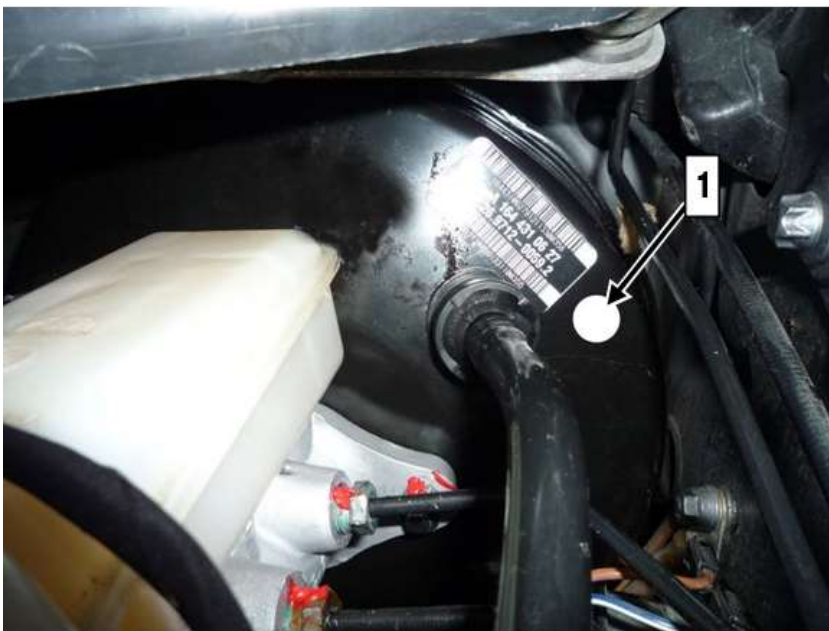
Figure 10

3. Apply marking with **white touch-up paint pen** (**Figure 10, 1**) to the inspected brake booster.
 - i** Under no circumstances should you treat the brake booster with anti-corrosion agent/paint.

i If the measure is ended, **do not** re-install a rubber sleeve. Apply marking with **white touch-up paint pen** (Figure 10, 1) to the brake booster checked.

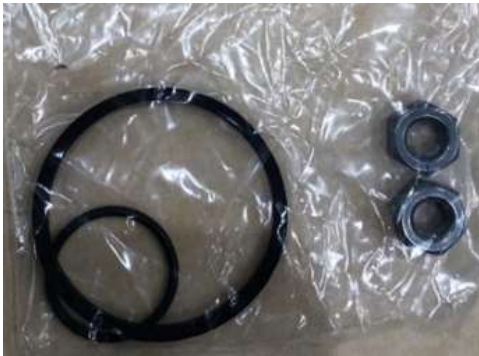
Figure 12

i The new brake booster contains a small parts kit (**Figure 12**).

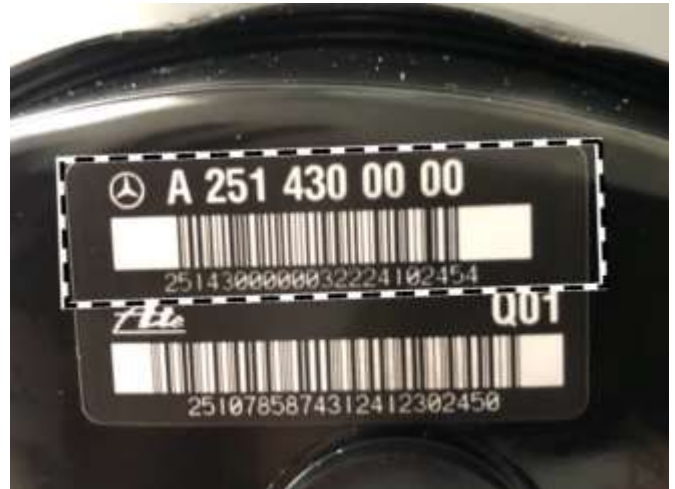
Figure 13

4. Read out serial number (**Figure 13**) using the **Mercedes-Benz PartScan** app.

i The serial number is automatically entered in VeDoc. Verify the VIN reads from the vehicle correctly.
