SAFETY RECALL

Low Pressure Fuel Circuit

Reference: 54B / NHTSA 24V-306

2021 (GA) Alfa Romeo Giulia

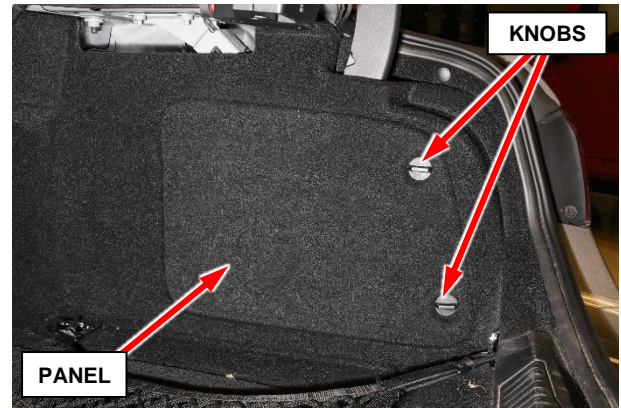
Figure 1 – Battery Access Panel

1. Open the trunk lid.
2. Rotate the knobs $\frac{1}{4}$ turn on the right-side trim panel and remove the battery access panel (Figure 1).

24. Install the T-10 fuel pump relay into the fuse box cavity (Figure 5).
25. Install the fuse box cover (Figure 4).
26. Install the trunk compartment load floor reinforcement (Figure 3).
27. Install the trunk compartment load floor carpet panel (Figure 2).
28. Align the battery access panel to the right-side trim opening and rotate the knobs $\frac{1}{4}$ turn (Figure 1).
29. Close the trunk lid.
30. Start the engine and check for any fuel leaks.
31. Using wiTECH, delete any DTCs that may have set during the service procedure.

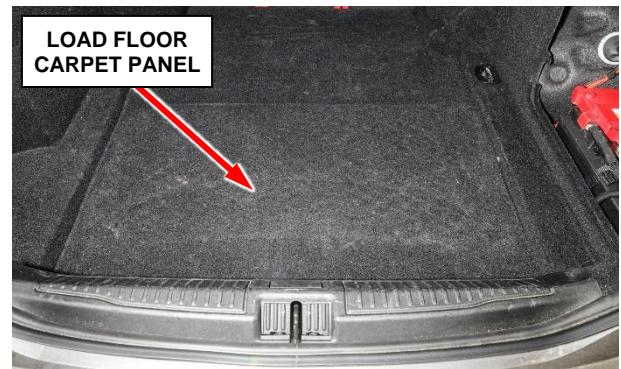
Figure 2 – Trunk Compartment

3. Remove the trunk compartment load floor carpet panel (Figure 2).

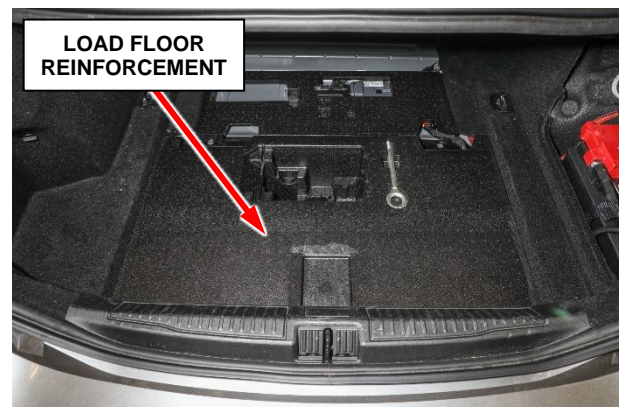
Figure 3 – Trunk Compartment

4. Remove the trunk compartment load floor reinforcement (Figure 3).

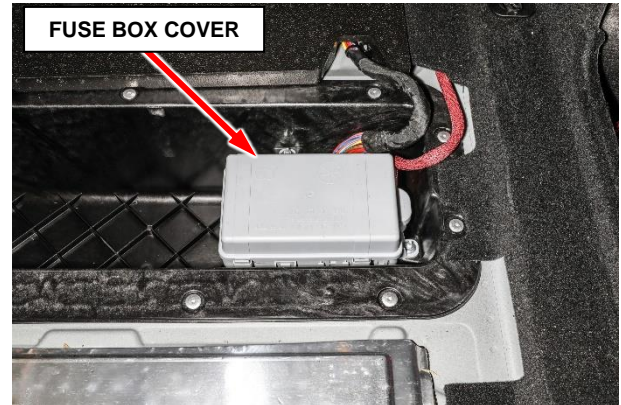
Figure 4 – Fuse Box

5. Remove the cover from the fuse box in rear of the vehicle (Figure 4).

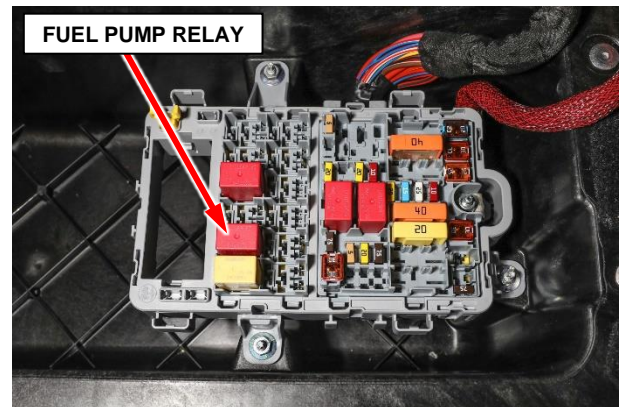
Figure 5 – Fuel Pump Relay

6. Locate the T-10 fuel pump relay and remove it and set aside (Figure 5).

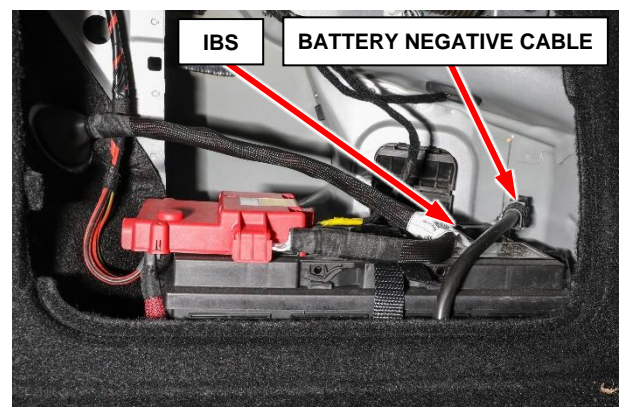
Figure 6 – Fuel Pump Relay

8. Within the battery compartment, press the release button and disconnect the battery negative cable from the post. If equipped with an Intelligent Battery Sensor (IBS), disconnect the IBS connector (Figure 6).

19. Connect the electrical connection for the fuel temperature-pressure sensor (Figure 12).
20. Secure the fuel line in both upper and lower retaining clips (Figures 10 and 12).
21. Position the coolant reservoir and tighten the fasteners securely (Figure 8).
22. Align and install the engine cover and fasten the screws securely (Figure 7).
23. Press the release button and connect the battery negative cable to the post. If equipped with an Intelligent Battery Sensor (IBS), connect the IBS connector (Figure 6).

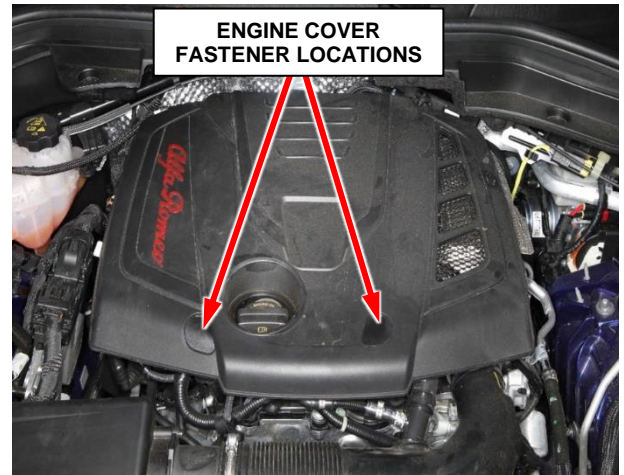
Figure 7 – Engine Cover

- Using a small blade screwdriver or equivalent pry on the engine cover caps to access the engine cover fasteners and remove the cover (Figure 7).

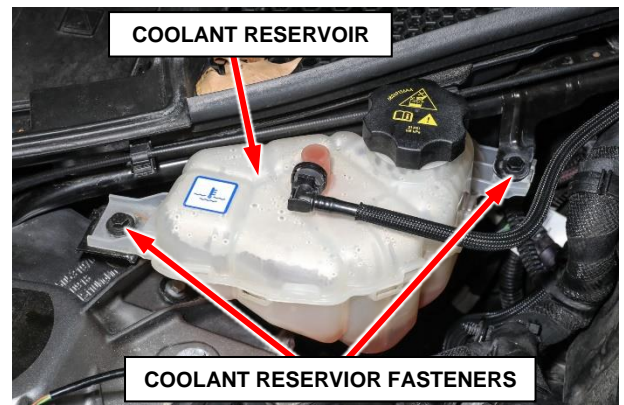
Figure 8 – Coolant Reservoir

- Remove the coolant reservoir fasteners (Figure 8).

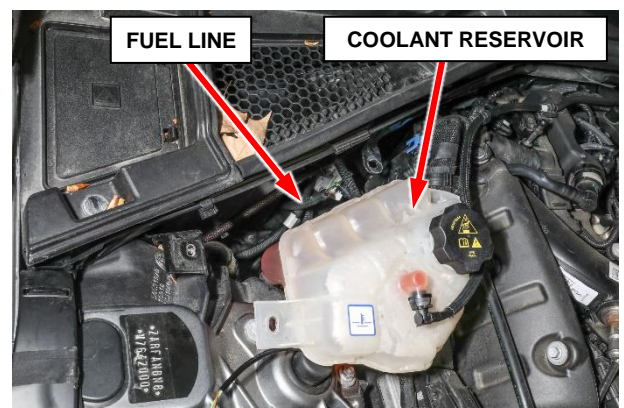
Figure 9 – Fuel Line Access

- Position the coolant reservoir forward to gain access to the fuel line (Figure 9).

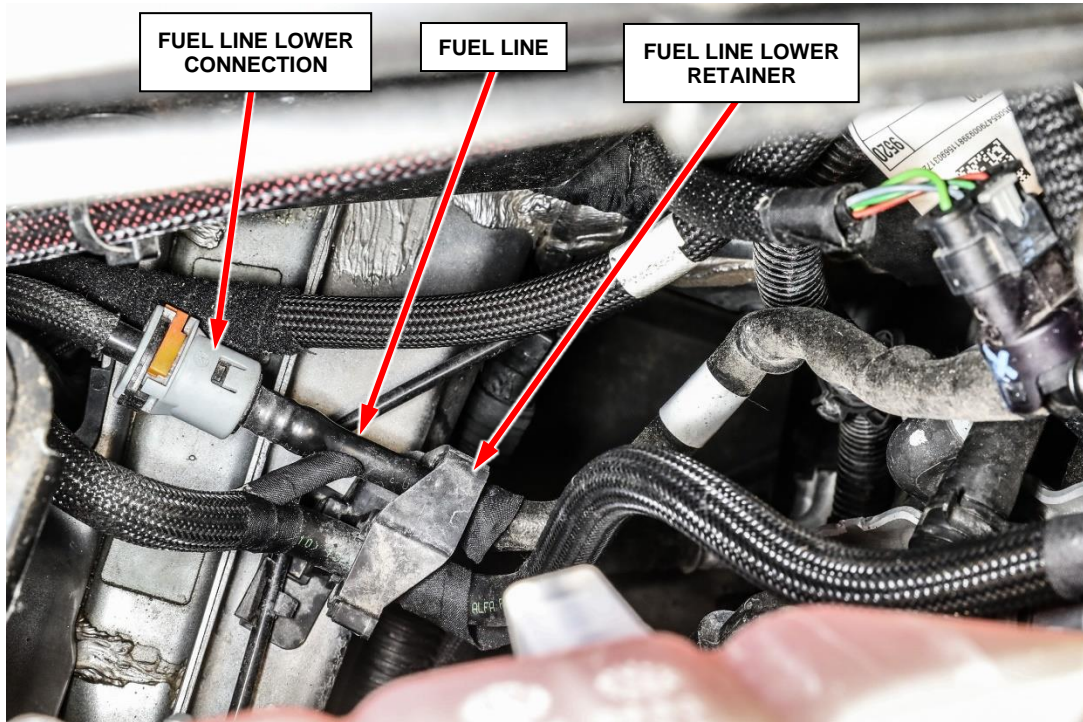
Figure 10 – Fuel Line Lower Portion

12. Release the fuel line from the lower retainer (Figure 10).

18. Install the **NEW** front fuel supply line, connect the quick connectors and engage the locks at both ends (Figures 10 through 13).

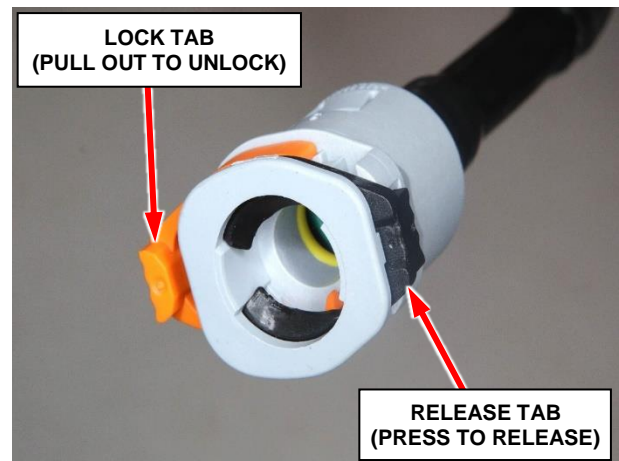
Figure 11 – Lower Fuel Line Lock

13. Unlatch the lower fuel line lock by pulling up the lock tab, then press on the release tab to disconnect the fuel line (Figure 11).

NOTE: Verify fuel line is fully seated and lock is engaged by slightly pulling on the fuel line and making sure it stays connected.

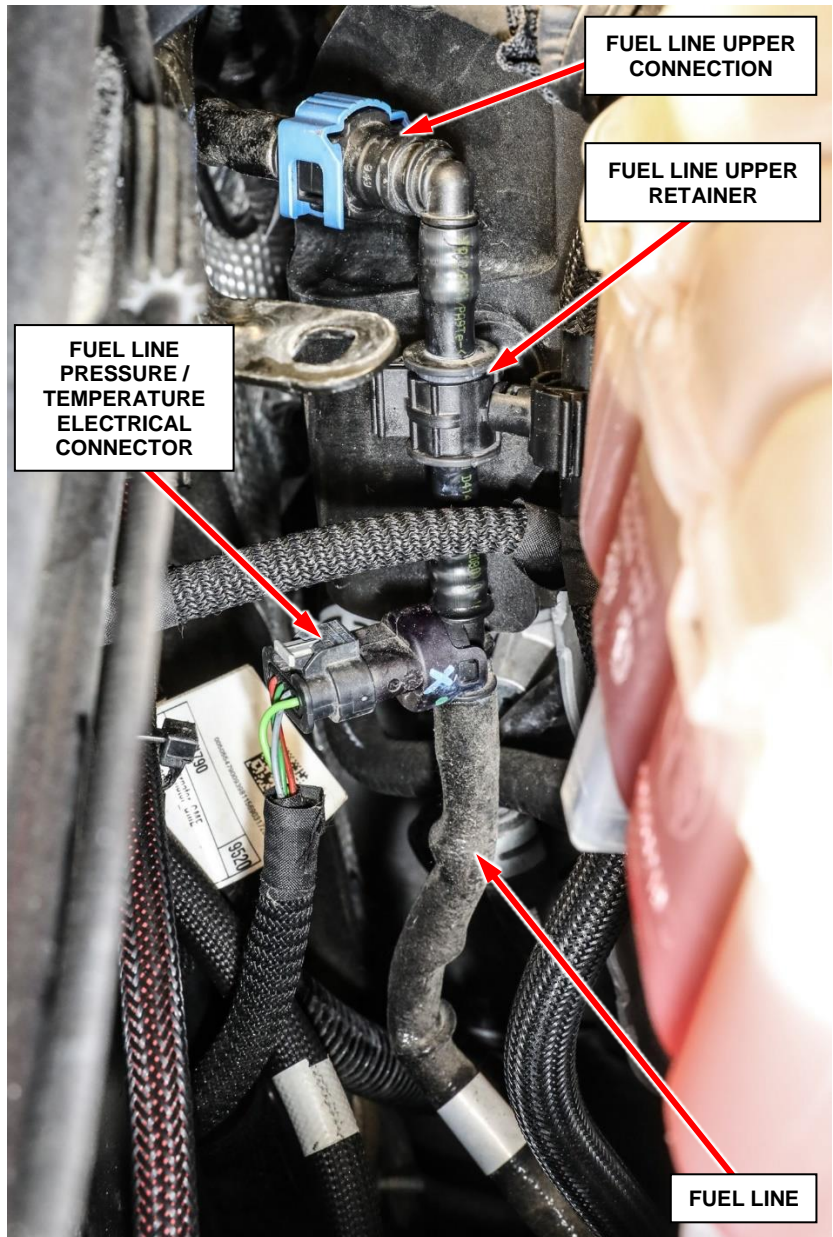
Figure 12 – Fuel Line Upper Portion

- 14. Disconnect the fuel pressure / temperature sensor electrical connector (Figure 12).

- 15. Release the fuel line from the upper retainer (Figure 12).

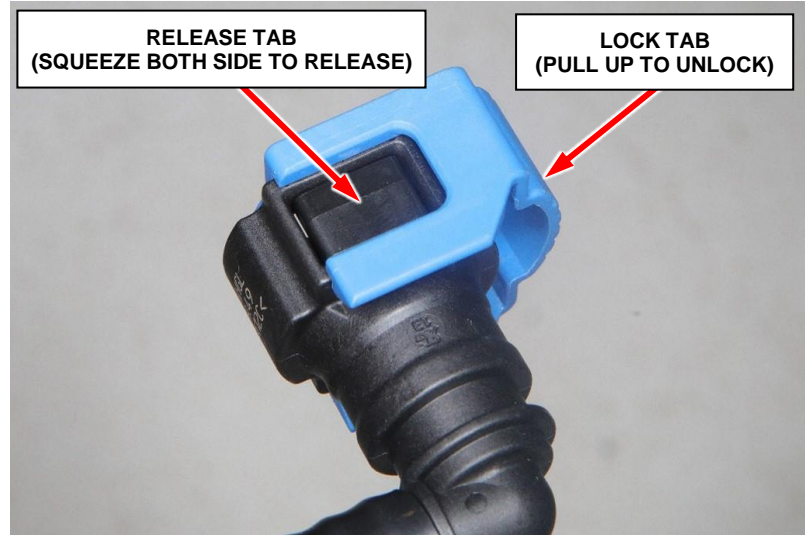
Figure 13 – Upper Fuel Line Lock

16. Unlatch the upper fuel line lock by pulling up on the lock tab, then squeeze both sides of the fuel line latch to disconnect the fuel line (Figure 13).

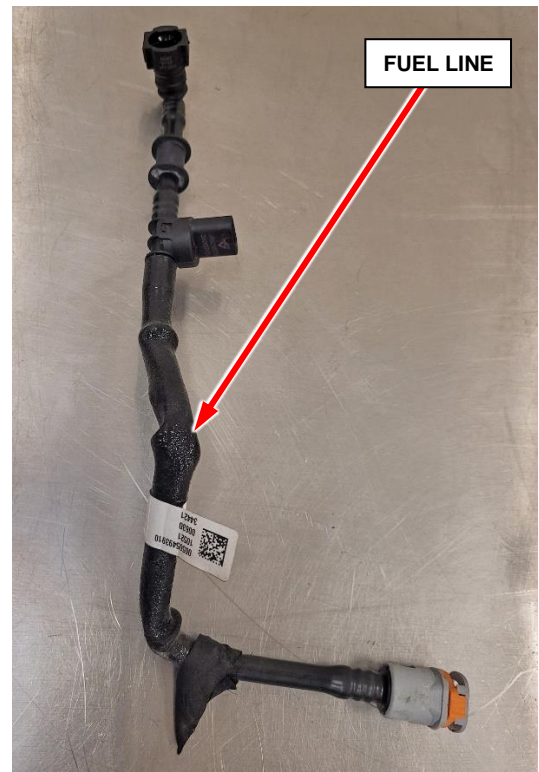
Figure 14 – Fuel Line

17. Remove and **DISCARD** the old fuel line (Figure 14).
