CAMERA MODULE REPLACEMENT AND ORIENTATION

Bulletin Type:	Recall	Publication Date:	June 2024
Bulletin #(s):	24V-309 USA 2024-256 Canada	Make(s):	Entegra Coach
Job Code(s):	9903607	Model(s):	Aspire
Flat Rate(s):	9903607 .30 HR Installation of Module and Brackets	Model Year(s):	2023-2025

Incident:	Camera Module is mounted upside down and dash camera goes blank
Affected Units:	2023-2025 Entegra Coach Aspire
Parts Kit:24V-309	Parts Kit #: 24V-309
	1 –MODULE,CONT RAMCO 360 BIRDS EYE VD CNFIG MFR# MUL.360.VSV.HD
	2 - BRACKET,MTG CAMR MDL 1.00X2.25X7.13 18GA PC BLK
	4 - SCREW,MACH TR QUAD 8-32X .50 ZC 4 - NUT,HEX KEPS 8-32 ZC
Misc. Tools & Supplies:	Philips screw driver
Parts Return Information:	Return Camera Control Module to Jayco

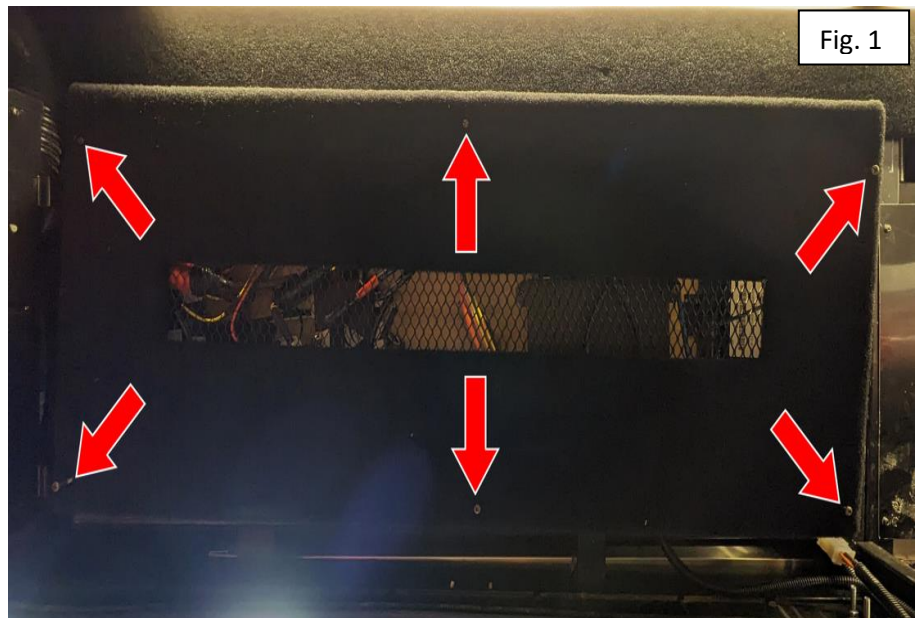
1. Camera module shown behind the access panel in figure 1 on the driver's side door three in the black box mounted to compartment ceiling.

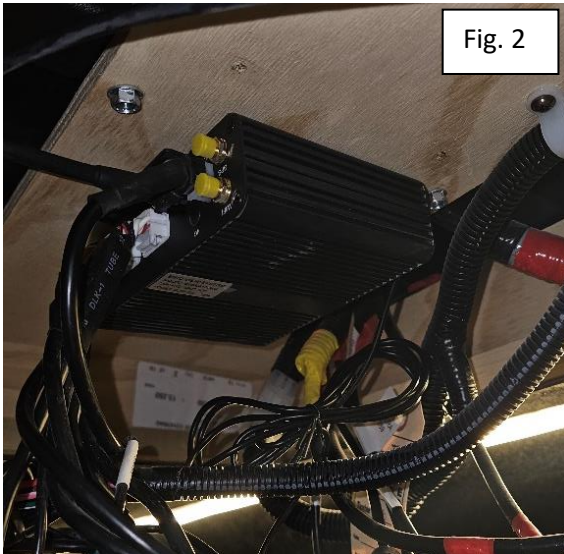
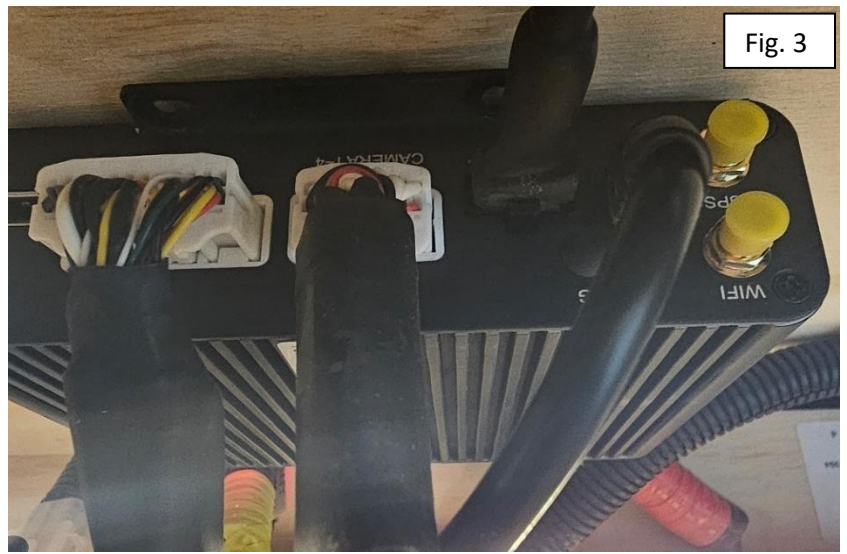
INCORRECT CAMERA MODULE INSTALLATION

- Figures 2 and 3 show the camera module mounted upside down and flush to the compartment ceiling.

- The correction is to replace the module. Use the new brackets for correct orientation. (Figures 4 and figure 5)

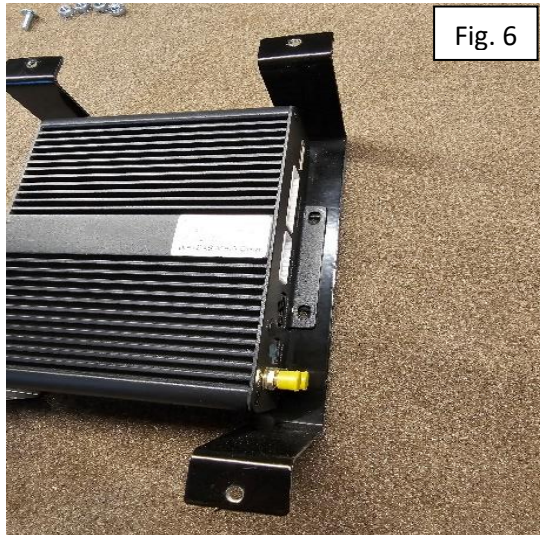
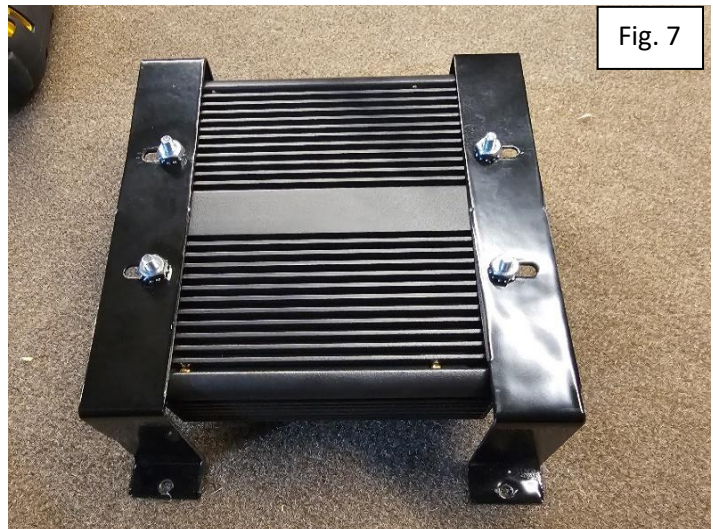
2. Attach new brackets to the original brackets using the 4 screws and nuts provided. (Figures 6 and 7)
3. Install new bracket camera module back to compartment ceiling and connect harnesses. (Figure 8)
4. Test operation of all cameras.
