Mercedes Chassis – Seat Wire Routing Rework:

INSPECTION & REMOVE OR SUBLET

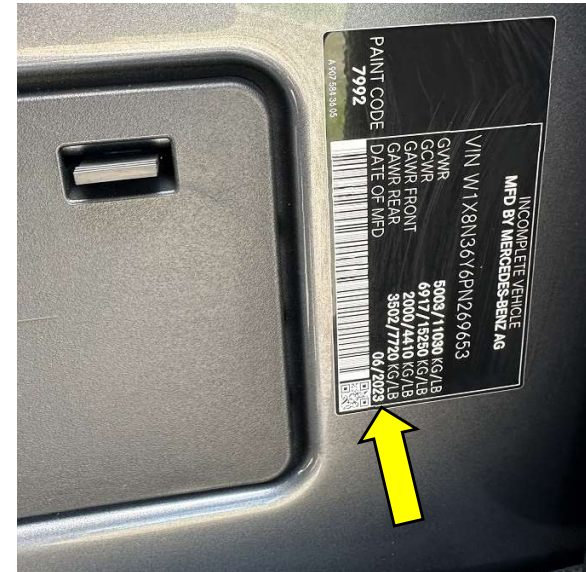
The instructions will differ depending on when the chassis was built. To identify the build date of the chassis, locate the Mercedes 'Incomplete Vehicle' label. The typical location of this label is on the side of the driver seat pedestal. See Image 1 for date location. There are two date ranges which will help identify which instructions to follow:

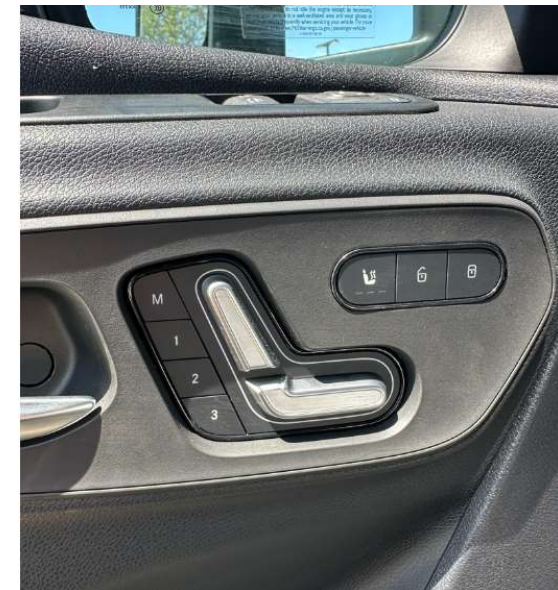
The instructions will differ depending on if a chassis has manually adjustable or electronically adjustable seats. See Image 2 for a typical Image of the electronic seat controls located on the chassis driver/passenger door panel. If electronic seat controls are not present, confirm that manual controls are present on the seat itself. Be mindful to review the heading of each page to ensure the correct instructions are being followed.

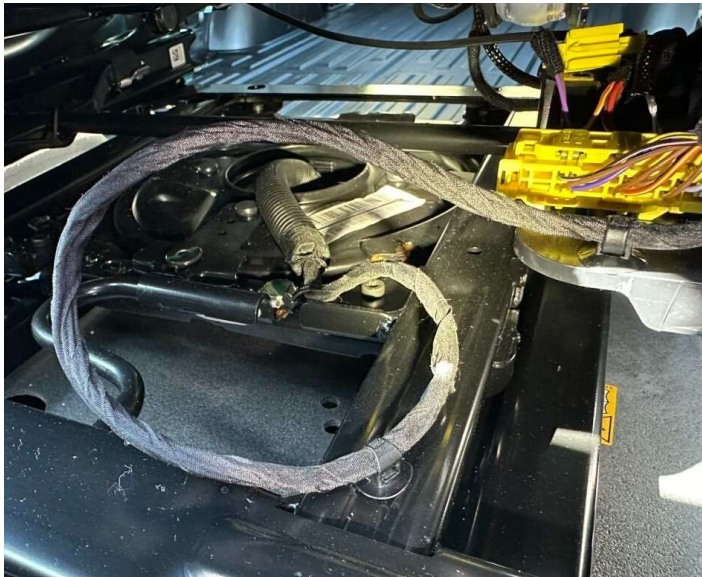
1. Put both the driver and passenger seats in its furthest up and back position, this will allow additional access.
2. Review the wire routing to ensure the OEM wire path from Mercedes is followed. See Image 1 for correct path.

- a. For mechanical seat chassis, this means the wire should route from the seat base up through the center circular cutout in the seat swivel, then go up and connect to the yellow chassis plug.

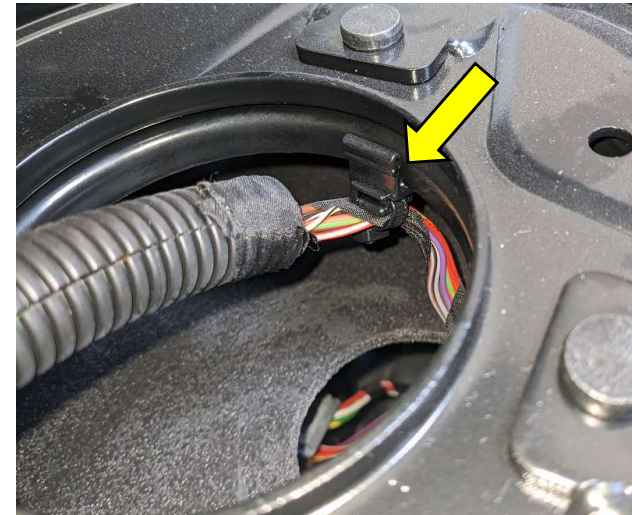
Image 2

- a. If wiring appears damaged, document with photos and contact Winnebago Technical Service.
4. To ensure the proper length of the OEM wire harness can be accessed, attach the Clip Wire Tie Mount furthest from the plug to the center circular cutout in the seat swivel. See Image 2. If Clip mount is visibly damaged, install provided Clip mount from kit next to existing mount. Cut the Wire Tie Tail but leave OEM mount in place.

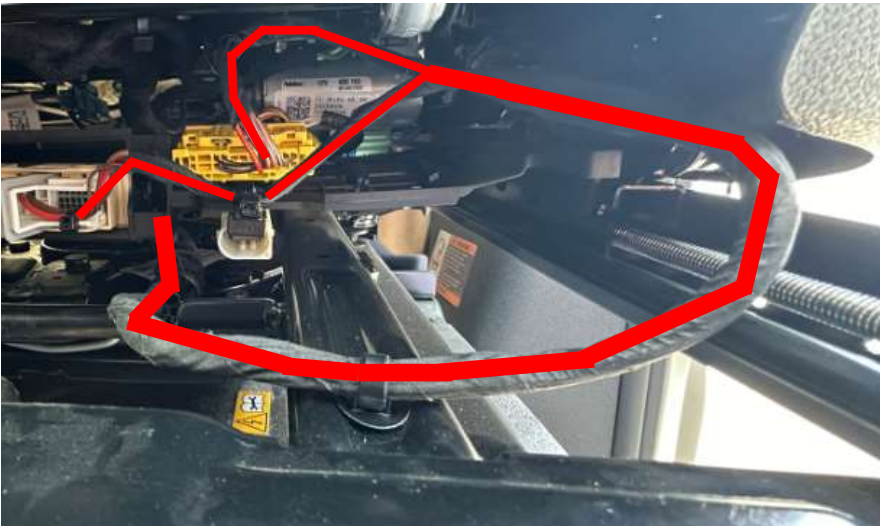
- a. For electronic seat chassis, this means the wire should route from the seat base up through the center circular cutout in the seat swivel, between the plugs and the carrier, and to the yellow and white plugs mounted to the underside of the seat. See Image 1 for correct routing.

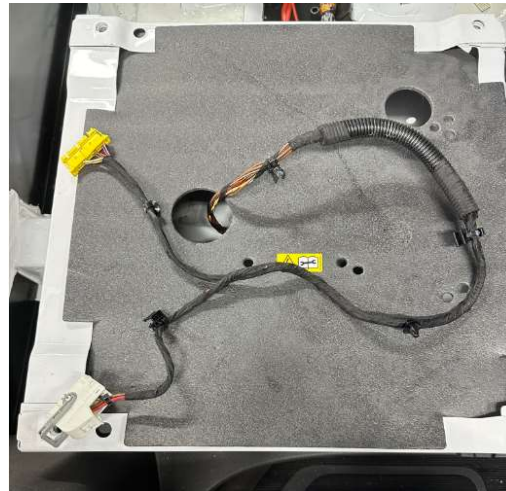
Image 2

- b. Note: Harness mounting points may differ from Image 1, depending on chassis model year.
3. Look along the OEM wire harness from the yellow and white plugs to the center circular cutout in the seat swivel for any damage that has occurred such as chaffing or cuts. See Image 2.

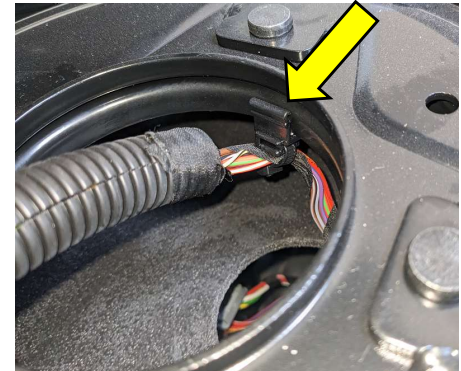
Image 3

- a. If wiring appears damaged, document with photos and contact Winnebago Technical Service.
4. To ensure the proper length of the OEM wire harness can be accessed, attach the Clip Wire Tie Mount furthest from the plug to the center circular cutout in the seat swivel. See Image 3. If Clip mount is visibly damaged, install provided Clip mount from kit next to existing mount. Cut the Wire Tie Tail but leave OEM mount in place.

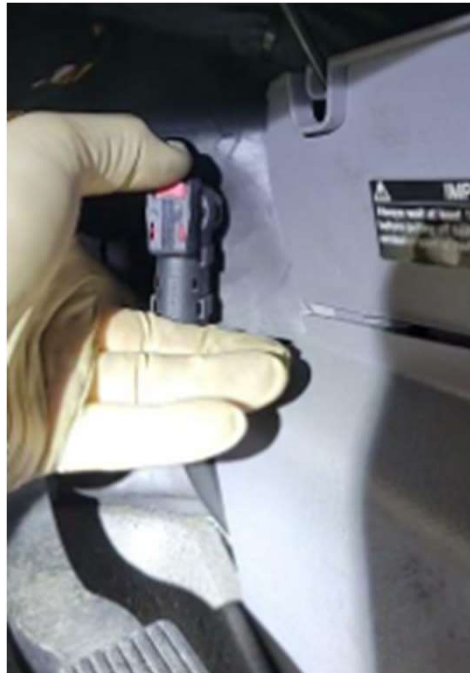
Image 1

1. If the wire route must be adjusted, it is important to disconnect the chassis 12V battery beforehand.
 - a. Chassis Battery Quick Disconnect located behind a closeout panel next to the throttle – See Image 1. If the unit doesn't have the quick disconnect, refer to the Sprinter user manual to disconnect the ground cable from the battery.
 - b. Allow for five minutes between disconnection of Chassis Battery Quick Disconnect and disconnecting any connectors from the driver and passenger seat.
 - c. **NOTE:** If the chassis battery ground is not disconnected five minutes or more before disconnecting any connectors from the seats, chassis faults may occur that will require a Mercedes service center to clear. This cost is not covered under this recall.

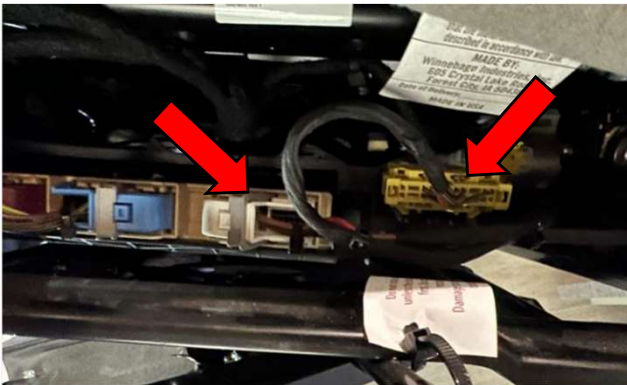
Image 1

1. Disconnect the yellow and white connectors from the driver and passenger seat as needed. See Image 1, red arrows for affected plugs.
2. Remove the 4 mounting bolts from the seat base using a ratchet and E12 Socket, an extension may be required. See Image 2.

4. Untangle the OEM harness from the Winnebago installed harnesses to ensure an appropriate length of the OEM harness is free to route as needed per Image 1.

6. Reconnect the affected plugs from the OEM harness to the seat following the OEM route. See Image 1.

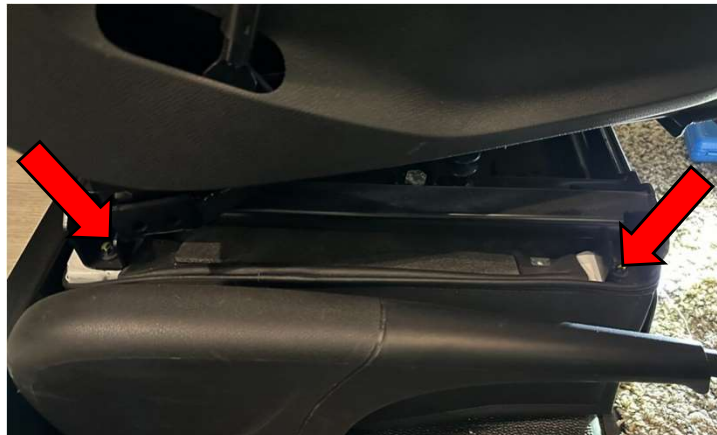
Image 2

5. Reinstall the foam cover and pull the OEM wire harness through. Set the seat onto the pedestal and align by starting the seat pedestal bolts by hand. Using a torque wrench with an E12 socket and extension, torque the seat pedestal bolts to 37 NM. Re-mark the torqued connections.

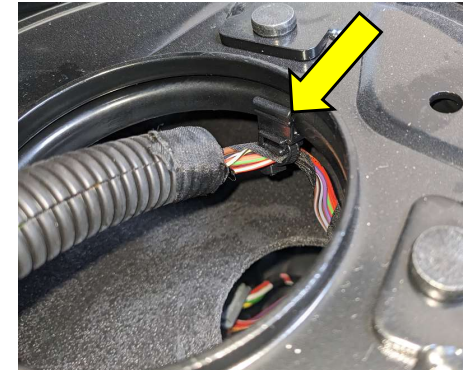
Image 3

- a. To ensure the proper length of the OEM wire harness can be accessed, attach the Clip Wire Tie Mount furthest from the plug to the center circular cutout in the seat swivel. See Image 3. If Clip mount is visibly damaged, replace with provided Clip mount from kit.

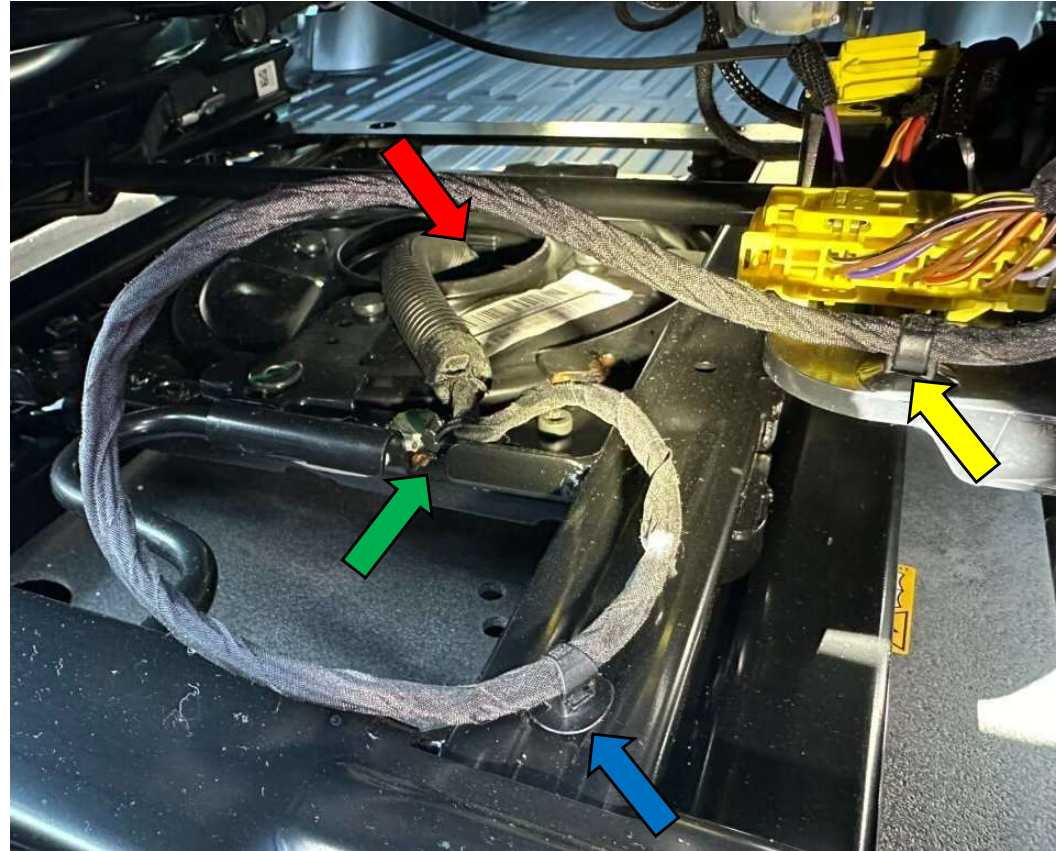
Image 1

1. Locate all OEM retention points on the harness.
 - a. For newer Chassis with manually adjustable seats there are 4 connection points:
 - @ Yellow Plug (Yellow Arrow)
 - @ Seat Rail (Blue Arrow)
 - @ Seat Base (Green Arrow)
 - @ Circular cutout (Red Arrow)
2. Ensure all wire tie mounts are installed in their proper location.
 - a. See list above for location
3. Inspect the wire tie mounts for any damage. If damaged, install replacement right next to existing mount on OEM harness. Cut tail from Wire Tie after installation, leave the OEM mount in place.
 - a. Clip Mount- firmly tug on clip to see if it will disengage from the metal flange.
 - b. Fir Tree Mount - firmly tug on mount to see if it will disengage from the mounting hole.

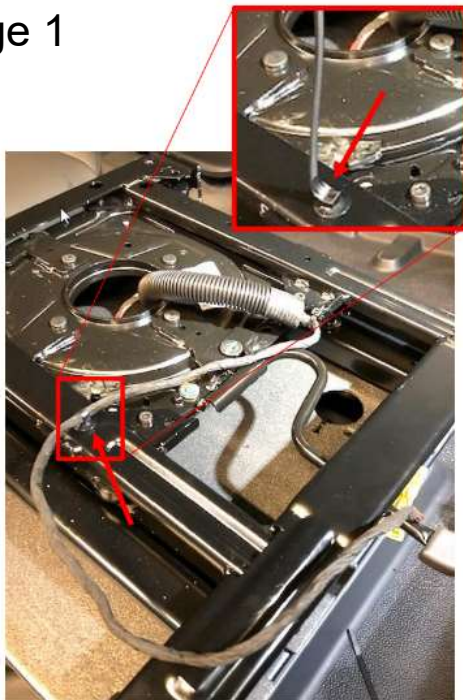
Image 1

1. Add retention points to the harness. For older Chassis with manually adjustable seats, there are 2 additional connection points:
 - a. Fir Tree Clip to hole in the swivel seat frame. See Image 1.
 - b. Wire Tie to the swivel seat frame. See Image 2.
- c. Note:** Additional Fir Tree and Wire Tie should be mounted to the outboard rail of the seat. Left side for the driver and right side for the passenger as referenced by the seat occupant. Images below are for the passenger seat, mirror for the driver seat. Trim Wire Tie Tails, leave any OEM mounts on the harness.

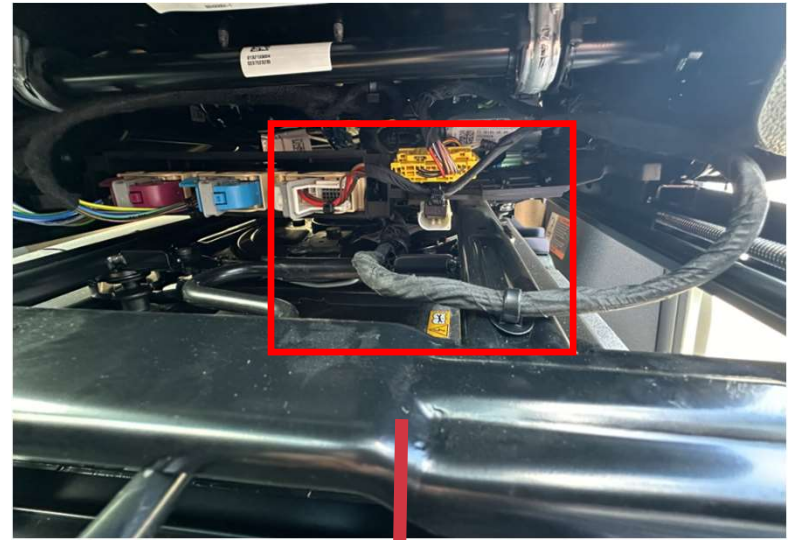
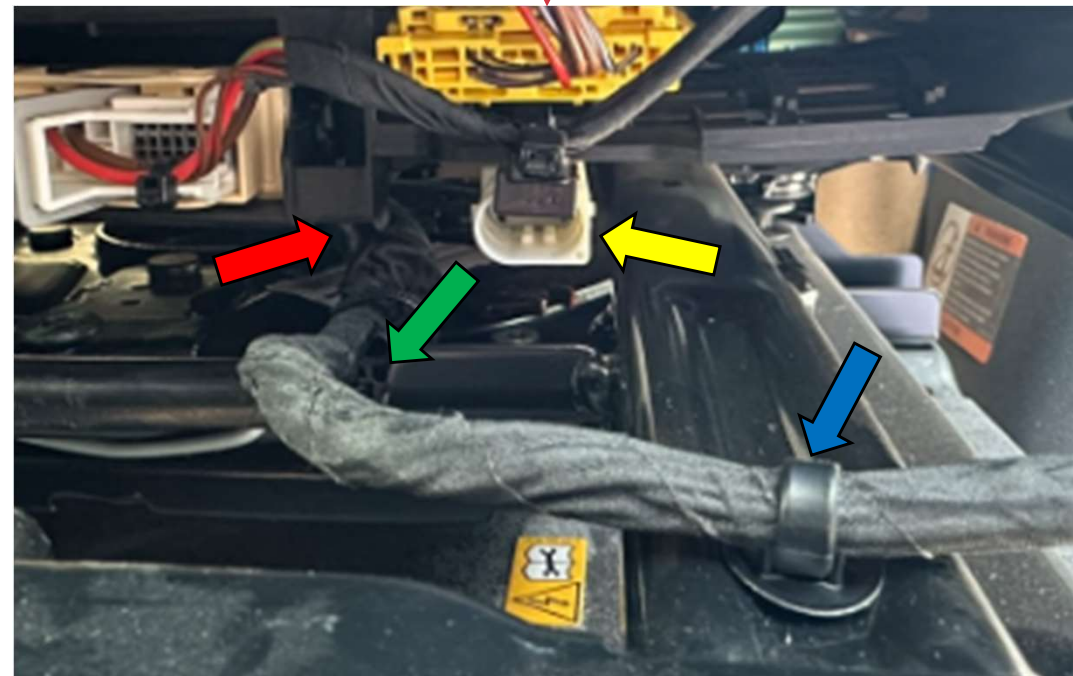
1. Locate all OEM retention points on the harness.
 - a. For newer Chassis with electronically adjustable seats there are 4 connection points:
 - @ White Plug (Yellow Arrow)
 - @ Seat Rail (Blue Arrow)
 - @ Seat Base (Green Arrow)
 - @ Circular cutout (Red Arrow)
 - Note: Fir Tree near yellow plug is not used and will not be reinstalled.
2. Ensure all wire tie mounts are installed in their proper location.
 - a. See list above for location
3. Inspect the wire tie mounts for any damage. If damaged, install replacement right next to existing mount on OEM harness. Cut tail from Wire Tie after installation, leave the OEM mount in place.
 - a. Clip Mount- firmly tug on clip to see if it will disengage from the metal flange.
 - b. Fir Tree Mount - firmly tug on mount to see if it will disengage from the mounting hole.

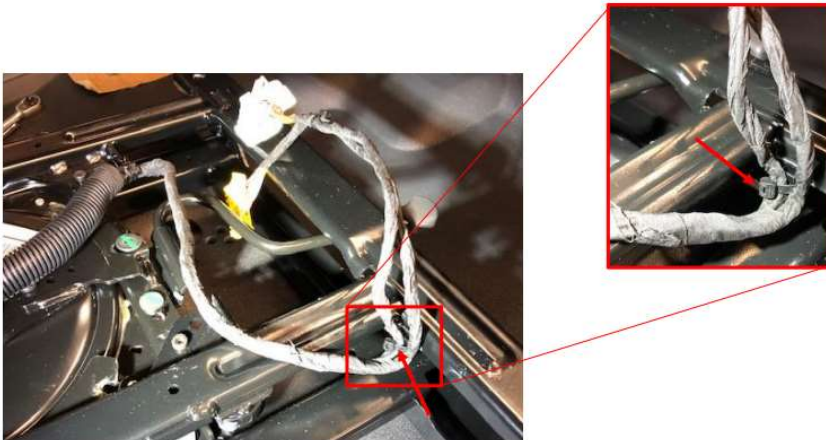
Image 1

1. Add retention points to the harness. For older Chassis with electronically adjustable seats, there are 2 additional connection points:
 - a. Clip Wire Tie Mount to rear flange of swivel base lead rail. See Image 1.
 - b. Wire Tie to secure the two plug wires together. See Image 2.
 - c. **Note:** Additional Clip Wire Tie Mount and Wire Tie should be mounted to the outboard rail of the seat. Left side for the driver and right side for the passenger as referenced by the seat occupant. Images below are for the passenger seat, mirror for the driver. Trim Wire Tie Tails, leave any OEM mounts on the harness.

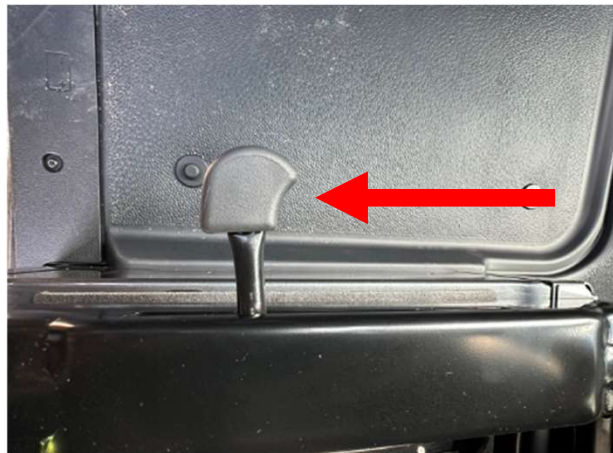
- a. Ensure the mounting locations hold their correct position.
3. Swivel the seat as far as it can go in both directions. See Image 1 for swivel lever identification.

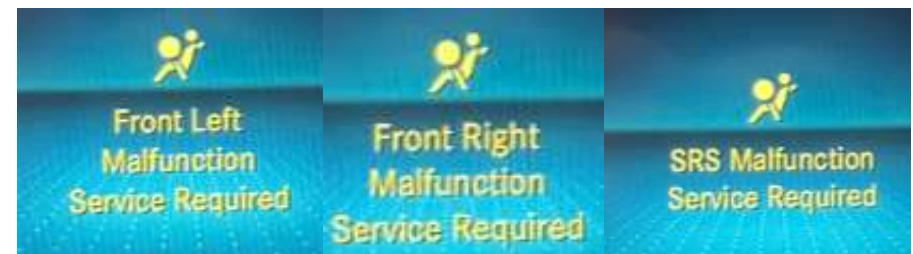
4. Firmly tug on all Wire Tie Mounts to ensure an appropriate retention to the seat (If not already completed in Step 3).
5. If no concerns arise from the testing above and the SRS/airbag warning is not showing on the dash, the rework is complete. See Image 2 for example warnings.

- a. If a warning is present, contact Winnebago Technical Service to coordinate additional repairs.
