SAFETY RECALL

Front Fascia Energy Absorbing Foam

Reference: 41B / NHTSA 24V-346

Remedy available for
2024 (WL) Jeep Grand Cherokee

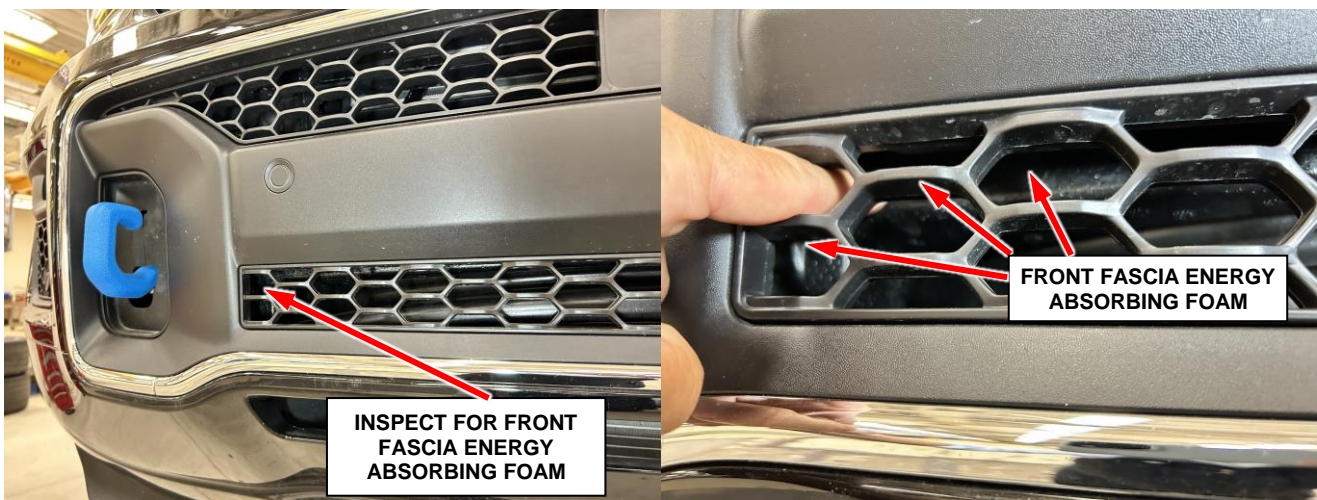
Figure 1 - Inspect for Front Fascia Energy Absorbing Foam

1. Looking through the lower grille in the fascia, check for Front Fascia Energy Absorbing Foam behind the fascia (Figure 1). Is the Front Fascia Energy Absorbing Foam present?
 - **Yes:** Return the vehicle to the customer and close the recall.
 - **No:** Complete Front Fascia Energy Absorbing Foam installation per the recall instructions below.

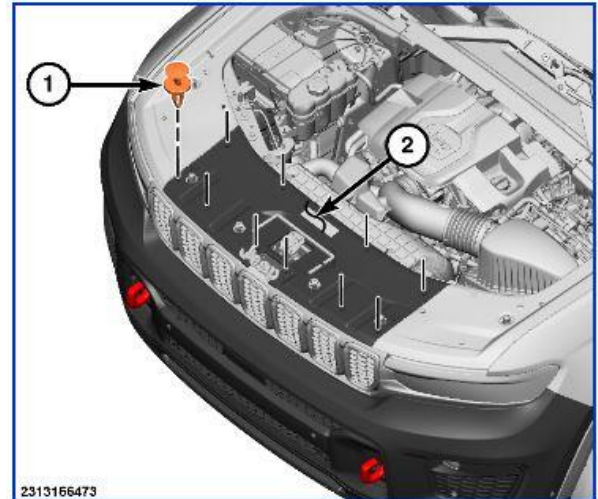
Figure 2 – Front Closeout Panel

1. Remove the fasteners (1) and remove the front closeout panel (2) (Figure 2).

- 1 - Fasteners
- 2 - Front Closeout Panel

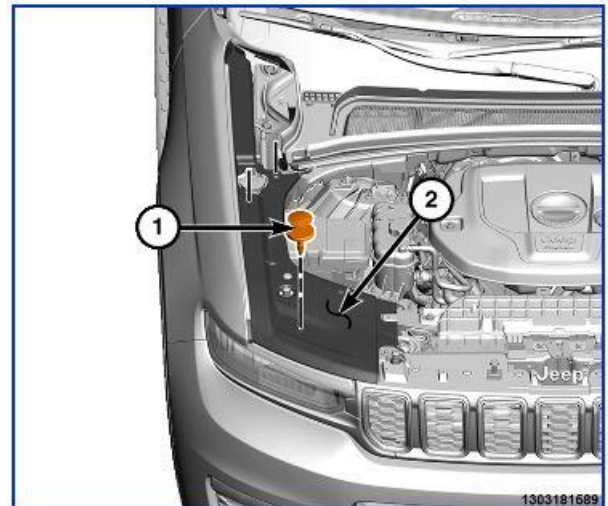
Figure 3 – Side Closeout Panel

2. Remove the fasteners (1) and remove the side closeout panels (2) from both sides of the vehicle (Figure 3).

- 1 - Fasteners
- 2 - Side Closeout Panel

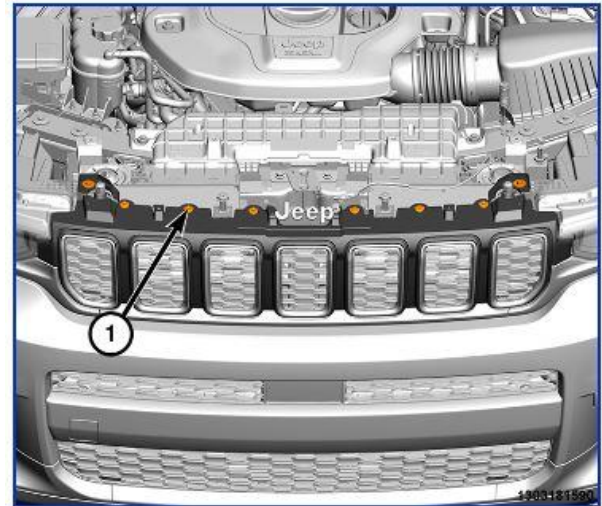
Figure 4 – Upper Grille Fasteners

3. Remove the upper grille fasteners (1) (Figure 4).

1 - Upper Grille Fasteners

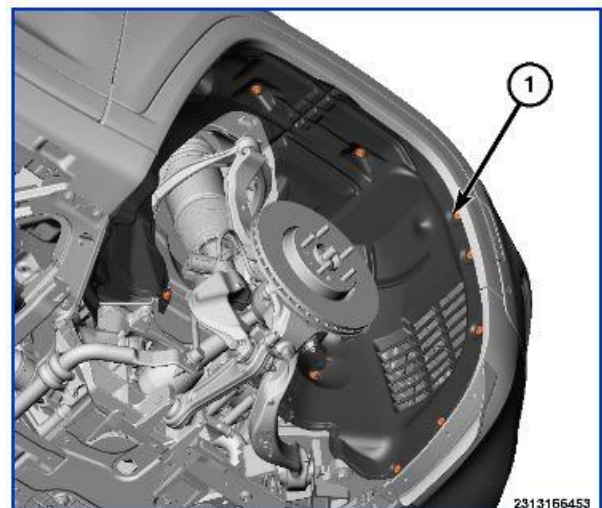
Figure 5 – Front Splash Shield

4. Raise and support the vehicle (Refer to 04 - Vehicle Quick Reference/Hoisting/Standard Procedure).
5. Remove both front wheels (Refer to 22 - Tires and Wheels / Removal and Installation).
6. Remove the front half of the front splash shield fasteners (1) from both sides of the vehicle and position the splash shield out of the way (Figure 5).

1 - Splash Shield Fasteners

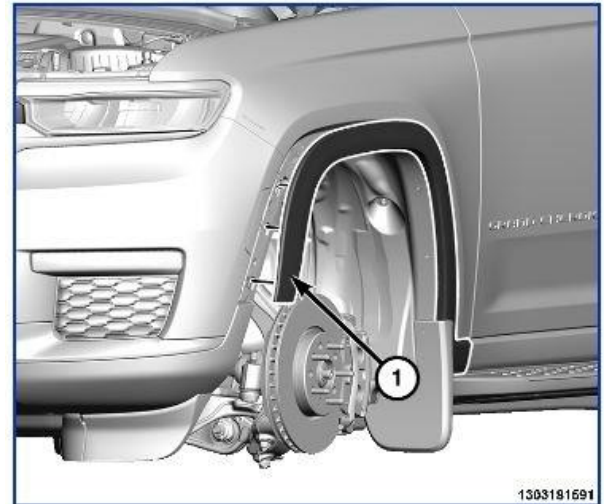
Figure 6 – Wheel Moldings

7. Reach into the wheelhouse and squeeze the wings of the clip fasteners (1) together using suitable tool to release the fasteners for the moulding where it overlaps the fascia (Figure 6).

1 - Wheel Molding

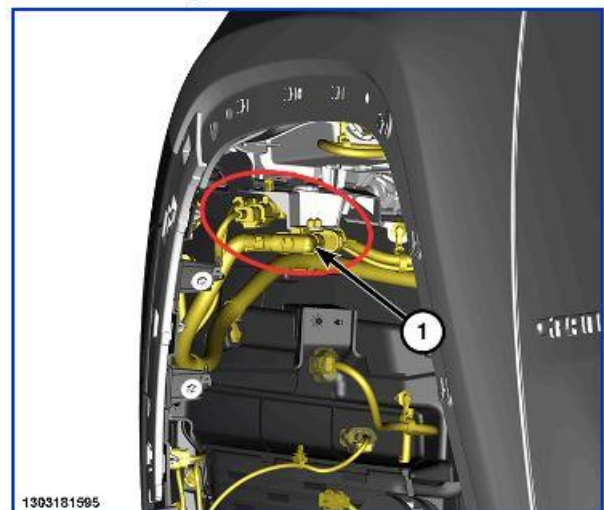
Figure 7 – Wire Harness Connectors

8. Disconnect the wire harness connectors on both sides of the vehicle, if equipped. Using suitable hose-pinching pliers, clamp-off the washer hose and disconnect (Figure 7).

1 - Wire Harness Connectors

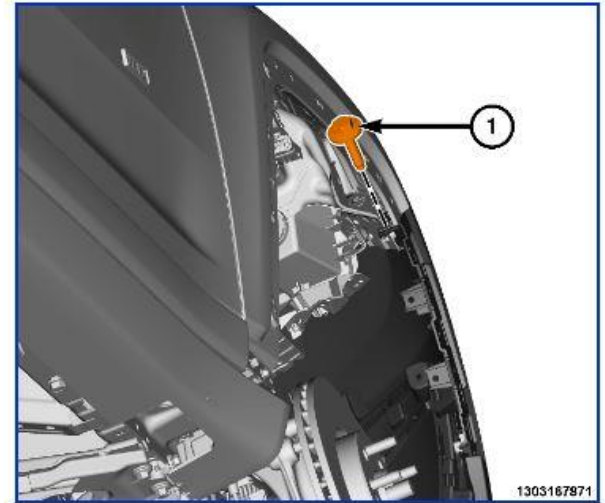
Figure 8 – Fascia to Fender Fasteners

9. Remove the fender fasteners (1) attaching the fascia to the fenders (Figure 8).
10. Remove the front belly pan (Refer to 13 - Frame and Bumpers/Under Body Protection/BELLY PAN/Removal and Installation).

1 - Fender Fastener

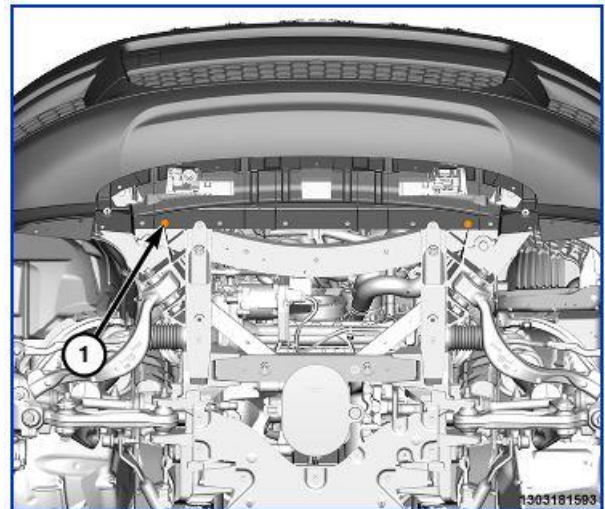
Figure 9 – Lower Fascia Fasteners

11. Remove the lower front fascia fasteners (1) (Figure 9).

1 - Lower Front Fascia Fasteners

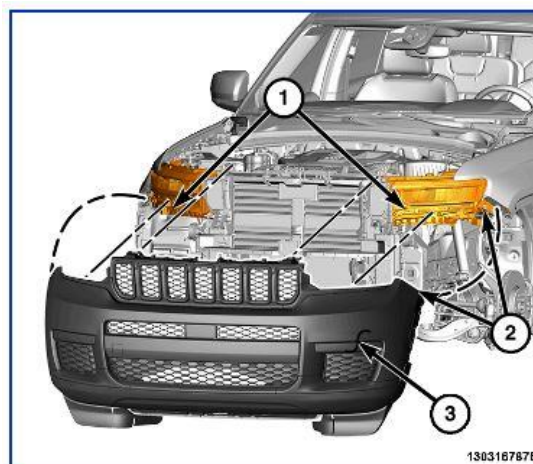
Figure 10 – Front Fascia Attachment

12. Carefully pull out and release the fascia attachments from the fender attachment brackets (2) (Figure 10).
13. Carefully pull out and release the fascia attachments from the headlamp brackets (1) (Figure 10).
14. Remove the front fascia, and place it face down on a soft work surface.

- 1 - Headlamp Brackets
- 2 - Fender Brackets
- 3 - Front Fascia

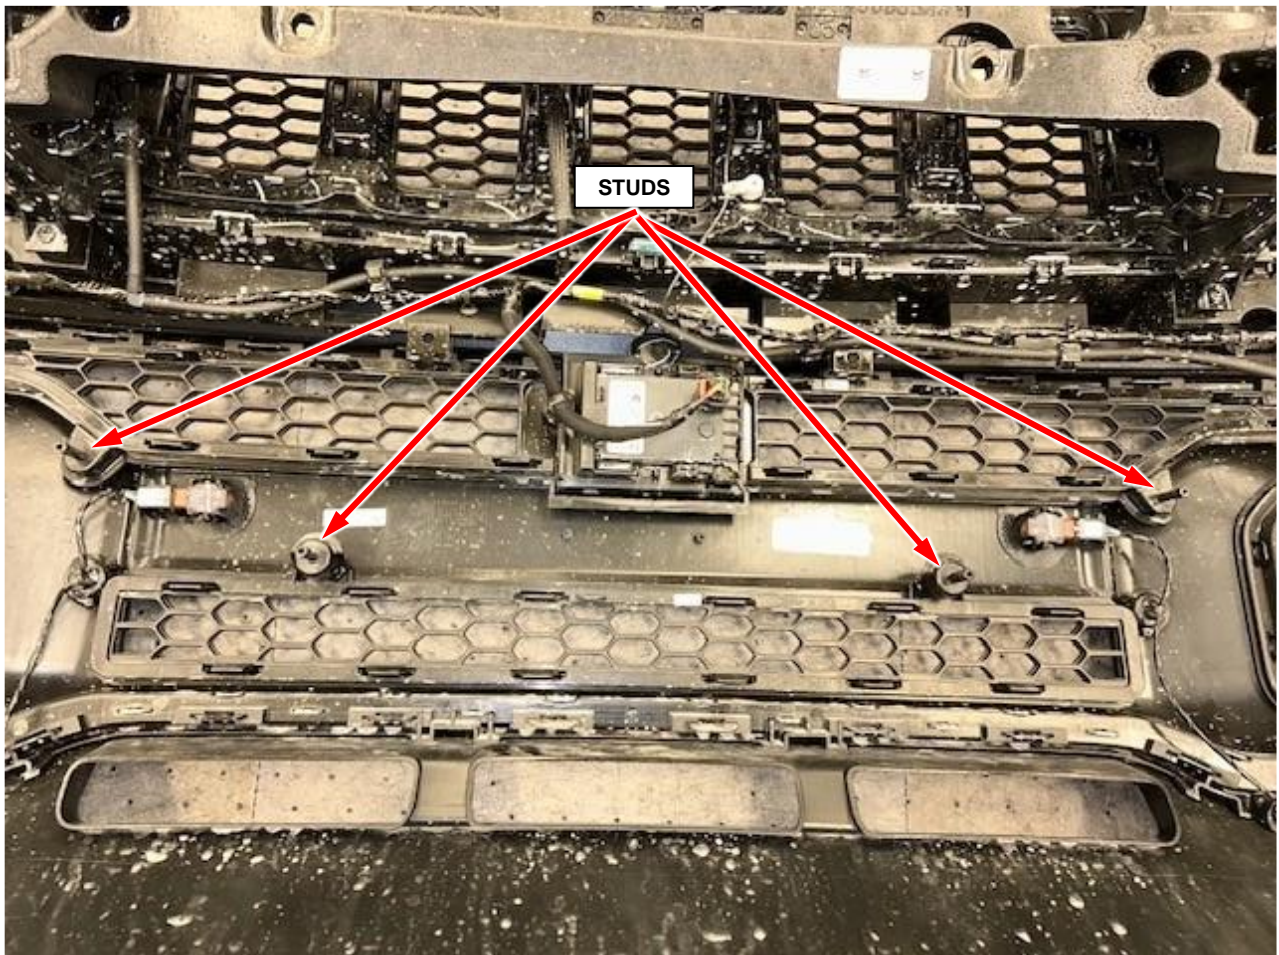
Figure 11– Front Fascia Energy Absorbing Foam Studs

15. Note the four mounting studs for the Front Fascia Energy Absorbing Foam (Figure11).

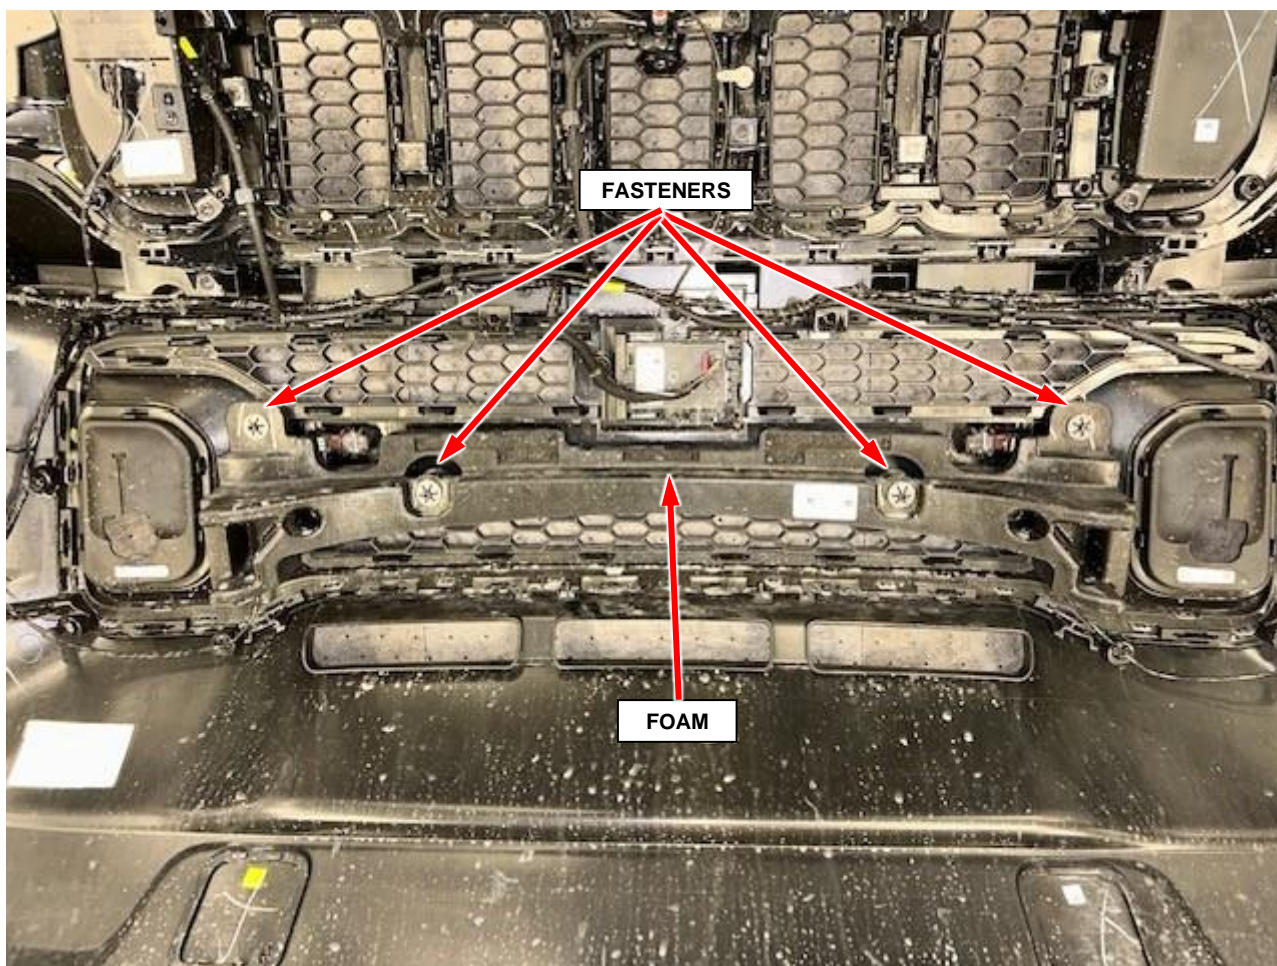
Figure 12– Front Fascia Energy Absorbing Foam Installed

16. Install the Front Fascia Energy Absorbing Foam as shown and secure it with four push on fasteners (Figure 12).
