Safety Recall Campaign

SC314 (Rev 2, 9/25/2024)

2022MY
Niro EV (DE EV)

HIGH VOLTAGE BATTERY
SAFETY PLUG REPLACEMENT (SC314)

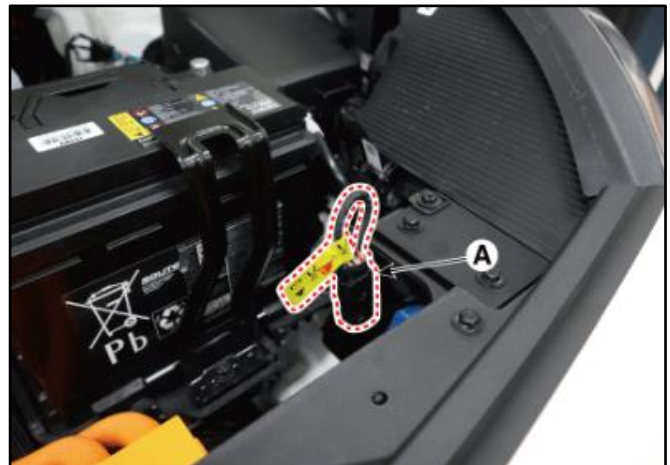
2. Perform the '**High Voltage Shut-Off Procedure**' (A) by referring to "Body Electrical System → High Voltage Shut-Off Procedures → High Voltage Shut-Off Procedures (Steps 1-4 Only)" in the applicable Shop Manual on KGIS.

It takes at least five (5) minutes for capacitor of the high voltage battery system to discharge completely.

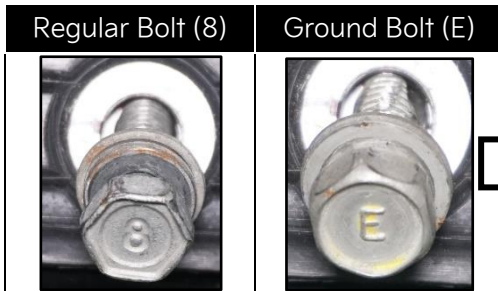
Mark the six (6) ‘ground (earth)’ bolts and their location to prevent mixing with regular bolt prior to reassembly.

Ground Bolt (E): 6 ea.

Regular Bolt (8): 34 ea.

Note: DO NOT REUSE the bolts or nuts.

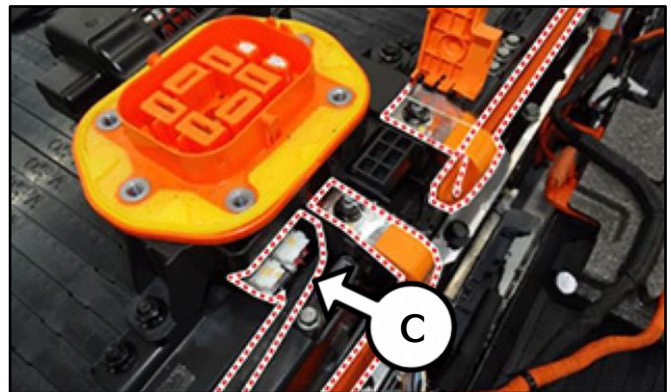
- 4.. Disconnect the service plug cable connectors (C).

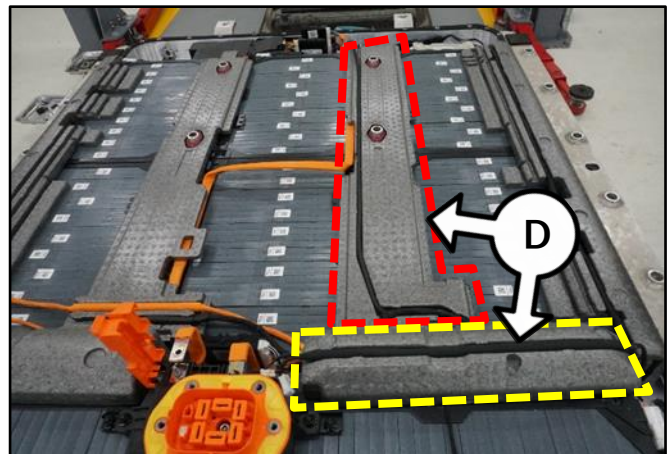
5. Remove the right battery pads (D).

Note: The left battery pads do NOT need to be removed.

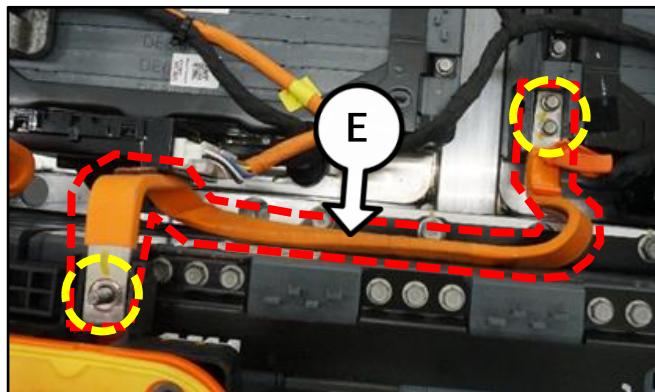
6. Loosen the two (2) bolts and one (1) nut to remove and discard the bus bar (E).

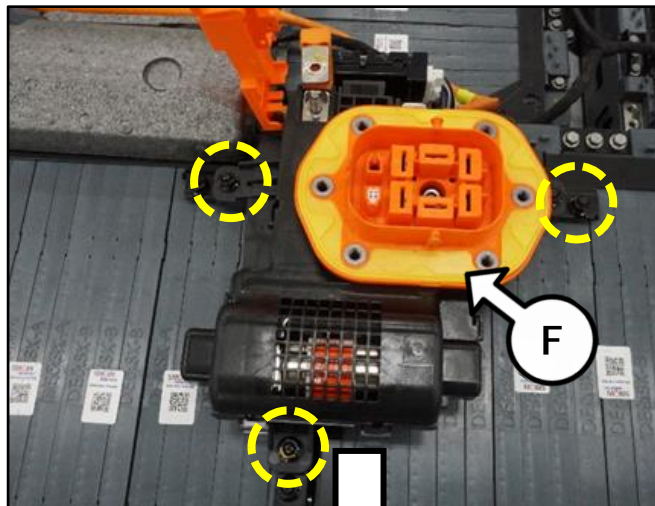
7. Loosen the three (3) nuts to remove the service plug assembly (F).

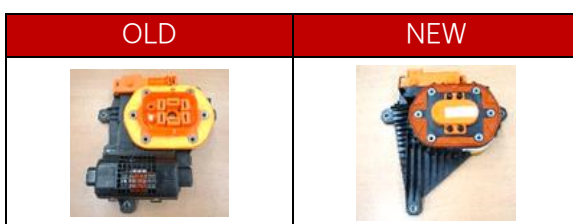
8. Install the new safety plug (F).

Tightening torque for Safety Plug Nuts:
7.2 - 8.7 lb.ft (9.8 - 11.8 N.m)

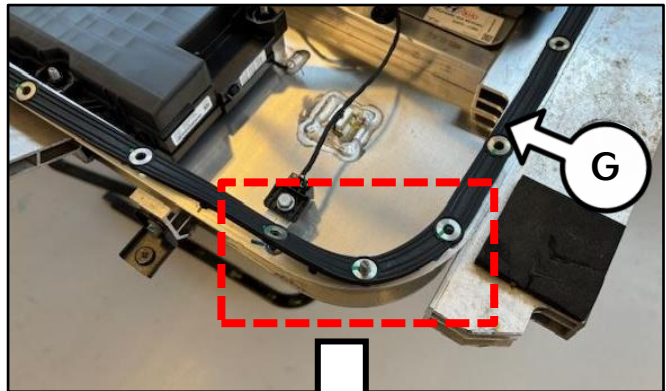
When assembling the new gasket, locate the two (2) tabs shown to the right and align them with the holes on the HVB lower case, as shown.

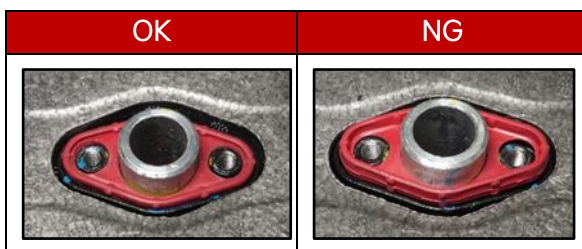
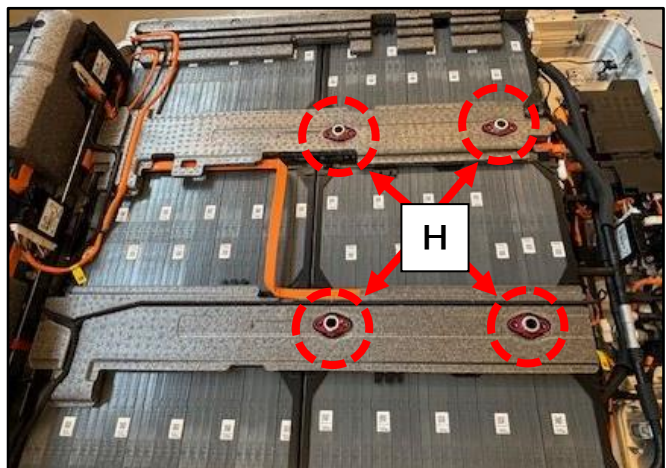
12. Install the four (4) NEW reinforcement bar gaskets (H).

Note: Ensure the gaskets are assembled correctly, as shown below.

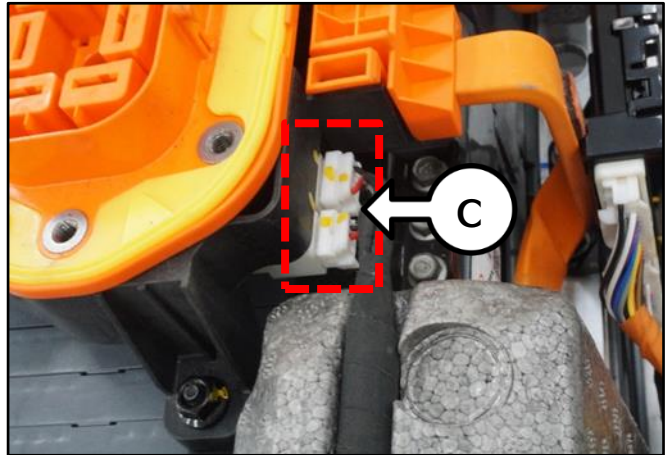
13. Reconnect the service plug cable connectors (C).

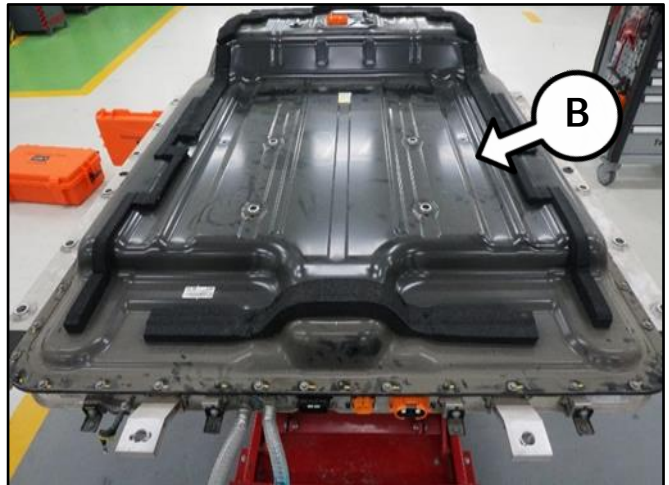
14. Reinstall the HVB upper case (B).

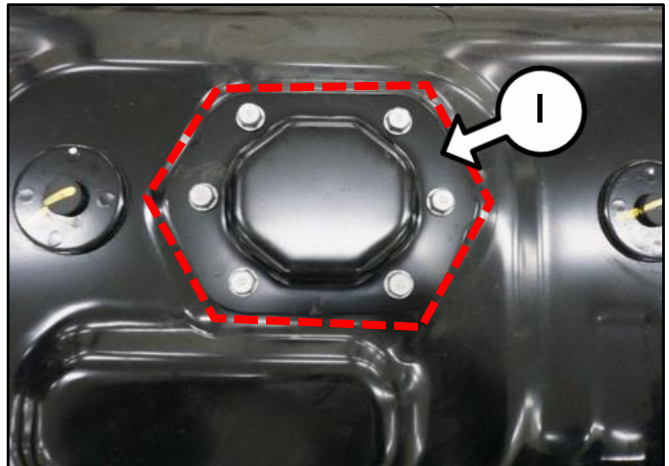
15. Install the new safety plug cover (I).

Tightening torque for Safety Plug Cover Bolts:
7.2 - 8.7 lb.ft (9.8 - 11.8 N.m)

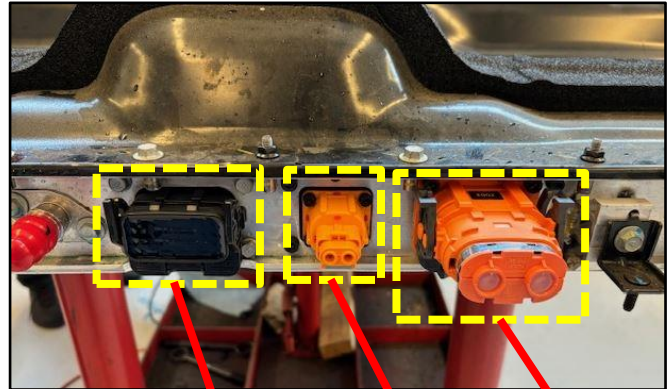
1. Install the sealing connectors onto the HVB, as shown.

Make sure to clean the HVB top case before attaching the low and high pressure hoses to ensure an air tight seal.

Figure	 	 	 
Name	BMS Connector	Heater Connector	HV Connector
Part No.	E004	E003	E002

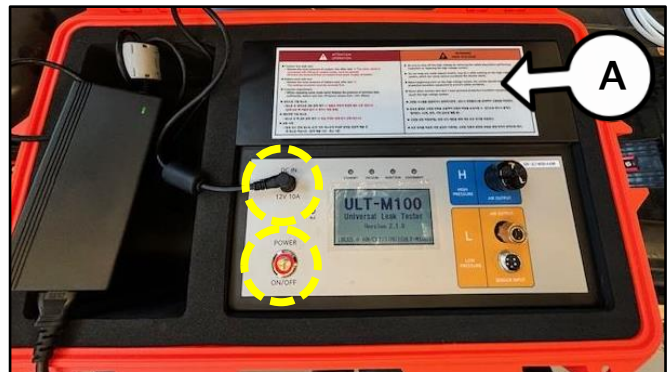
- 2a. Attach the 12V power cord to the leak tester (A), as shown.

- 2b. Press the 'POWER ON/OFF' button.

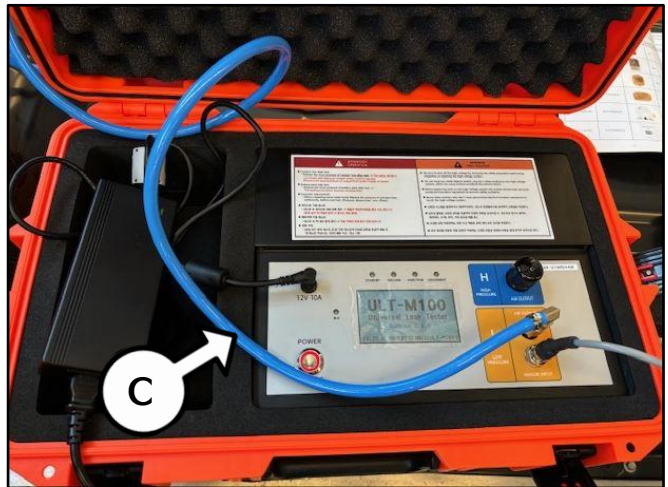
9. Connect 'Air Injection Hose' (C) to the 'L - Low Pressure Air Output', as shown.

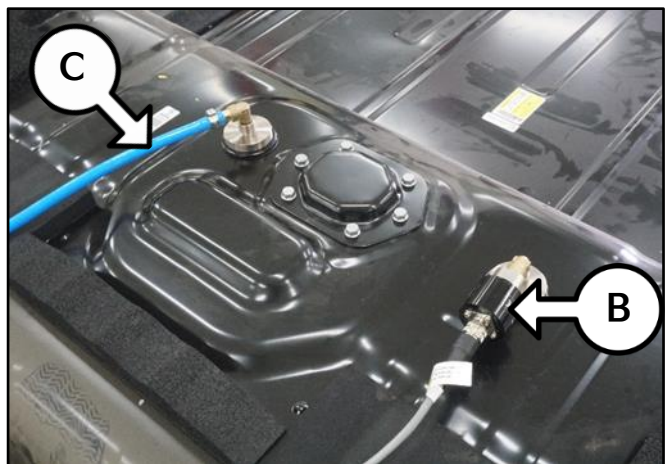
10. Connect the Pressure Sensor Module (B) and Air Injection Hose (C) to the HVB case, as shown.

Note: Ensure the HVB case is clean and free of debris to ensure an airtight seal.

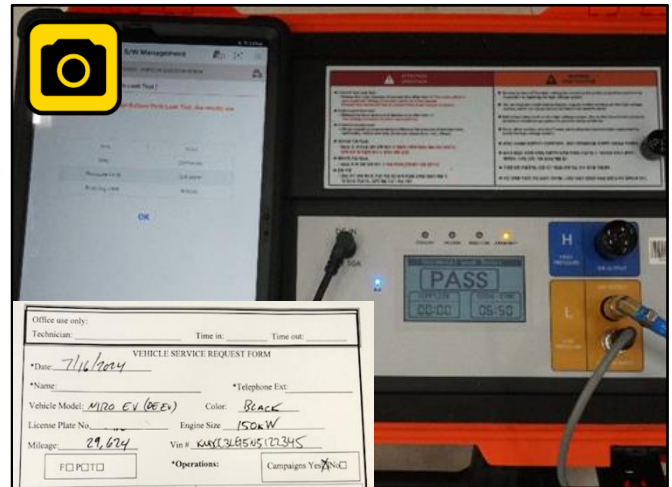
14. Once the leak test has completed, a 'PASS' result should be displayed on the leak tester (A). Attach one clear KVID photo showing the 'PASS' result and the RO information.

Note: If a 'FAIL' result is displayed, confirm all case nuts and bolts are properly torqued, no gaskets are pinched or there is nothing preventing an airtight seal, and then perform steps 3 - 13. If a 'FAIL' result is still displayed, refer to 5-5. Self Test [Battery Pack Air Injection Adapter] in the Universal Leak Tester User Guide pg. 23.
