RECALL

R24DA: EV Fuel Fired Heater – Fuel Leak (FMVSS 301)

Models Affected: Certain 2021-2023 Model Year Blue Bird Electric Buses equipped with feature 01345-02

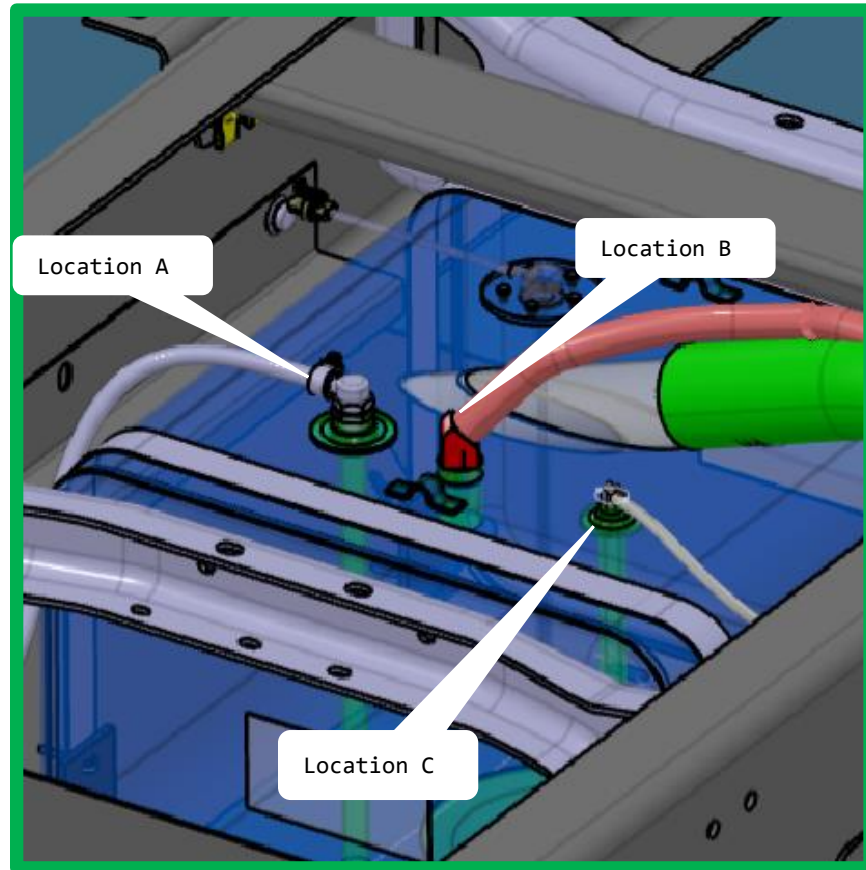
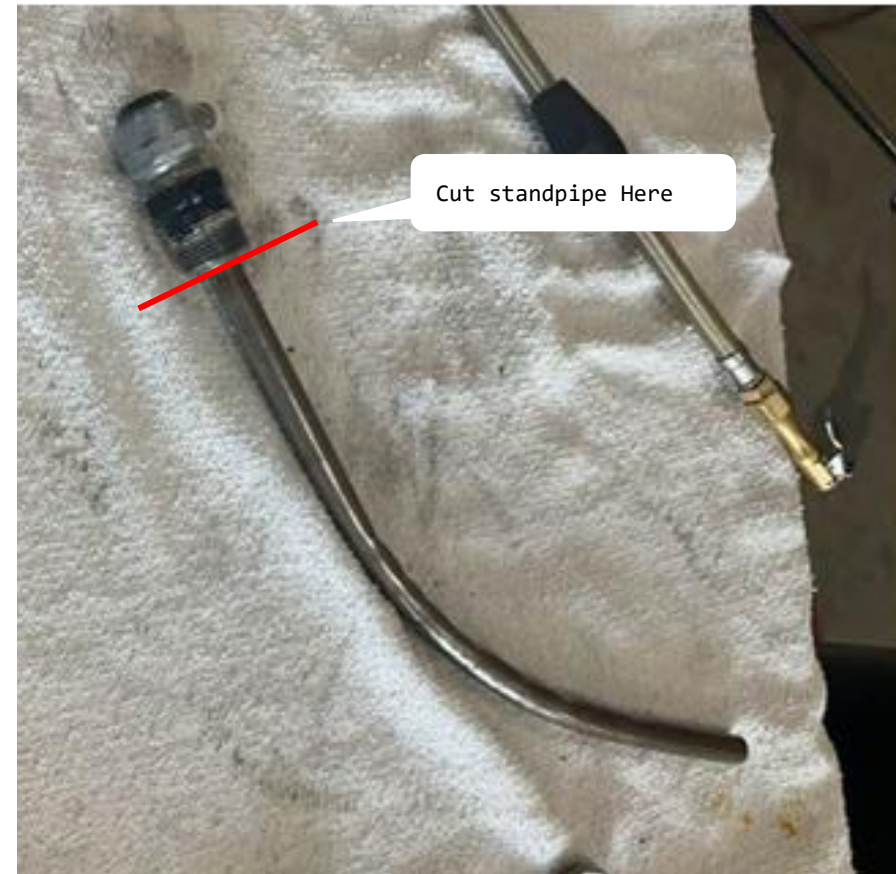
Step 3: Remove the threaded bung at location A out of the tank. It will have a stand pipe attached to the bottom

NOTE: You will need to bend the stand pipe as you remove the fitting from the tank. Bend as little as required to fully remove the bung/fitting assembly

Step 3: Cut the stand pipe off the bottom of the fitting

Step 4: Clean the threads on the fitting, apply Loc-tite™ 567 or equivalent, and install into the tank

Step 5: Re-Install the vent valve and associated plumbing

Step 6: Correct any other mis-installed fittings in location B and C
