RECALL 24V387 / 2024-307 REMEDY INSTRUCTIONS

Concern:
There may not be an amber intermediate clearance lamp installed on the road and curbside of the vehicle, which fails to meet F/CMVSS 108.

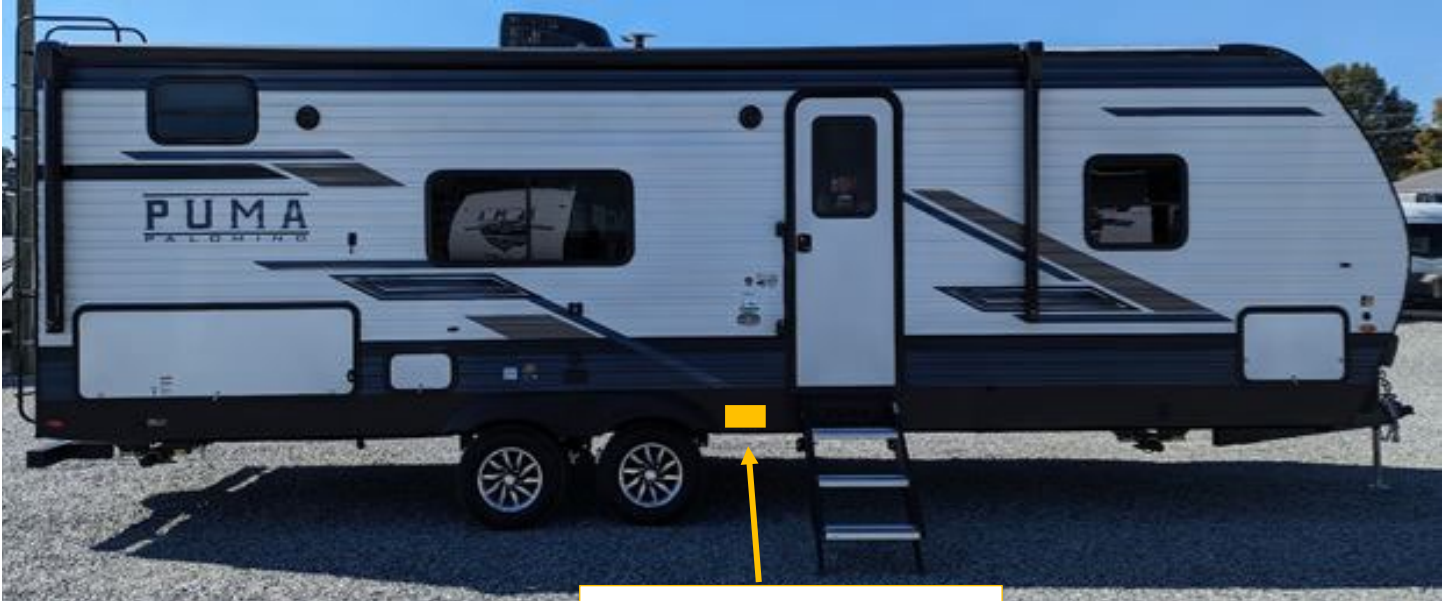
FIGURE 1 – DOOR SIDE

INSTALL AMBER CLEARANCE LAMP

STEP 1: AT THE MIDSHIP LOCATION FIGURES 1 & 2, ON THE OFF DOOR SIDE WALL SIDE OF THE COACH, INSIDE THE UNDERBELLY, A WIRE HARDNESS MAY BE FOUND;

STEP 5: LOCATE THE MIDDLE OF THE VEHICLE AND MARK THE "J WRAP METAL" AND DRILL A HOLE JUST LARGE ENOUGH TO FIT THE STEM OF THE LAMP THROUGH;

STEP 6: INSTALL THE AMBER CLEARANCE LAMP IN A HORIZONTAL POSITION AND ROUT ITS WIRES INTO THE "J WRAP METAL";

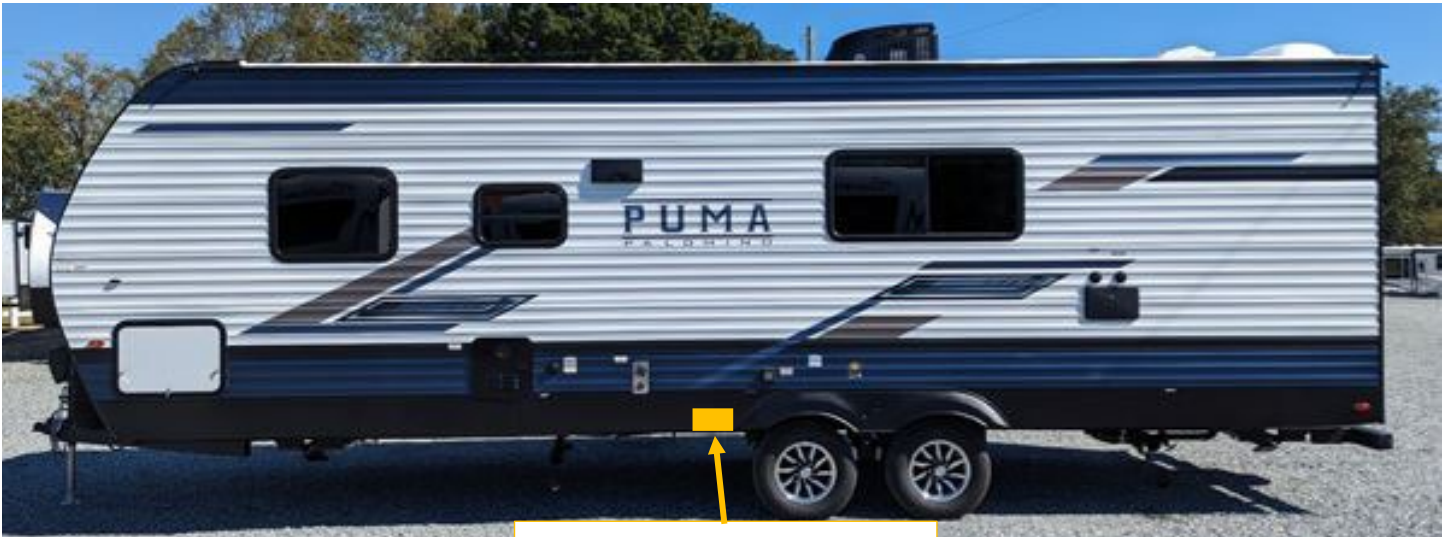
FIGURE 2 – OFF DOOR SIDE

INSTALL AMBER CLEARANCE LAMP
