**HYUNDAI**  
**Technical Service Bulletin**

GROUP <b>RECALL</b>	NUMBER <b>24-01-048H</b>
DATE <b>JUNE 2024</b>	MODEL(S) <b>TUCSON (NX4A) SANTA CRUZ (NXT)</b>

**SUBJECT:** MOTOR DRIVEN POWER STEERING  
POWER PACK REPLACEMENT  
(RECALL 261)

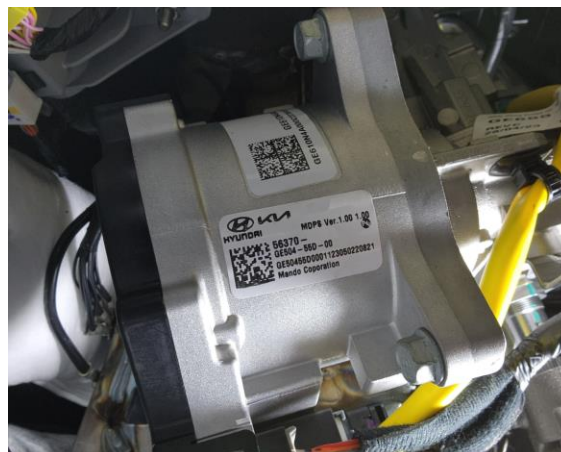
**Description:** The motor-driven power steering (MDPS) assembly in certain Tucson (NX4A) and Santa Cruz (NXT) vehicles might contain a printed circuit board (PCB) inside the Electric Power Pack that was assembled with contaminated flux during supplier manufacturing, increasing the risk of an electrical short. A short on the PCB controller could lead to a malfunction of the MDPS assembly, resulting in MIL illumination and loss of power steering assist during vehicle operation. Follow the information in this bulletin to replace the Electric Power Pack.

1. Refer to the shop manual to remove the power pack (A):
  - **Steering System > Motor Driven Power Steering > MDPS PowerPack Assembly > Repair procedures**

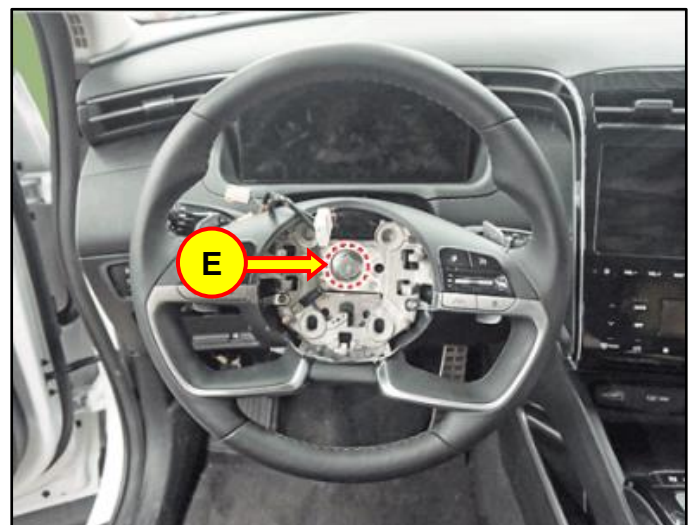
Use a new steering wheel bolt (E) when reinstalling the steering wheel.

**Steering Wheel Bolt Tightening Torque:**

lb-ft	34
N.m	47
