## Thor Motor Coach Recall Repair Instructions

Recall #	<b>24V-427 2024-417</b>		
Description/Title:	<b>Power sofa breaker</b>		
Affected Product Line(s):	<b>Certain 2025 Tranquility, Sanctuary</b>		
Service Campaign # :	<b>RC000305</b>		
Repair Code:	<b>Inspect Only: TMCRC10114V  Inspect with Repair: TMCRC10115V</b>	Released Date:	<b>7/22/2024</b>
Time Allowed:	<b>Inspect Only: 0.1  Inspect with Repair: 0.3</b>	Document Revision:	<b>A</b>

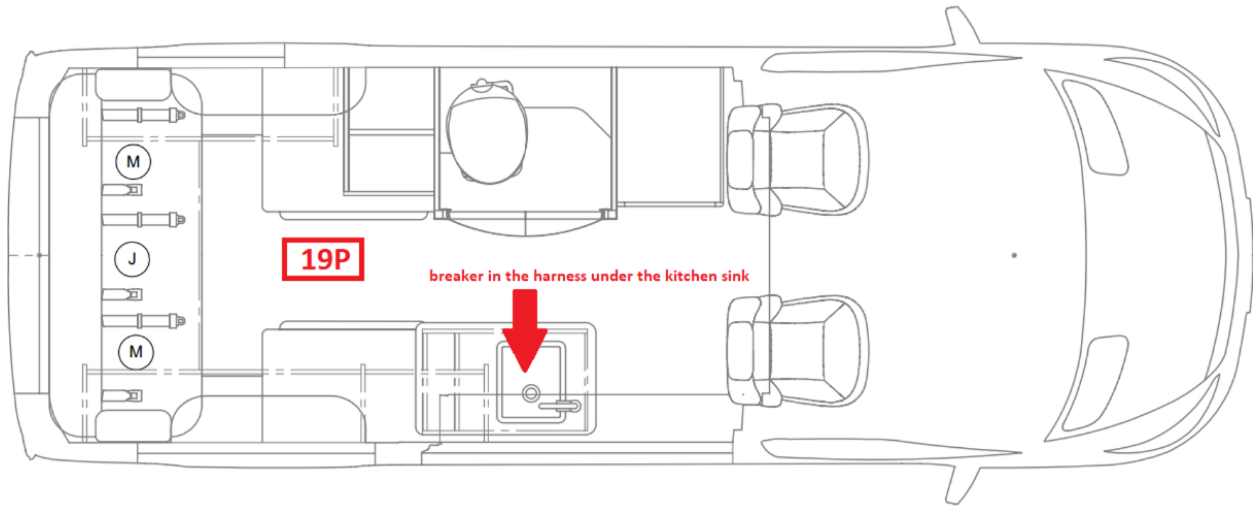
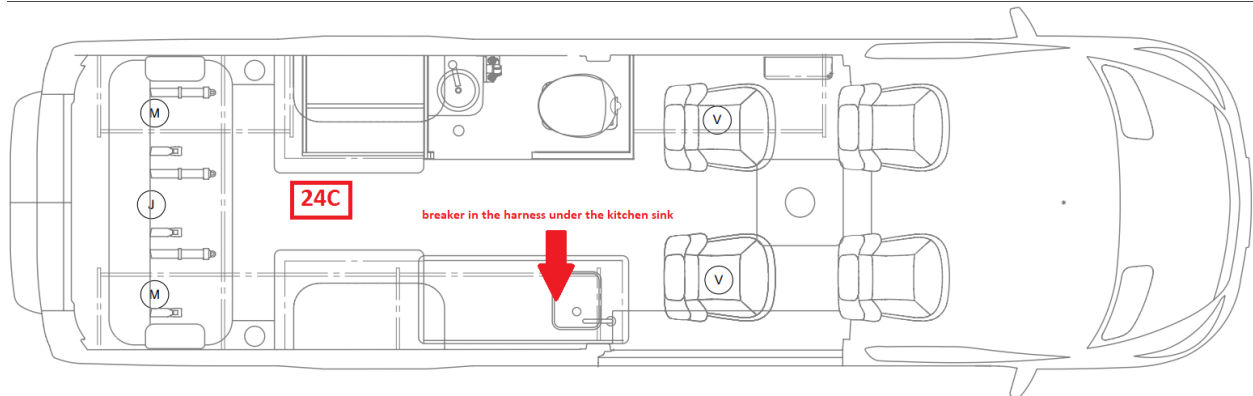
1. The breaker is located underneath the kitchen sink.

### 12V BREAKERS

NO	GA	COLOR	AMPS	POWER TO
	10	RED	20	SOFA

2. If the breaker is 50amp, it will need to be replaced with a 20amp breaker. Continue to Step 3.

3. Unplug the coach and turn off the inverter.
4. Disconnect the ground cable from the house battery.
5. Remove the 50amp breaker and replace with 20amp breaker.
6. Reconnect the ground cable to the house battery.
7. Plug the coach back in.
