RECALL 24V429 / 2024-331 REMEDY INSTRUCTIONS

Make(s): STARCRAFT BUS Model(s): SCHOOL BUSES Model Year(s): 2009 - 2022	Repair Code: RC-045-00-09-004330 Allotted Time: .33 HRS. Inspection Code: RC-045-00-05-004329 Allotted Time: .10 HRS.
	Concern: The 30" front passenger barrier may not be located correctly.	Photo(s) Required: NO Prior Authorization Required: YES Part(s) Kit Number: N/A Part(s) Return: N/A

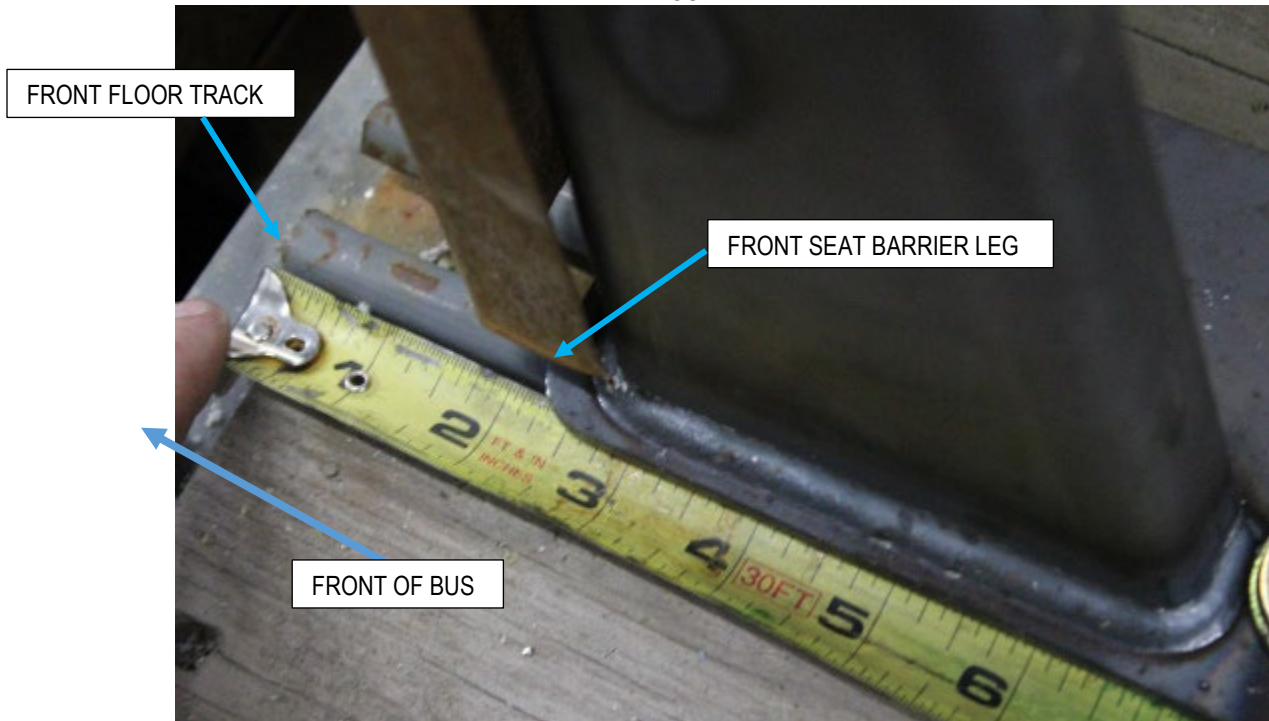
FIGURE 1 REF.

STEP 1: MEASURE FROM THE FRONT OF THE FLOOR RAIL TO THE FRONT EDGE OF THE FRONT SEAT BARRIER (FIGURE 1 REF.)

- IF THE MEASUREMENT FALLS WITHIN $2\ 1/4" \pm 1/8"$, NO FURTHER ACTION NEEDED, CLAIM INSPECTION CODE;
- IF THE MEASUREMENT FALLS OUTSIDE OF $2\ 1/4" \pm 1/8"$, MOVE ON TO REMEDY;

STEP 1: LOOSEN THE SINGLE FLOOR BOLT AND THE PASSENGER SIDE WALL BOLTS OF THE FRONT BARRIER;

- DISCARD THE BOLTS AS THEY ARE NOT USEABLE AGAIN;

STEP 2: MOVE THE SEAT BARRIER AS ONE PIECE UNTIL THE FRONT EDGE OF THE SEAT BARRIER IS WITHIN $2\ 1/4" \pm 1/8"$ OF THE FRONT

FLOOR RAIL (FIGURE 1 REF.)

STEP 3: SECURE THE FRONT SEAT BARRIER TO THE FLOOR TRACK USING A NEW 7/16"-20 X 1", GRADE 8 BOLT AND TIGHTEN TO 50 FT. LBS.;

STEP 4: SECURE THE FRONT SEAT BARRIER TO THE WALL USING TWO NEW 7/16"-20 X 1", GRADE 8 BOLTS AND TIGHTEN TO 80 FT. LBS.;
