Recall Campaign Bulletin

Campaign No. 2024100002, October 2024

SUBJECT: **Model E-Class, CLS, and AMG GT 4-Door (213, 238, 257, and 290 platform)
Model Year 2019 – 2025**

Replace Transmission Wiring Harness

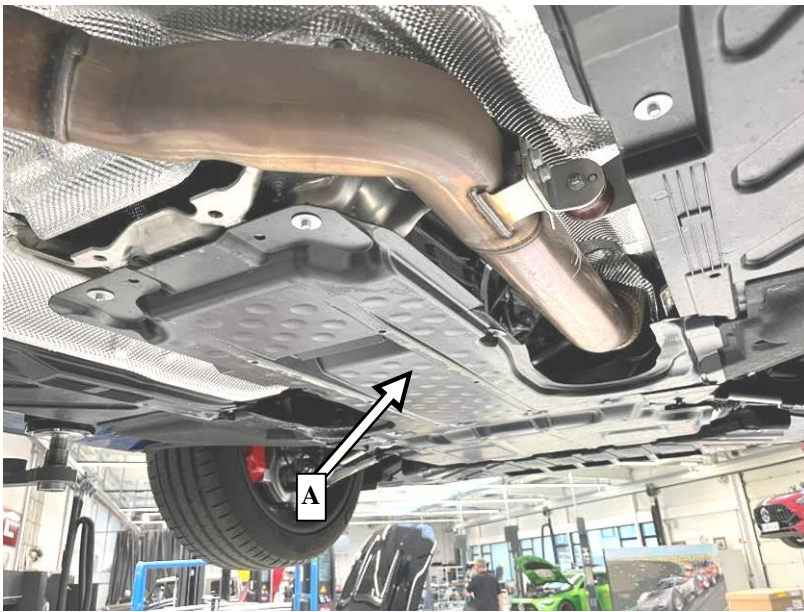
Figure 1

2. Remove rear engine compartment lining (**Figure 1, A**).

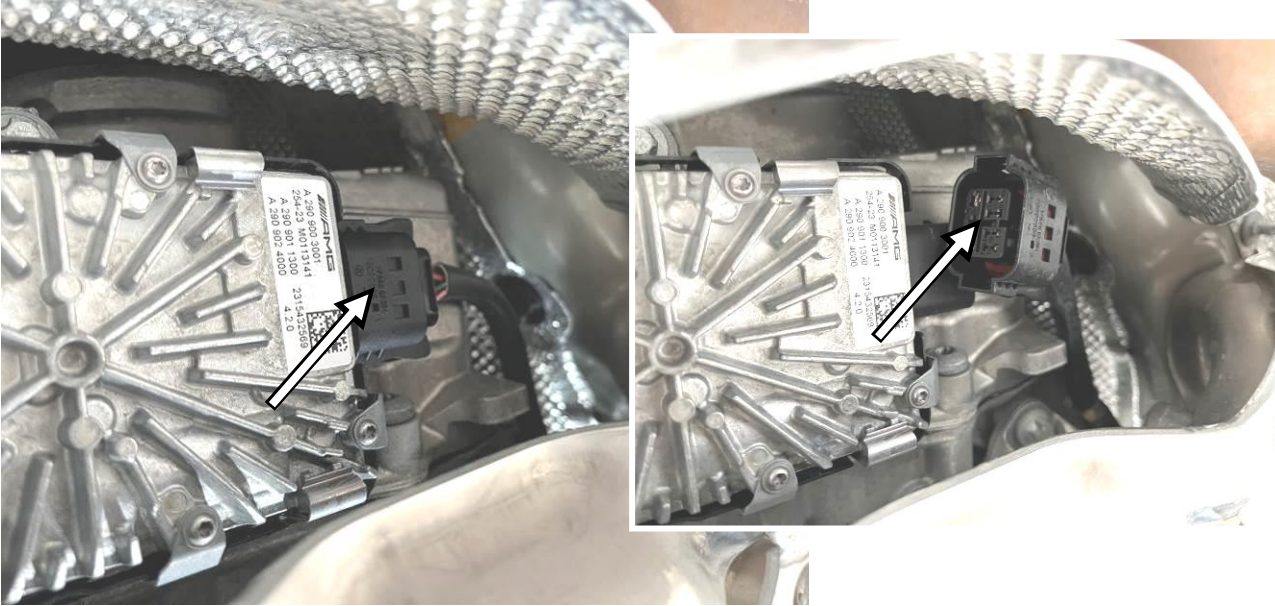
Figure 2

3. Disconnect electrical connector (**Figure 2**) at transfer case control unit (N45) above rear transmission crossmember and guide the wiring harness out toward the front, in the direction of the transmission.

i To do this, gently press the heat shield under the transfer case down slightly.

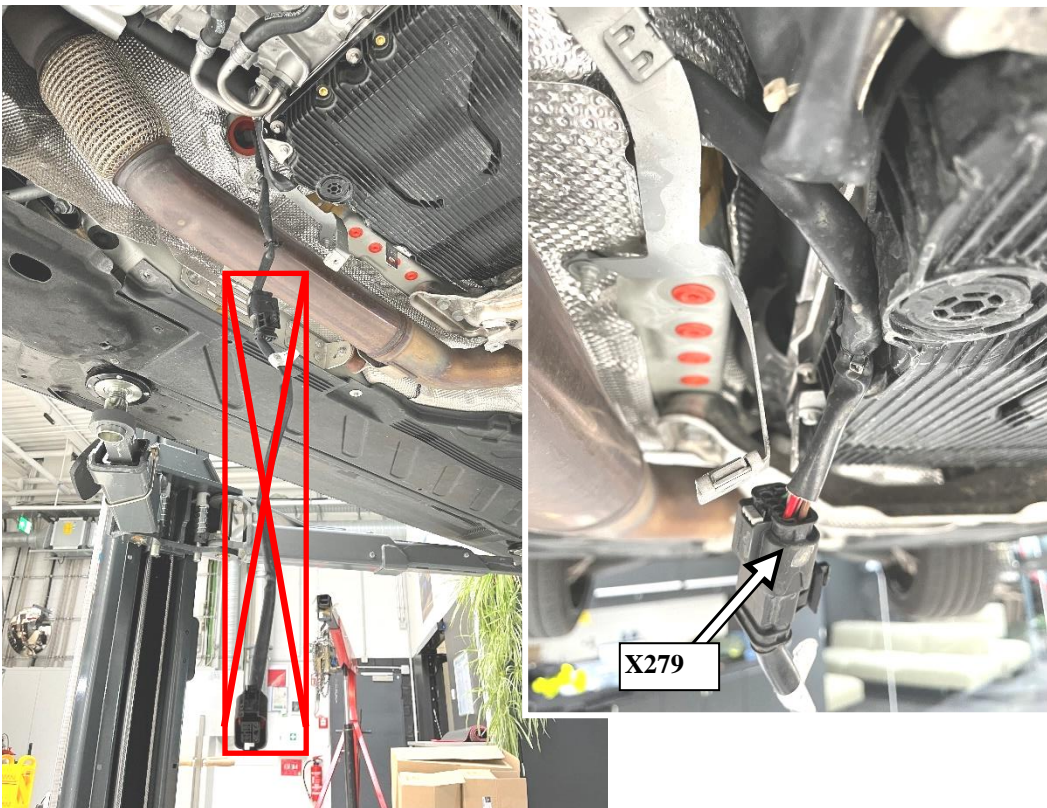
Figure 3

i Once the harness is guided out, disconnect the hanging line (**Figure 3**) from the wiring harness on the vehicle side.

i The removed wiring harness from the connector coupling (**Figure 3, X279**) to the connector coupling of the transfer case control unit (N45) is not reinstalled and can be discarded (**Figure 3 – marked in red**).

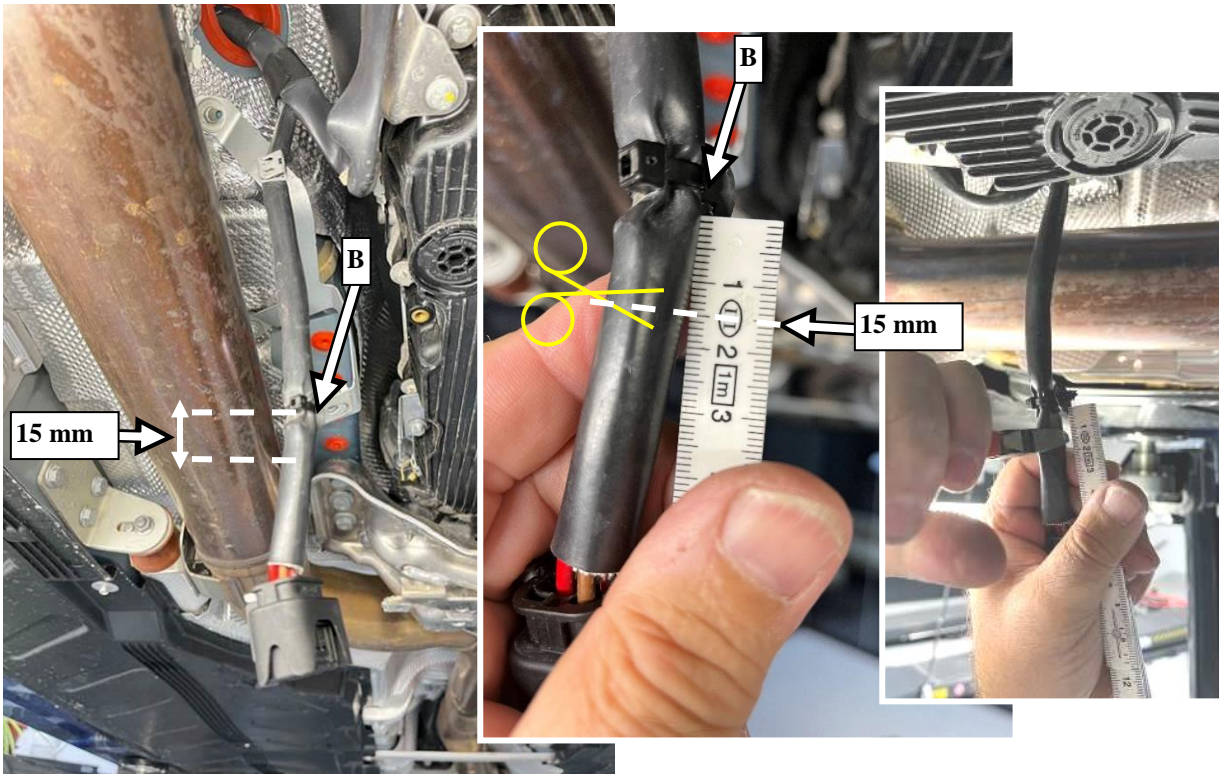
Figure 4

4. Cut the vehicle side wiring harness 15 mm below the cable tie (Figure 4, B) and then remove the cable tie installed above it, including the fastening clip (Figure 4, B).

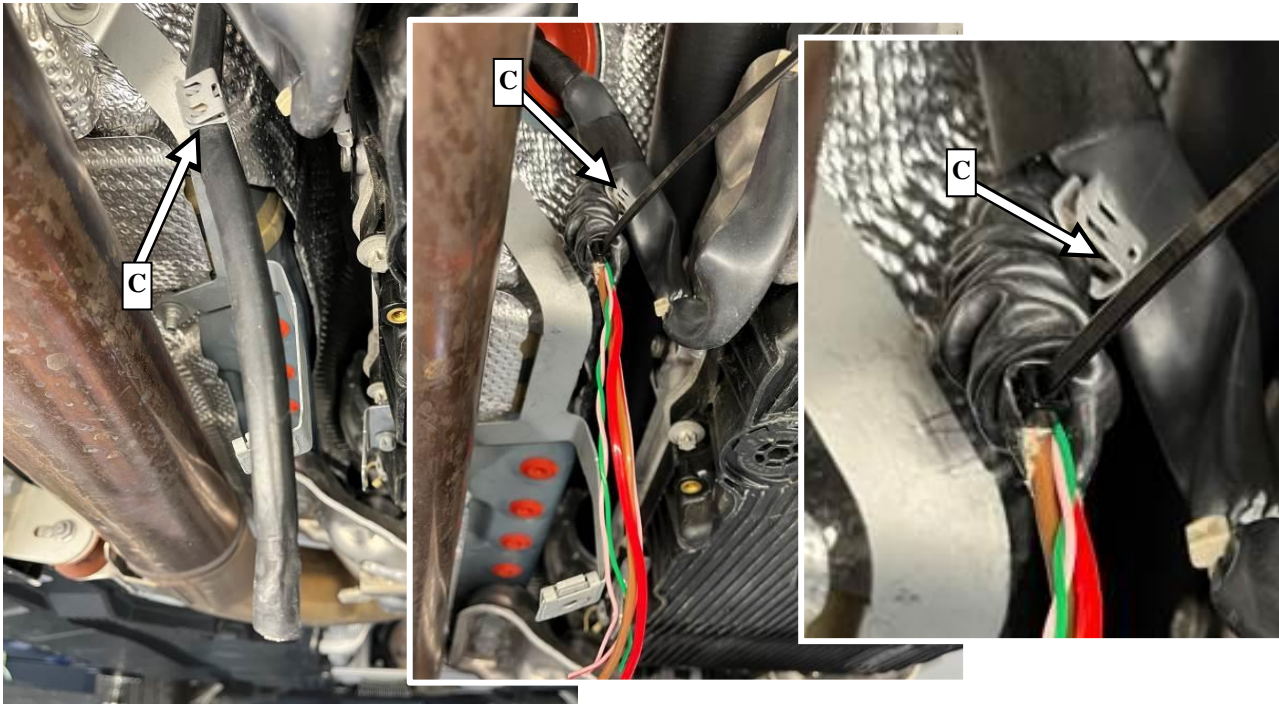
Figure 5

5. Slide the fabric protective hose on the vehicle side wiring harness upward as far as possible toward the retaining clamp (Figure 5, C) and use a cable tie to temporarily secure it against sliding down (cable tie will be removed in Step 12).

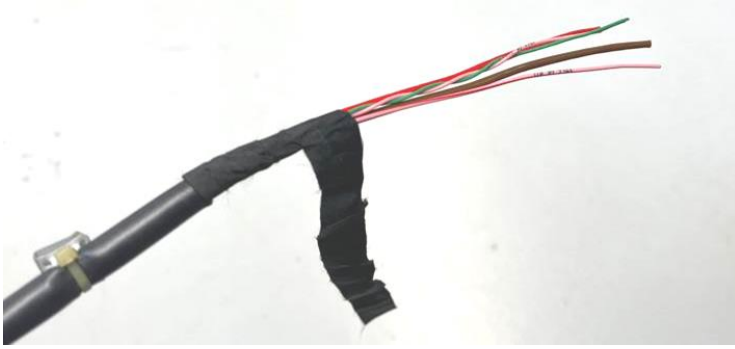
Figure 6

6. Completely remove the fabric insulating tape of the new repair wiring harness up to the fabric protective hose (**Figure 6**).

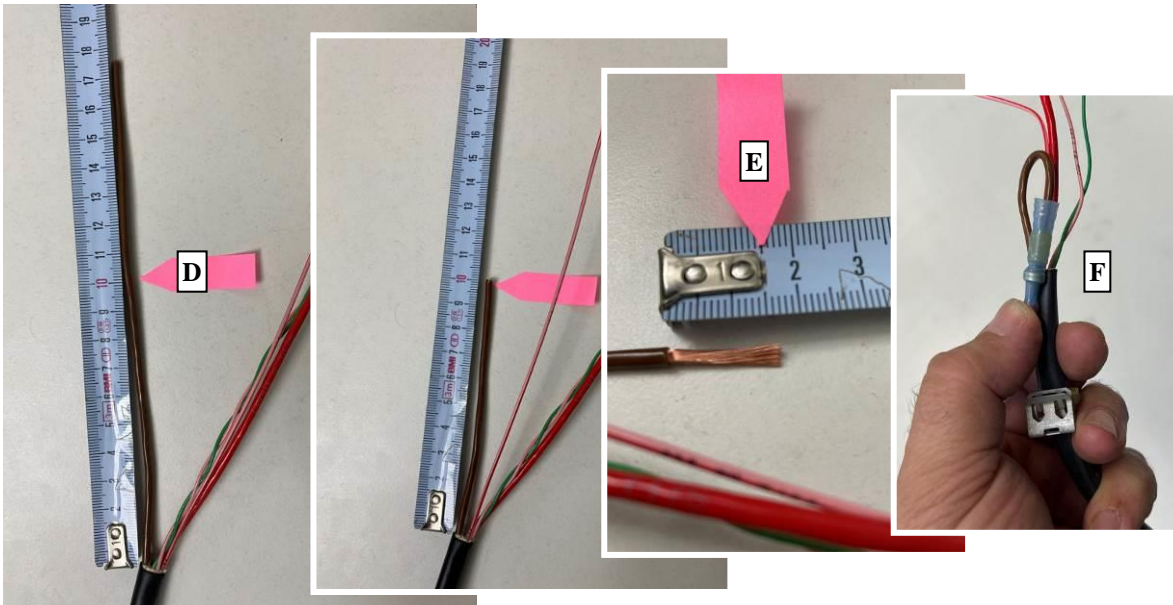
Figure 7

7. Shorten the brown cable of the repair wiring harness to a length of **100 mm** measured from the fabric protective hose (**Figure 7, D**). Insert the soldering end sleeve halfway into the fabric protective hose (**Figure 7, F**).

i Strip the end of the brown cable **15 mm** (**Figure 7, E**) and slide it into the soldering end sleeve (**Figure 7, F**).

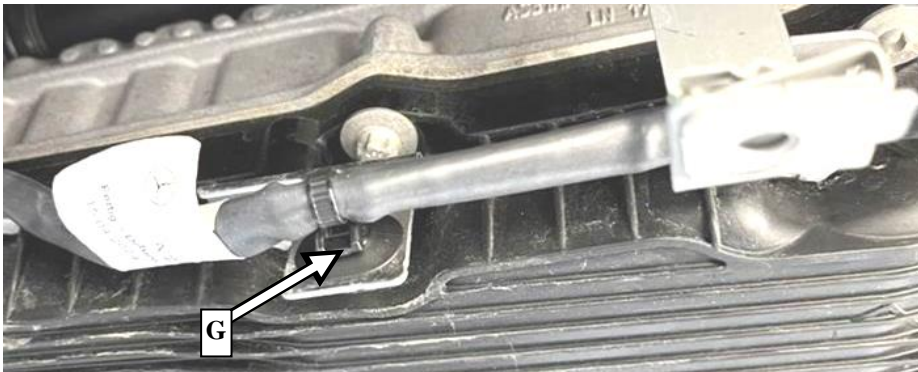
Figure 8

8. Clip the new repair wiring harness with preinstalled fastening clip (**Figure 8, G**) into the transmission bracket.

i The installation with a fastening clip aids in maintaining the length specification when soldering.

i For soldering, the repair wiring harness can be released from the fastening clip (**Figure 8, G**) again.

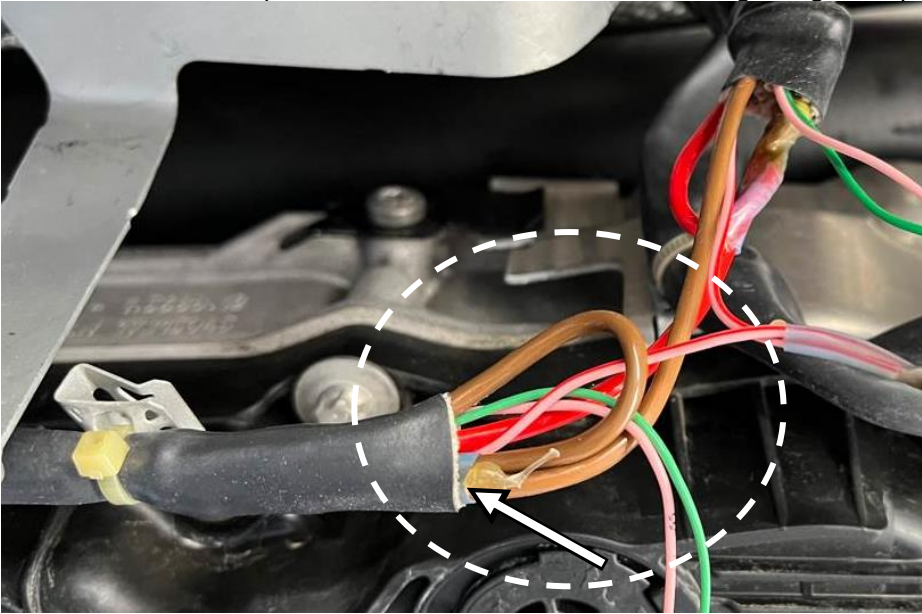
Figure 9

10. Remove the soldering end sleeve from the fabric protective hose, solder both stripped and twisted brown cable ends using a heat gun and reinsert it as far as possible into the fabric protected hose after cooling (**Figure 9**).

i Observe the specifications in **AR00.19-P-0100-09A** regarding the repair of wiring harnesses using an end sleeve.

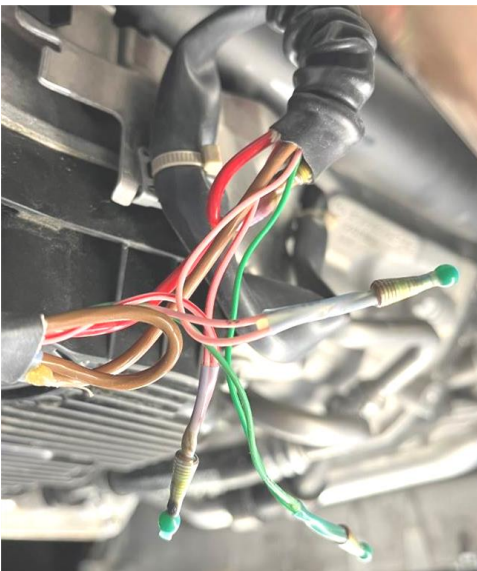
Figure 10

11. Solder the remaining cables of the same color with soldering end sleeves (**Figure 10**) without any tension or pressure on the cables or solder joints. The cables can be shortened if necessary.

i Offset the cable lengths so that the soldering end sleeves do not rest on top of each other.

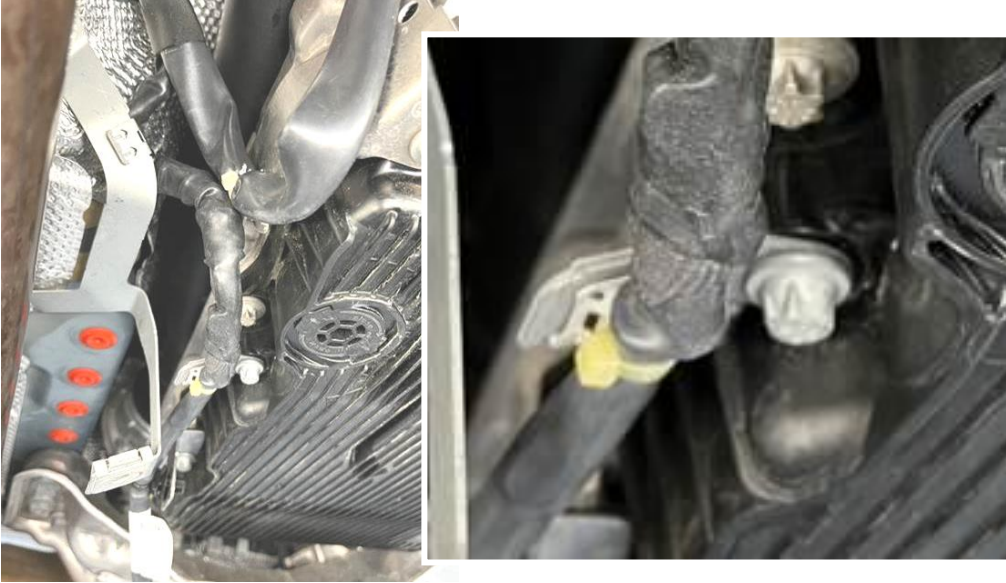
Figure 11

12. Remove the cable tie for fastening the fabric protective hose (secured during Step 5) and carefully slide the fabric protective hose over the wiring harness and the soldering end sleeves (**Figure 11**).

- i** Arrange the soldering end sleeves within the wiring harness so that they are staggered/offset from one another.
- i** Wrap the ends of the two fabric protective hoses together using fabric insulating tape.

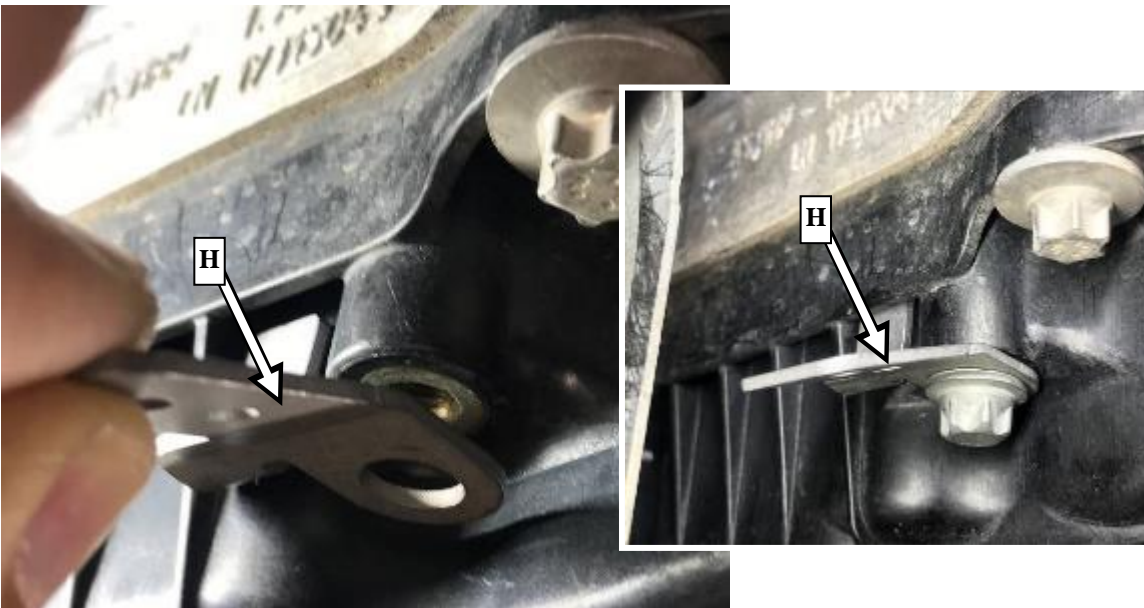
Figure 12

13. In vehicles **without a wiring harness bracket**, attach an additional wiring harness bracket (**Figure 12, H**) with a new screw to the oil pan.

- i** **Only required on vehicles without a wiring harness bracket!**
- i** Threaded bushing is already present in the oil pan.
- Nm** Wiring harness holder to oil pan: **8 Nm**.

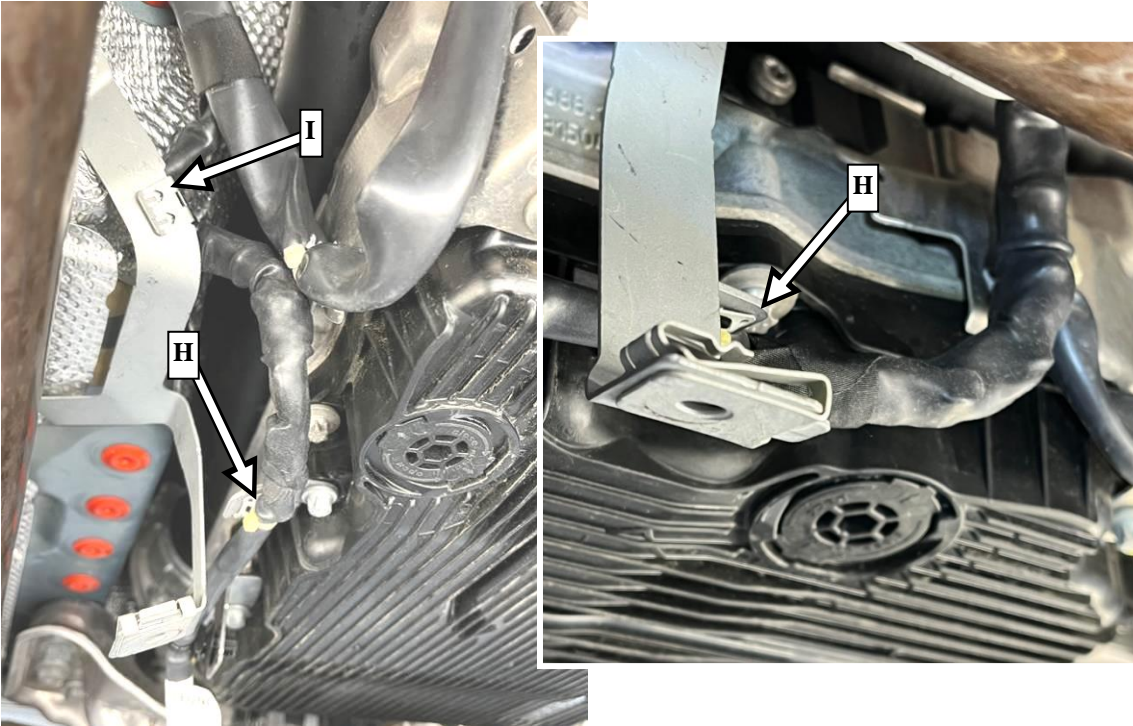
Figure 13

14. Route the wiring harness along the transmission to the connector coupling of the transfer case (N45).

i Clip the retaining clamp onto the wiring harness bracket (**Figure 13, H**).

i Clip the retaining clamp onto the holder (**Figure 13, I**).

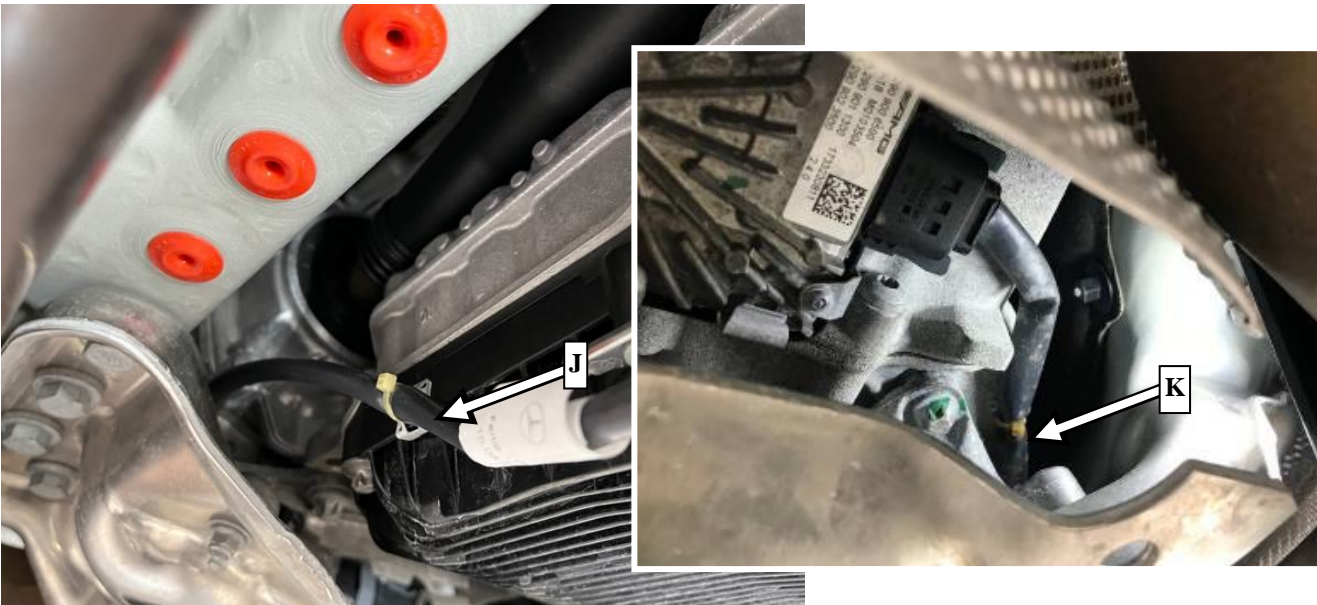
Figure 14

15. Clip the retaining clamp onto the rib of the oil pan of the transmission (**Figure 14, J**), clip the retaining clamp onto the rib of the transfer case (**Figure 14, K**) and connect the connector coupling of the transfer case control unit (N45).

i The transfer case control unit (N45) connector must engage audibly.

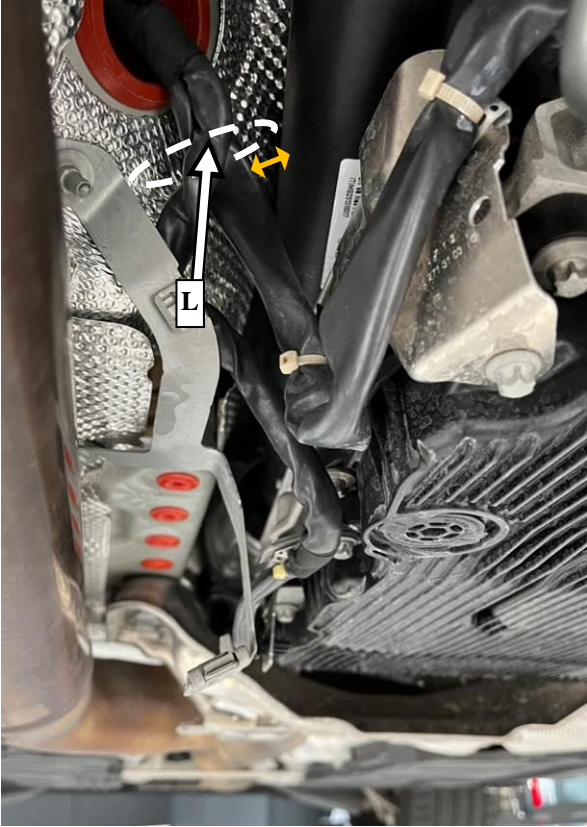
Figure 15

16. Ensure the routing distance of the new wiring harness is **at least 10 mm** from the drive shaft between the transfer case and the front axle differential (**Figure 15, yellow arrow**).

i If the distance is less than **10 mm**, increase the distance with an additional heat-resistant cable tie (**Figure 15, L**).
