# TECHNICAL INSTRUCTIONS

SAFETY RECALL 24TA09

**CURTAIN SHIELD AIRBAGS MAY NOT DEPLOY AS INTENDED**

**CERTAIN 2024 MODEL YEAR GRAND HIGHLANDER AND GRAND HIGHLANDER HV**

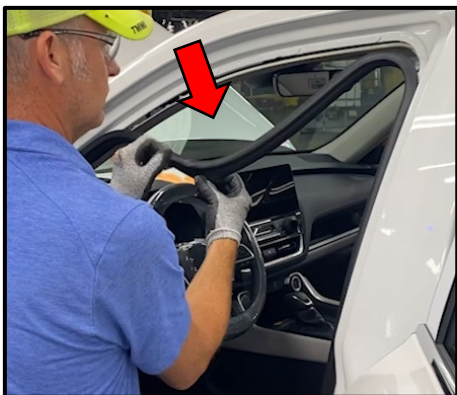
1. Fold down the Weatherstrip LH Front Door opening weatherstrip

**Note: Fold it in a manner where it does not get damaged.**

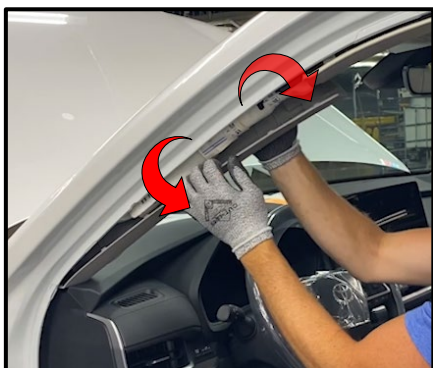
2. Remove the LH A-pillar Garnish

- a. Pull back the A-pillar garnish
- b. Cut the tether clips
- c. Remove the speaker (if applicable)
- d. Remove the 2 tether clips from the body and A-pillar and discard.

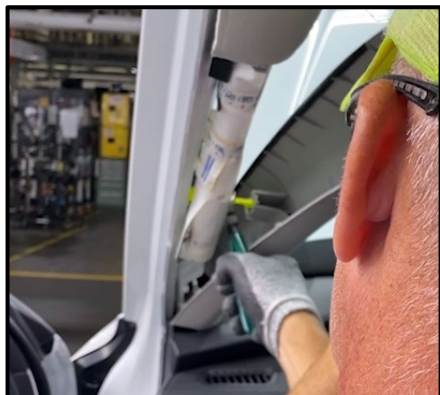
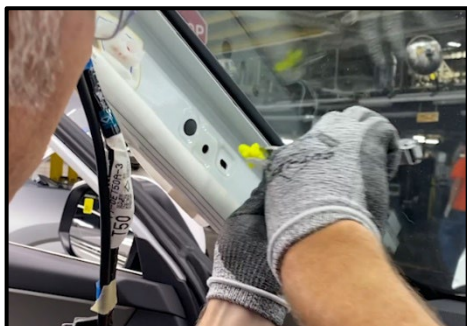
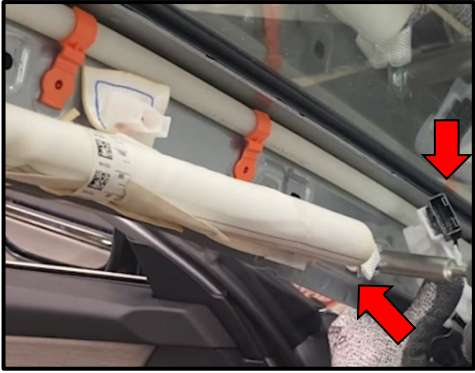
**3. Remove the CSA tether bolt**

- a. Remove the tether bolt and the metal tether tab from the A-pillar.

**Note: Do not discard the CSA tether bolt, it will be reused during reassembly.**

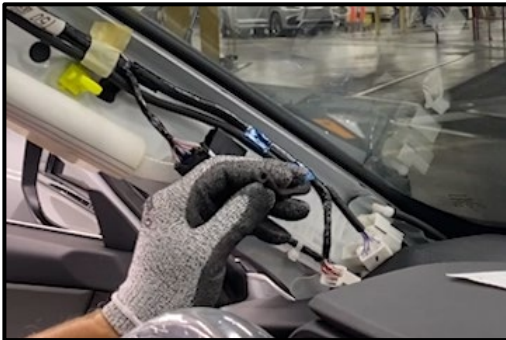
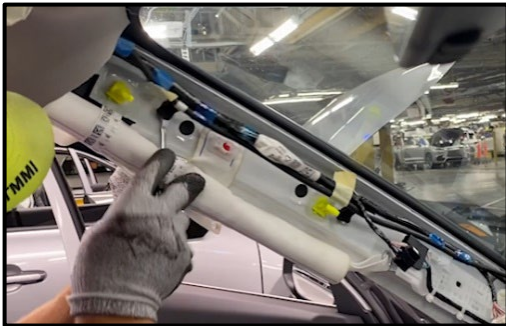
**4. Disconnect the Wire harnesses, Washer fluid hose, and antenna**

- a. Disconnect the wire harness connection  
b. Disconnect the washer hose and use a rag to collect any drainage during the hose disconnection  
c. Remove the 2 Antenna wire harness clips from the body

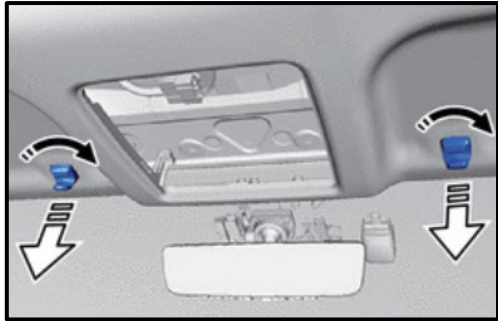
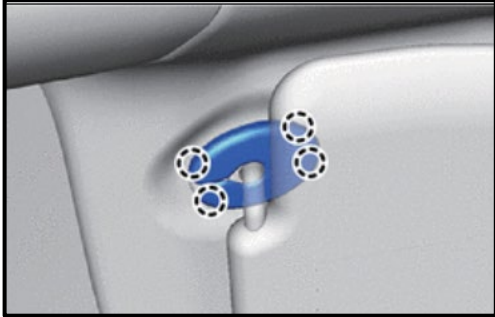
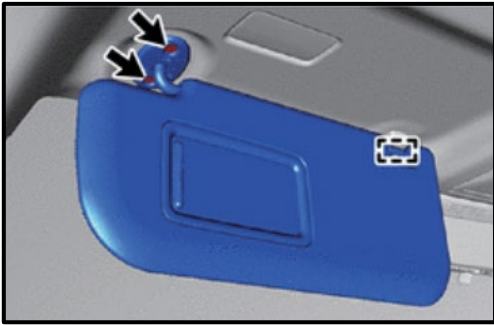
- 5. Remove the LH sun visor and sun visor holder**
- a. Remove the sun visor holder by twisting 45°
  - b. Remove the sun visor cap
  - c. Remove the 2 sun visor screws to remove the sun visor.

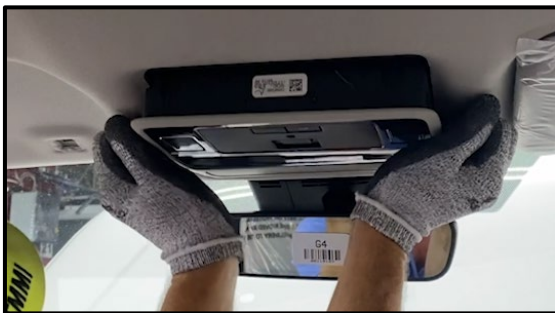
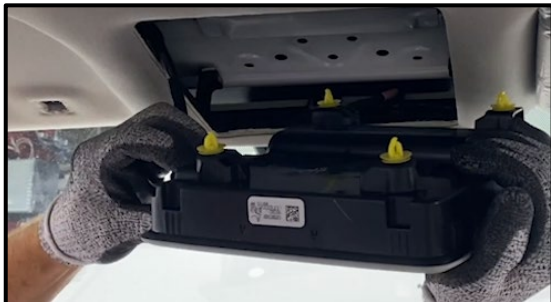
- 6. Remove the Overhead Console**
- a. Remove by prying up on the rear edge and disconnect the wire harness.
  - b. Disconnect the Sunroof wire harness (If present)

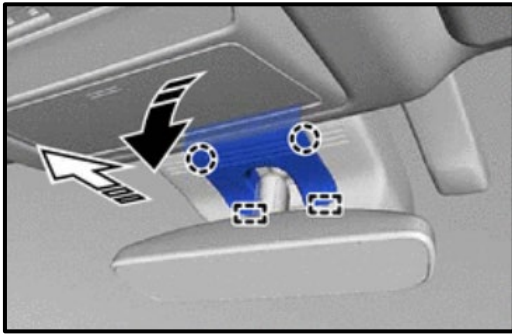
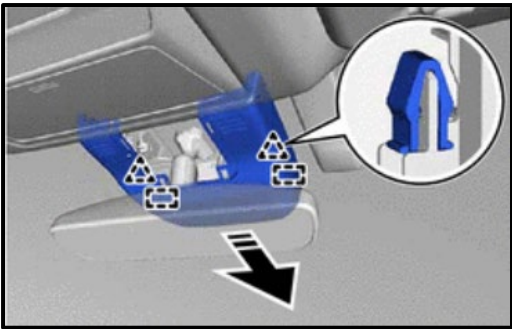
**7. Remove the rear-view mirror covers and wire harness connection**

- a. Remove the 2 rear view mirror covers.
- b. Remove the rain sensor cover and disconnect the wire harness (If present)

**Note: Do not pull the cover the cover straight off the windshield, this will result in part damage.**

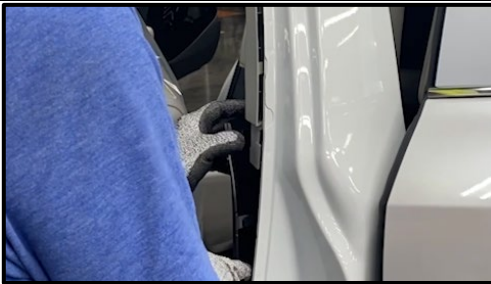
**8. Loosen the LH B-pillar lower garnish**

- a. Pull back the top portion of the lower B-pillar Garnish to expose the upper B-pillar clips.

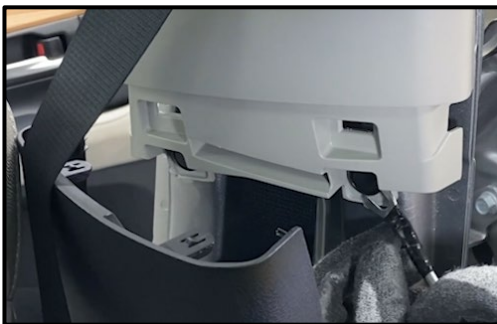
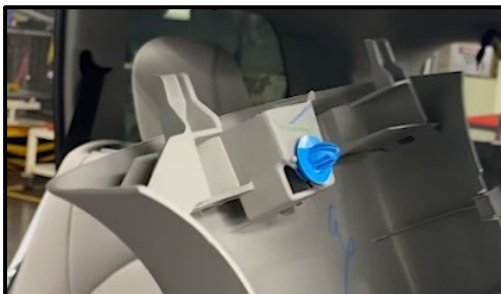
**9. Remove the LH B-pillar upper garnish**

- a. Remove the 2 black clips from the lower portion of the B-pillar garnish.
- b. Loosen the top portion of the B-pillar upper garnish by loosening the blue clip using a clip remover.

**Note: Do not forcefully pry loose the upper B-pillar. This will result in damage to the blue clip holder.**

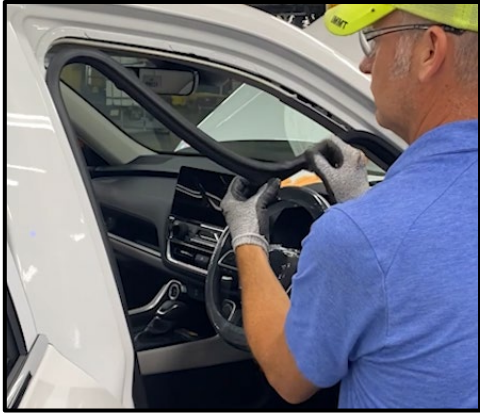
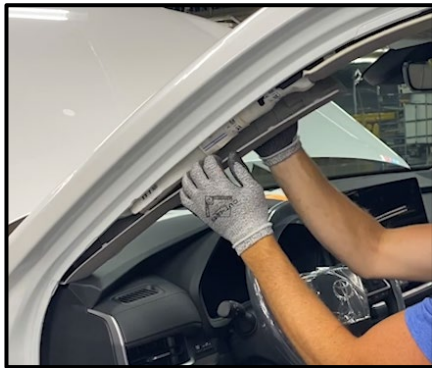
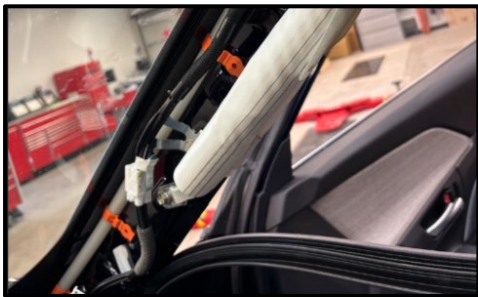
## 10. Move to RH Front side

- a. Fold down the upper RH weatherstrip
- b. Remove the RH A-pillar garnish
- c. Remove the RH CSA tether bolt

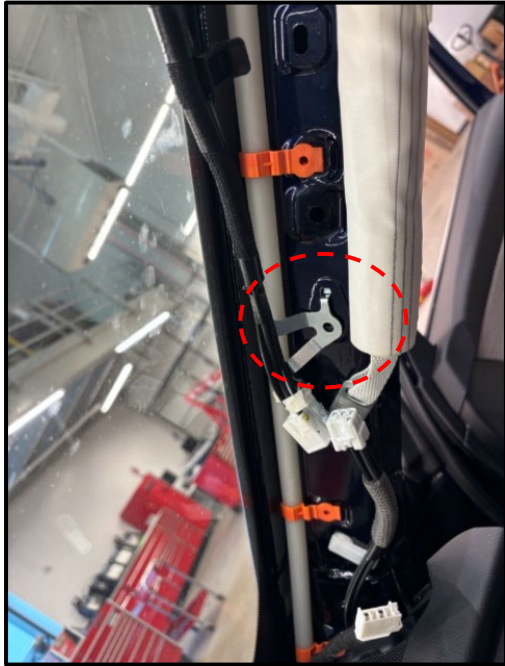
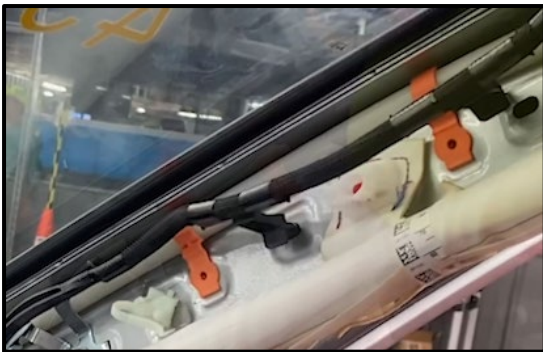
## 11. Remove Antenna bracket and wire harness

- a. Remove the Antenna bracket bolt.
- b. Disconnect the Antenna wire harness
- c. Remove the 2 wire harness clips from the body

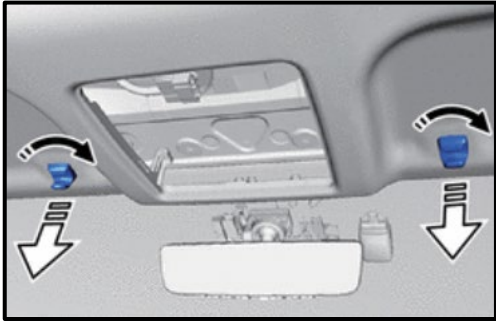
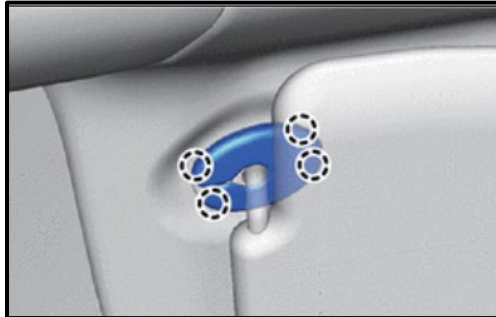
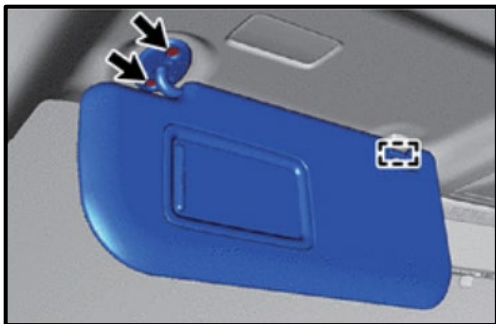
## 12. Remove the RH sun visor and sun visor holder

- Remove the sun visor holder by twisting 45°.
- Remove the sun visor cap.
- Remove the 2 sun visor screws to remove the sun visor.

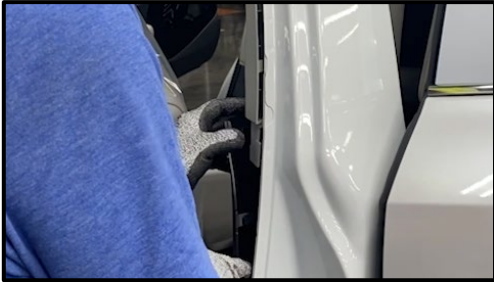
**14. Loosen the RH B-pillar lower garnish.**

- a. Pull back the top portion of the lower B-pillar Garnish to expose the upper B-pillar clips.

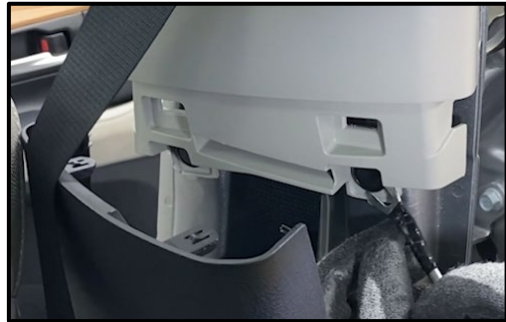
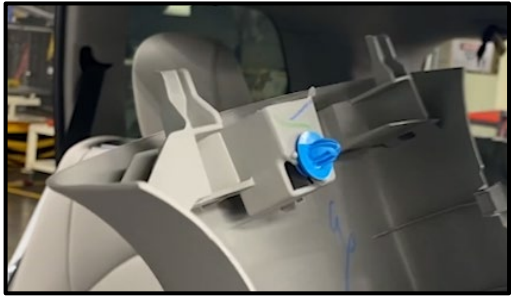
**15. Remove the RH B-pillar upper garnish.**

- a. Remove the 2 black clips from the lower portion of the B-pillar garnish.
- b. Loosen the top portion of the B-pillar upper garnish by loosening the blue clip using a clip remover.

**Note: Do not forcefully pry loose the upper B-pillar. This will result in damage to the blue clip holder.**

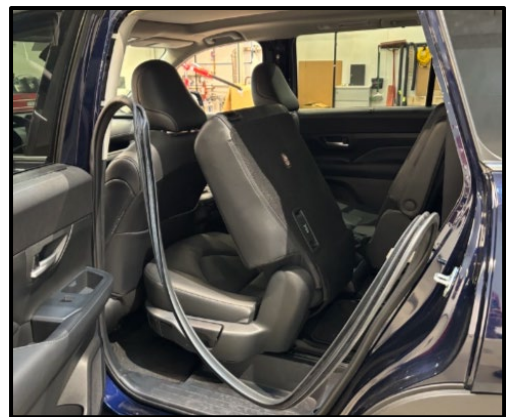
**16. Fold down the Weatherstrip LH & RH Rear Door opening weatherstrip.**

**Note: Fold it in a manner where it does not get damaged.**

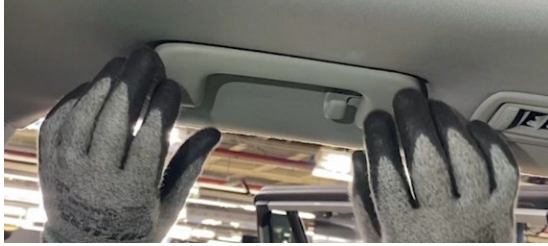
### 17. Remove the LH & RH Rear assist grips

- a. Remove the assist grip caps
- b. Remove the assist grip clamps from the body

**Note: Use caution not to mutilate the assist grip caps when removing.**

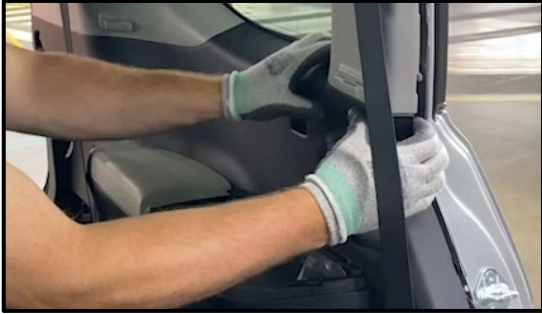
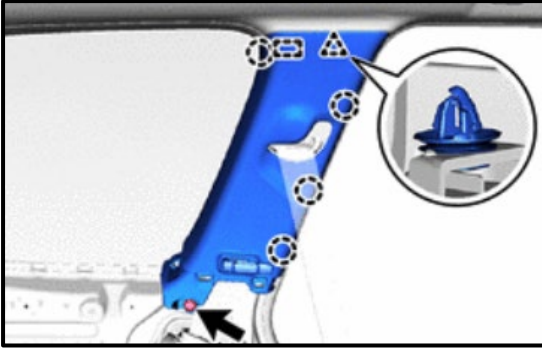
## 20. Unfastening the LH & RH C-pillar trim

- a. Unfasten the top portion of the lower C-pillar trim to expose the lower portion of the upper C-pillar trim.
- b. Remove the black clip on the lower portion of the upper C-pillar trim.
- c. Remove the upper C-pillar trim and let hang down out of the way.

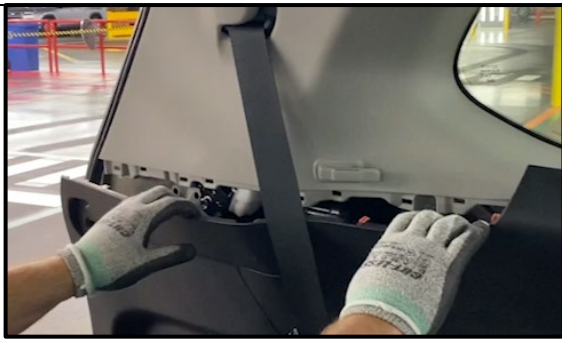
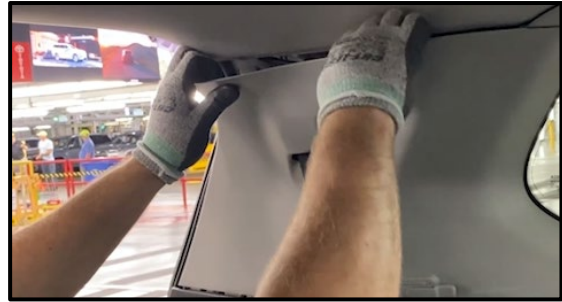
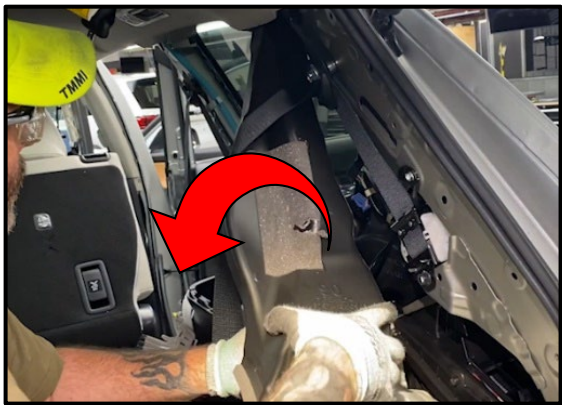
- 21. Unfastening the LH & RH Upper D-pillar trim**
- Pull back the top portion of the lower D-pillar trim.
  - Remove the Upper D-pillar trim and hang it down out of the way.
  - Remove the Rear Air duct on the RH side. **(If applicable)**

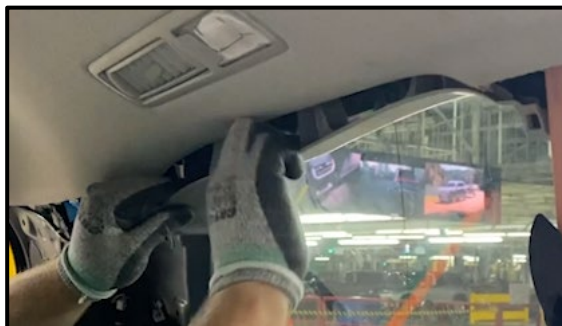
- 22. Unfastening the LH & RH Quarter window trim**
- Pull down on the Quarter window granish and let hang.
- NOTE: DO not remove the Quarter window trim, unfasten it and let it hang.**

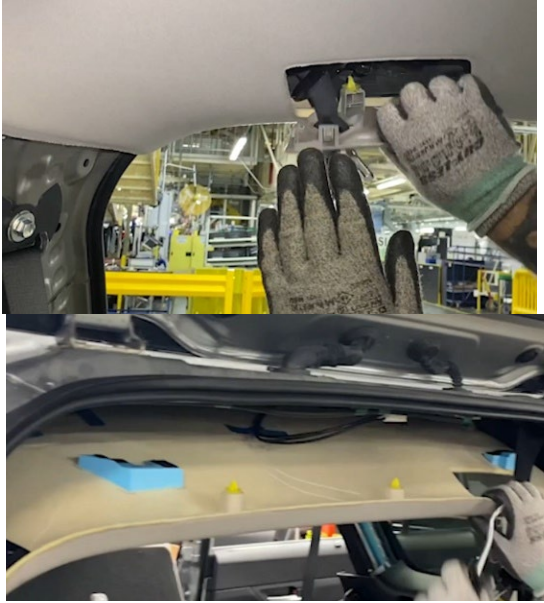
### 23. Rear Headliner clips and seatbelt

- a. Remove the 3<sup>rd</sup> row seatbelt trim from the headliner.
- b. Unfasten the rear headliner clips.
- c. Disconnect the rear headliner wire harness connections.

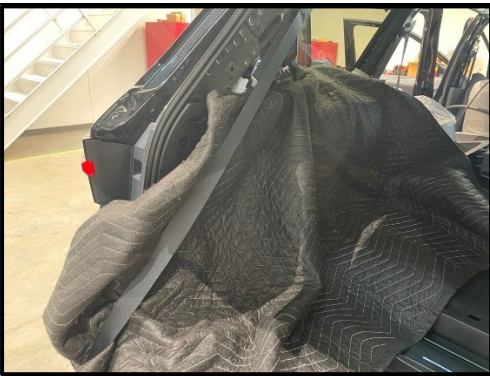
### 24. Mutilation prevention to D-pillar trim

- a. Place a protector/cover to the lower D-pillar trim to mitigate mutilation to the interior trims.

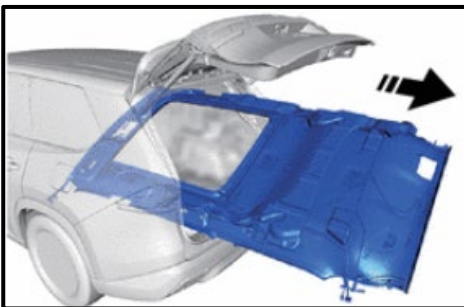
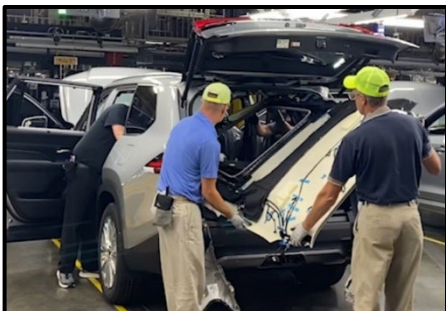
### 25. Headliner removal

- a. Pull down on the headliner to release it from roof.
- b. Store headliner in a manner to prevent mutilation and contaminants.

**NOTE: Due to the length of the headliner it is best to use a minimum of 3 people to remove from the vehicle to prevent mutilation to the headliner.**

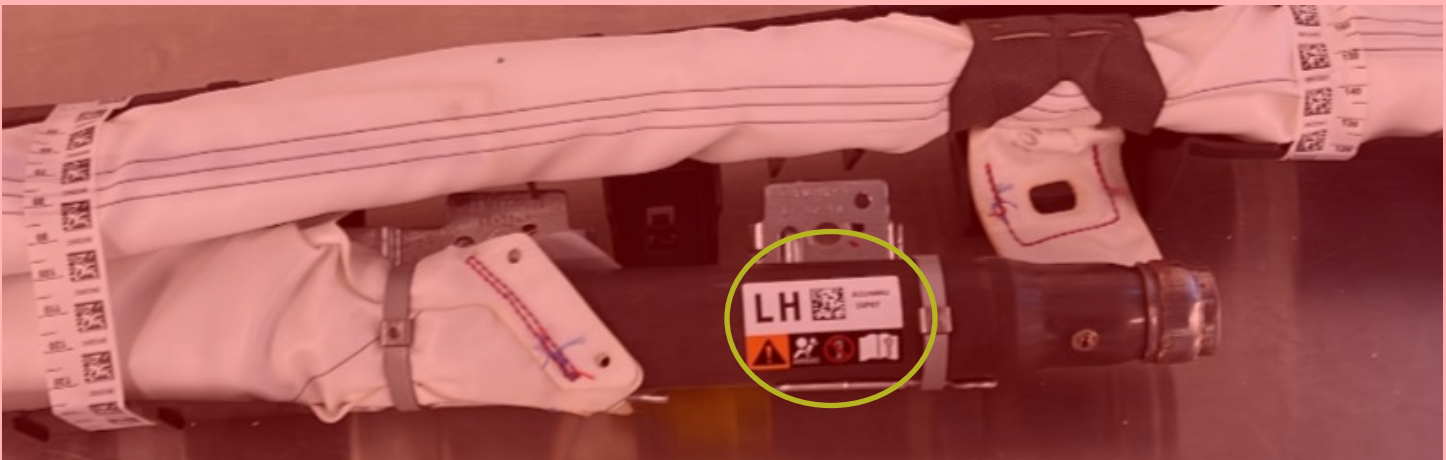
E) Scan the Old Airbag QR codes on the airbag inflator – **DO NOT SCAN ANY OTHER CODES**

ORIGINAL Curtain Shield Airbag Assembly Serial Number

Scan or enter the **original** Curtain Shield Airbag Assembly Number.

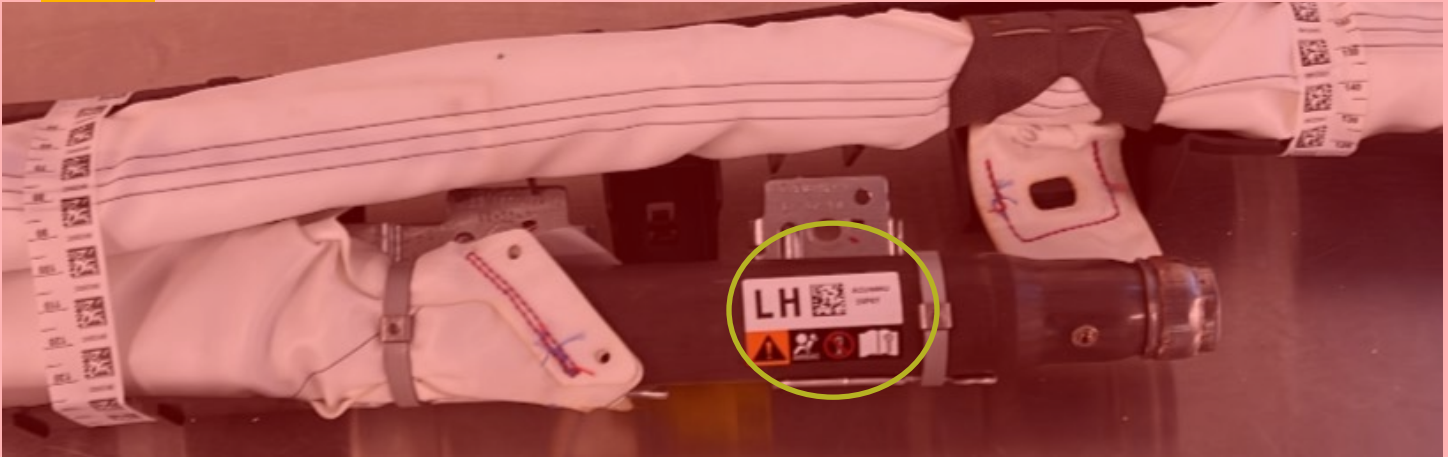
F) Scan the New Airbag QR codes on the airbag inflator – **DO NOT SCAN ANY OTHER CODES**

REPLACEMENT Curtain Shield Airbag Assembly Serial Number

Scan or enter the **replacement** Curtain Shield Airbag Assembly Number.

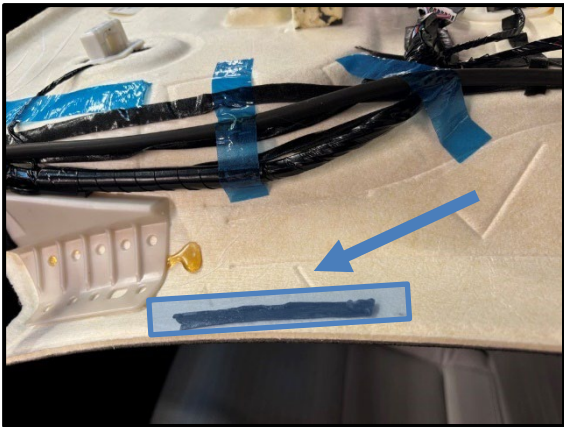
**31. Covering the Butyl on the LH side**

- a. If the Butyl tape is present, apply the blue Nitto tape on top of the Butyl tape, completely covering the Butyl tape.

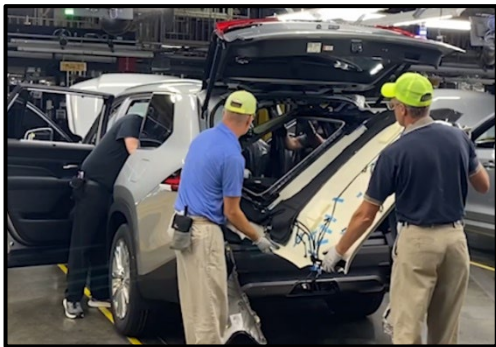
**32. Reinstall the Headliner**

- a. Install the headliner into the vehicle
- b. Refasten all headliner clips to the roof

**NOTE: Due to the length of the headliner it is best to use a minimum of 3 people to install. This will prevent mutilation or cracking to the headliner.**

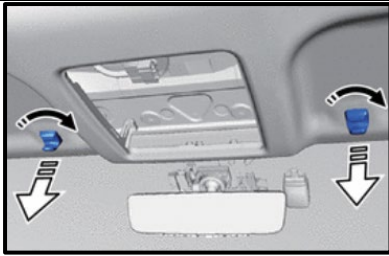
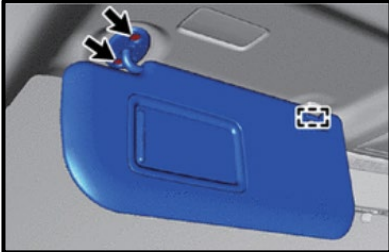
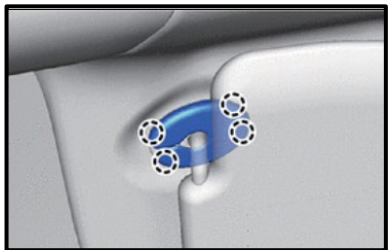
### 33. Reinstall the LH & RH sun visor and sun visor clips

- a. Install the sun visor clips into the body.
- b. Install the sunvisors
- c. Install the sun visor caps.

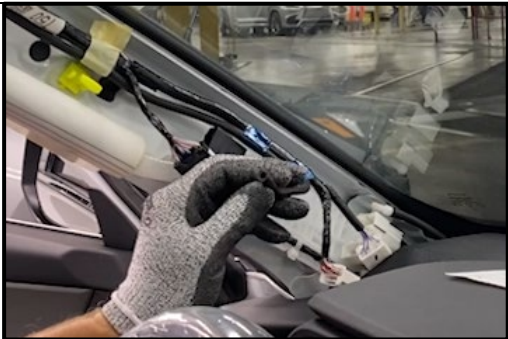
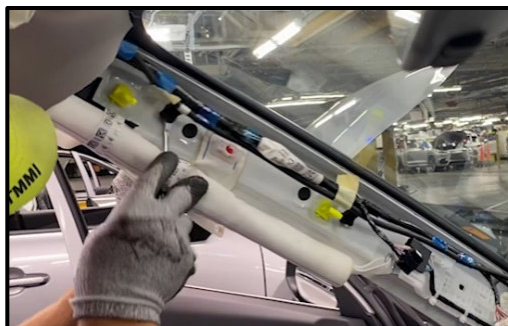
### 34. Wire harnesses, Washer fluid hose, and antenna Install (LH A-pillar)

- a. Connect the 2 Antenna wire harness clips to the body
- b. Connect the wire harness connection.
- c. Connect the washer hose.

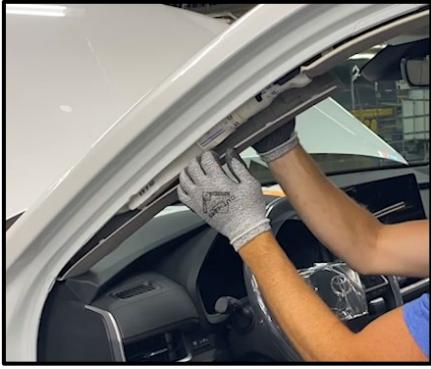
### 35. Reinstall the LH A-pillar garnish

- a. Install **NEW** tether clips to the the A-pillar garnish.
- b. Install the speaker into the garnish (If applicable)
- c. Line up the A-pillar garnish and install

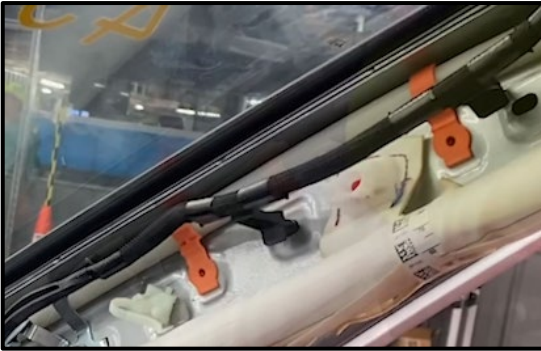
### 36. Wire harnesses and antenna Install (RH A-pillar)

- a. Connect the 2 Antenna wire harness clips to the body
- b. Connect the antenna wire harness connection and tighten bracket.

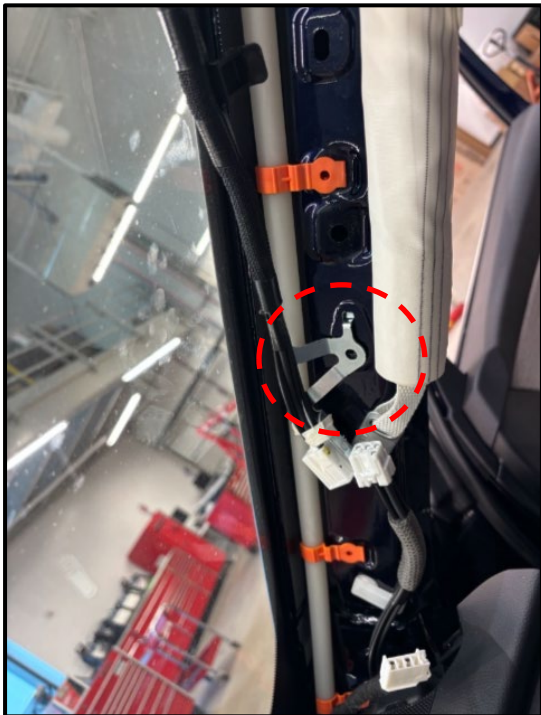
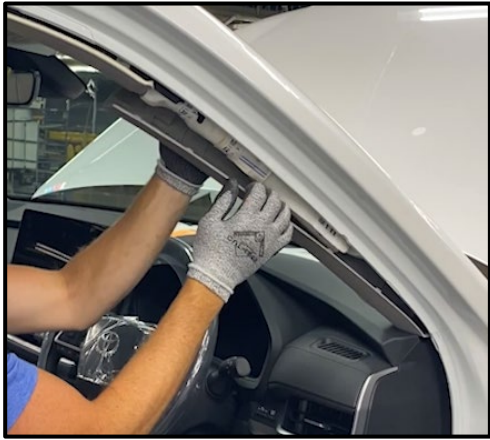
### 37. Reinstall the RH A-pillar garnish

- a. Install **NEW** tether clips to the the A-pillar garnish.
- b. Install the speaker into the garnish (If applicable)
- c. Line up the A-pillar garnish and install

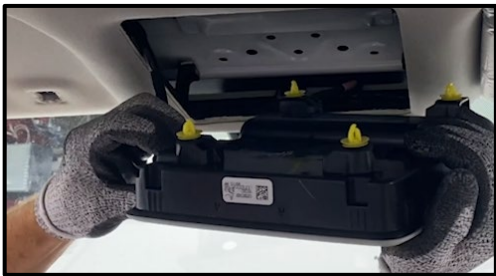
### 39. Reinstall the Rear view mirror covers and connections

- a. Connect all mirror connections.
- b. Reinstall all mirror covers.
- c. Connect Rain sensor (If Applicable)

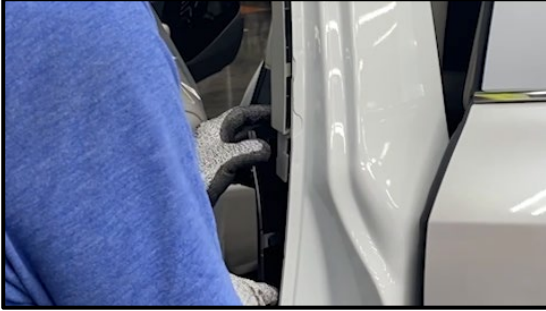
- 41. Reinstall the LH & RH Upper B-pillar garnish**
- a. Clip in the upper B-pillar garnish
  - b. Install the black clips on the lower portion
- Note: Ensure the Seatbelt adjust is aligned correctly and it adjust correctly before moving to the next step.**

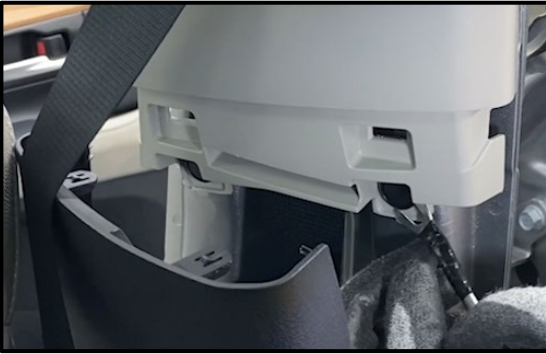
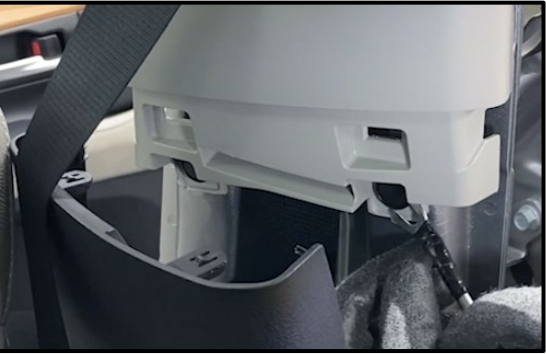
- 42. Reinstall the LH & RH lower B-pillar garnish**
- a. Install the lower B-pillar garnish

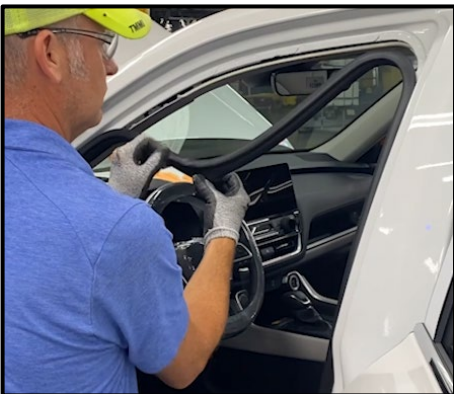
- 43. Reinstall the LH & RH #1 door weatherstrips.**
- a. Install the door opening weatherstrips

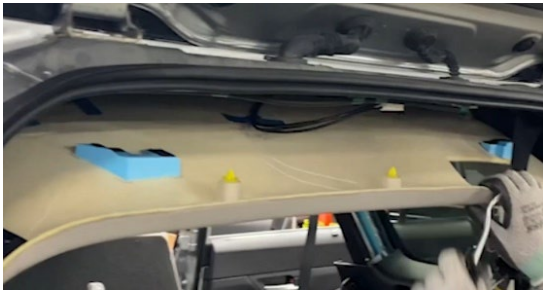
#### 45. Install Rear headliner clips and rear wire harness/ washer hose

- a. Connect all rear wire harnesses.
- b. Install the headliner clips
- c. Connect the rear washer hose

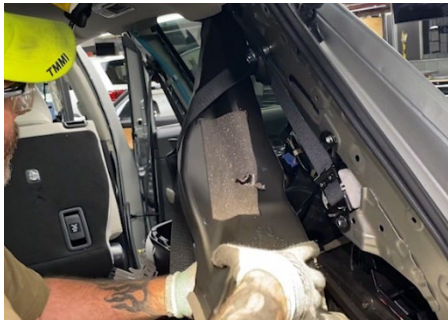
#### 46. Install the LH & RH quarter trim and HVAC duct

- a. Install the HVAC duct on the RH side (If applicable)
- b. Install the quarter trims.

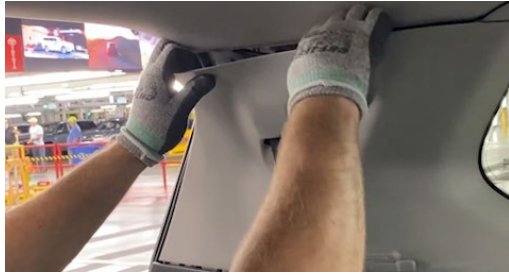
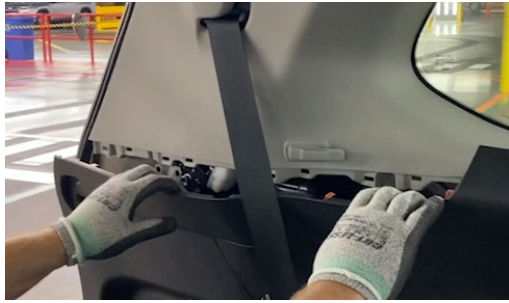
**47. Install the LH & RH upper and lower D-pillar garnishes**

- a. Install the upper D-pillar garnish
- b. Install the lower D-pillar garnish

**NOTE: Ensure the seatbelts move freely.**

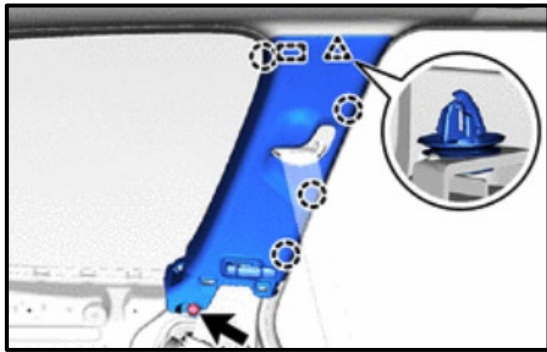
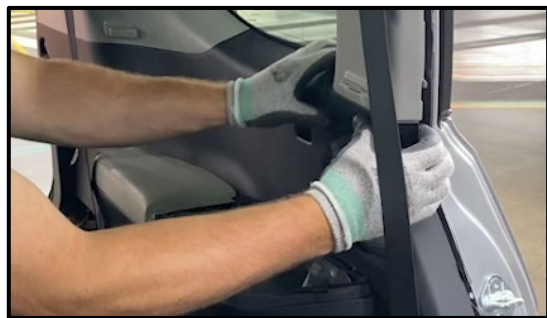
**48. Install the LH & RH upper and lower C-pillar garnishes**

- a. Install the upper C-pillar garnish
- b. Install the lower C-pillar garnish

**NOTE: Ensure the seatbelts move freely.**

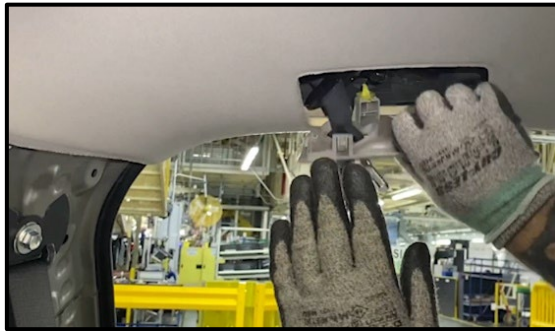
**50. Install the 3<sup>rd</sup> row seatbelt trim**

- a. Install the 3<sup>rd</sup> row seatbelt trim and confirm operability.

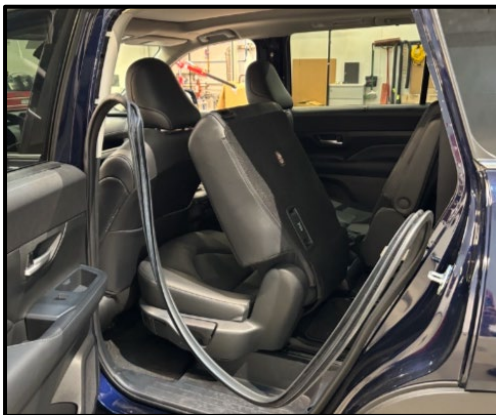
**51. Install the LH & RH#2 door weather strips**

- a. Install the door opening weatherstrips
