SAFETY RECALL 24LA05

CURTAIN SHIELD AIRBAGS MAY NOT DEPLOY AS INTENDED

CERTAIN 2024 MODEL YEAR TX350, TX500H, TX550H+ VEHICLES

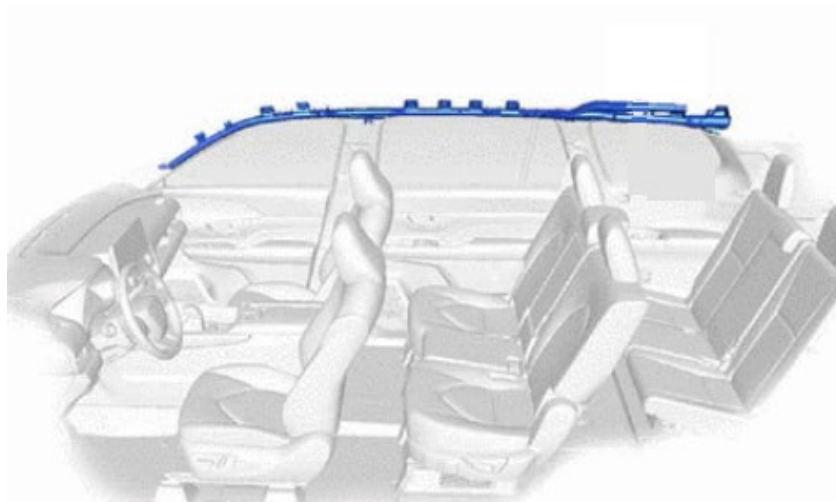
LH and RH Curtain Shield Airbags

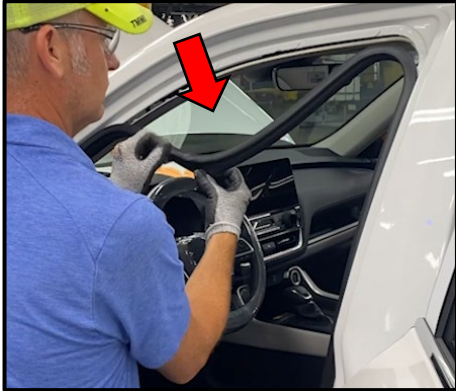
1. Fold down the Weatherstrip LH Front Door opening weatherstrip

Note: Fold it in a manner where it does not get damaged.

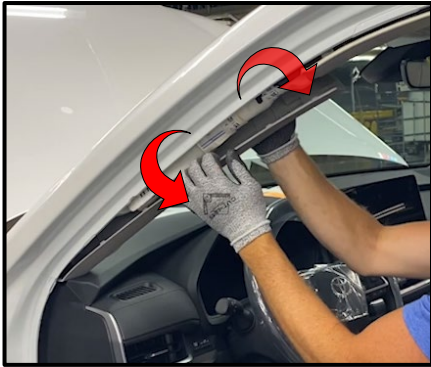
2. Remove the LH A-pillar Garnish

- a. Pull back the A-pillar garnish
- b. Cut the tether clips
- c. Remove the speaker (if applicable)
- d. Remove the 2 tether clips from the body and A-pillar and discard.

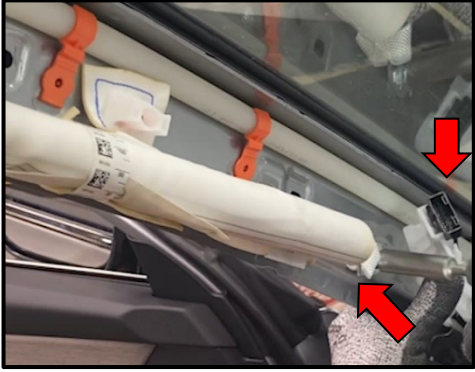
3. Remove the CSA tether bolt

- a. Remove the tether bolt and the metal tether tab from the A-pillar.

Note: Do not discard the CSA tether bolt, it will be reused during reassembly.

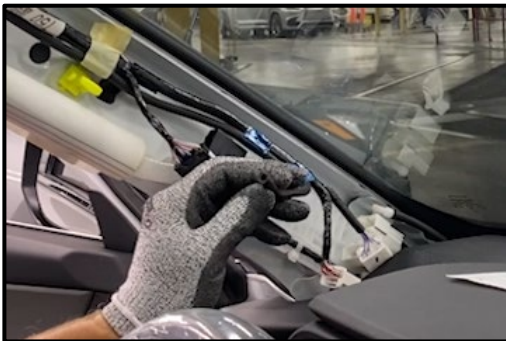
4. Disconnect the wire harnesses, Washer fluid hose, and antenna

- a. Disconnect the wire harness connection
- b. Disconnect the washer hose and use a rag to collect any drainage during the hose disconnection
- c. Remove the 2 Antenna wire harness clips from the body

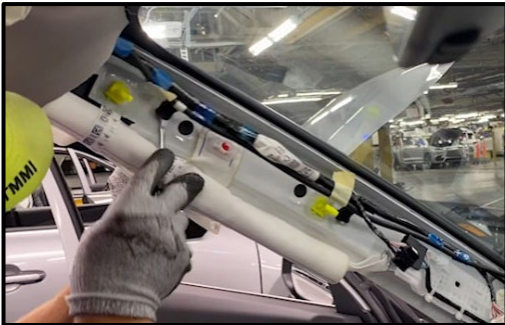
- 5. Remove the LH sun visor and sun visor holder**
- a. Remove the sun visor holder by twisting 45°
 - b. Remove the sun visor cap
 - c. Remove the 2 sun visor screws to remove the sun visor.

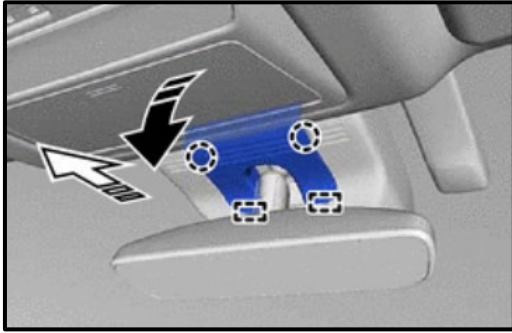
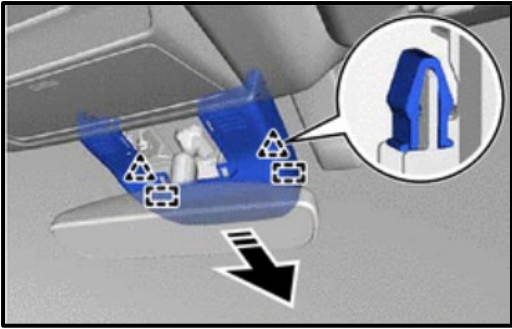
7. **Remove the rear-view mirror covers and wire harness connection**
- a. Remove the 2 rear view mirror covers.
 - b. Remove the rain sensor cover and disconnect the wire harness (If present)
- Note: Do not pull the cover the cover straight off the windshield, this will result in part damage.**

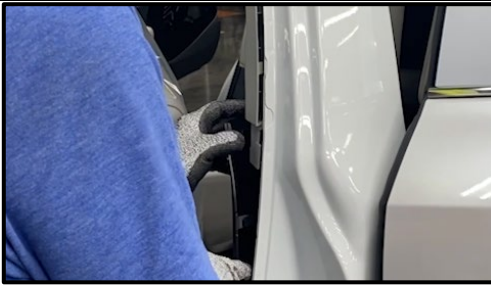
8. **Loosen the LH B-pillar lower garnish**
- a. Pull back the top portion of the lower B-pillar Garnish to expose the upper B-pillar clips.

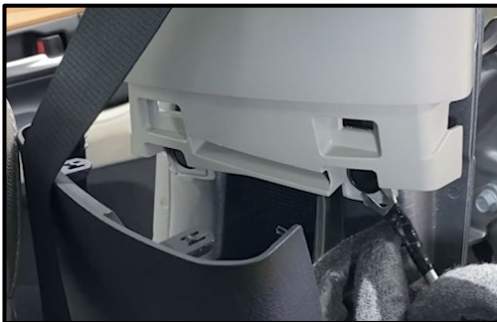
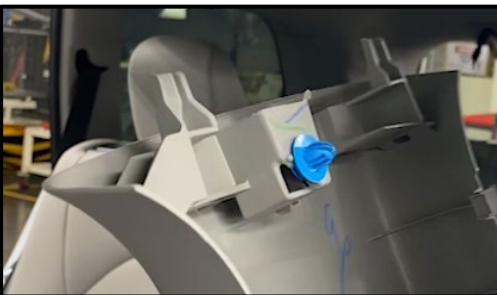
9. **Remove the LH B-pillar upper garnish**
- a. Remove the 2 black clips from the lower portion of the B-pillar garnish.
 - b. Loosen the top portion of the B-pillar upper garnish by loosening the blue clip using a clip remover.
- Note: Do not forcefully pry loose the upper B-pillar. This will result in damage to the blue clip holder.**

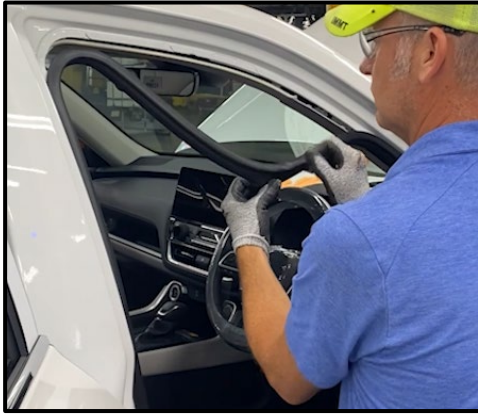
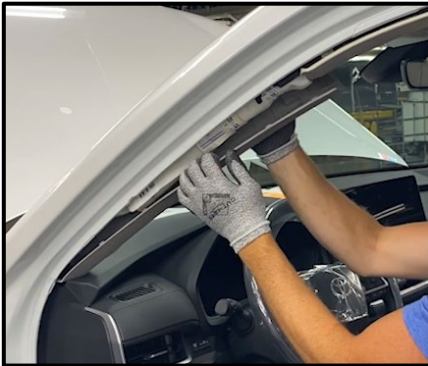
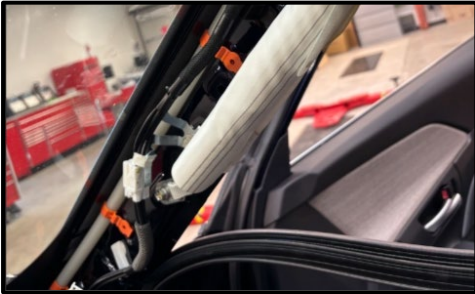
10. Move to RH Front side and repeat steps 1-3

- a. Fold down the upper RH weatherstrip
- b. Remove the RH A-pillar garnish
- c. Remove the RH CSA tether bolt

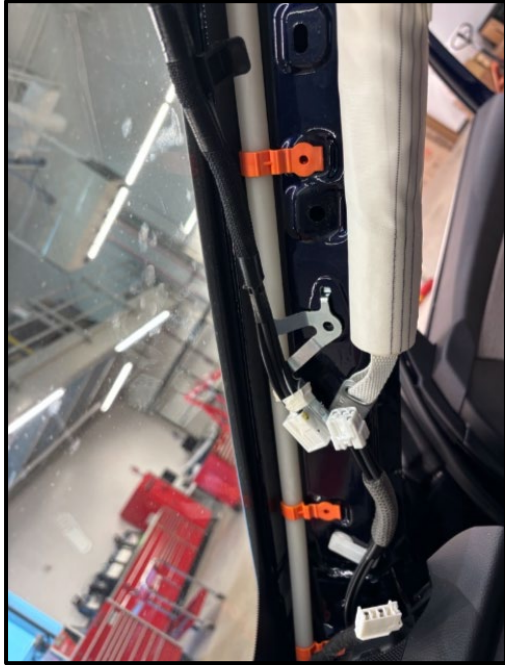
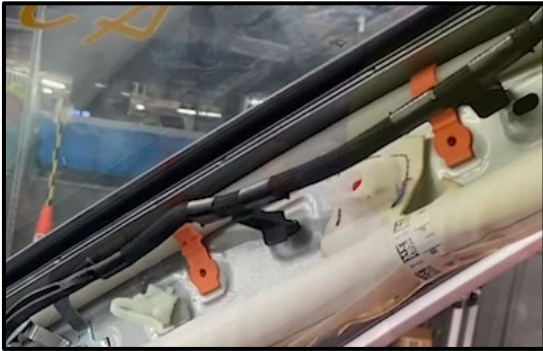
11. Remove Antenna bracket and wire harness

- a. Remove the Antenna bracket bolt.
- b. Disconnect the Antenna wire harness
- c. Remove the 2 wire harness clips from the body

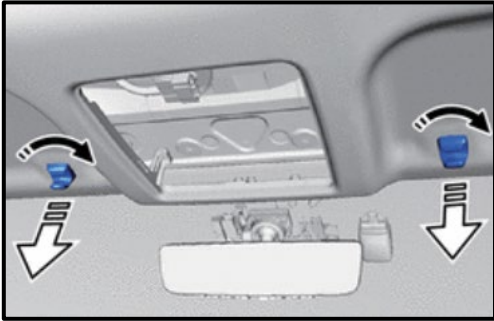
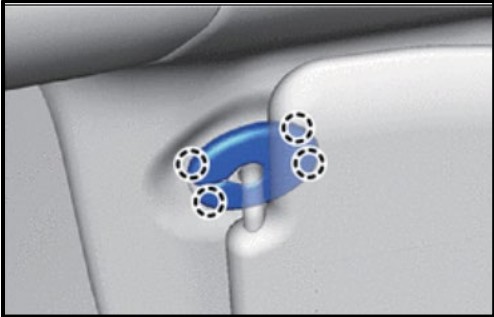
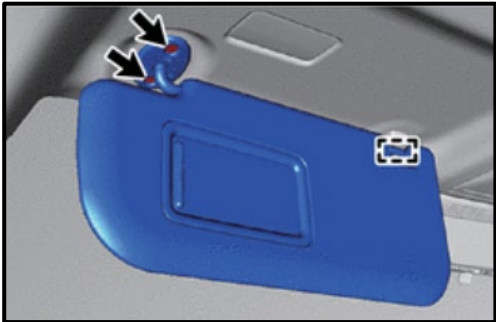
12. Remove the RH sun visor and sun visor holder

- a. Remove the sun visor holder by twisting 45°.
- b. Remove the sun visor cap.
- c. Remove the 2 sun visor screws to remove the sun visor.

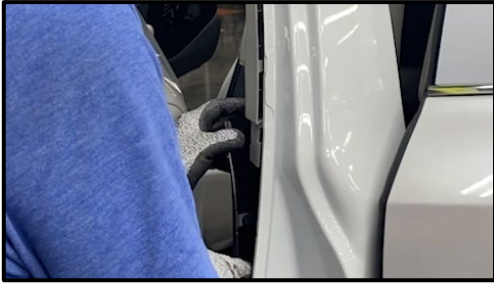
14. Loosen the RH B-pillar lower garnish.

- a. Pull back the top portion of the lower B-pillar Garnish to expose the upper B-pillar clips.

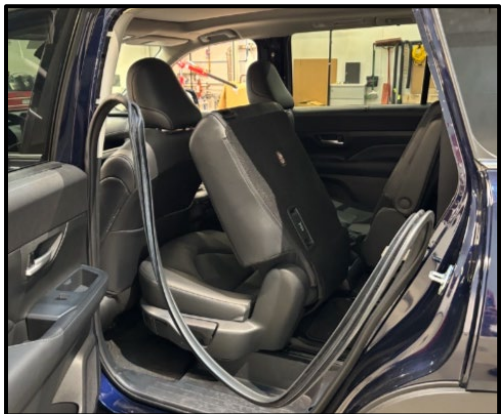
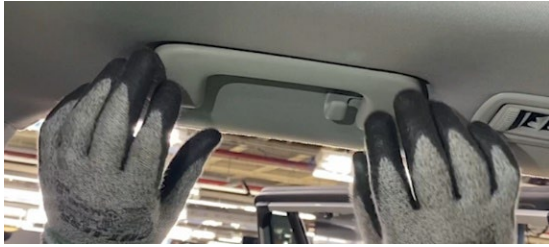
17. Remove the LH & RH Rear assist grips

- a. Remove the assist grip caps
- b. Remove the assist grip clamps from the body

Note: Use caution not to mutilate the assist grip caps when removing.

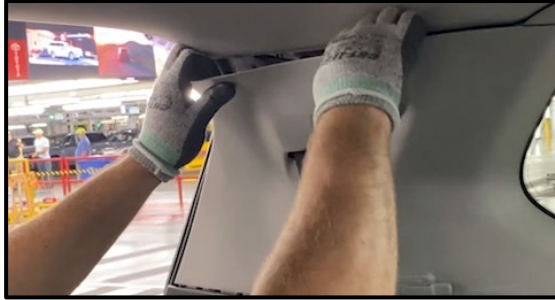
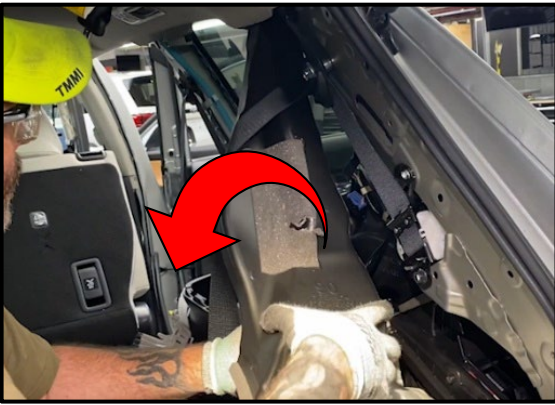
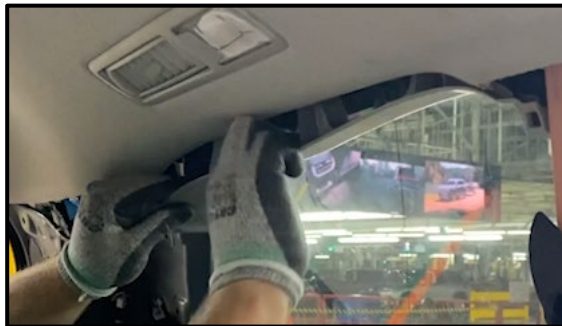
22. Unfastening the LH & RH Quarter window trim

- a. Pull down on the Quarter window granish and let hang.

NOTE: DO not remove the Quarter window trim, unfasten it and let it hang.

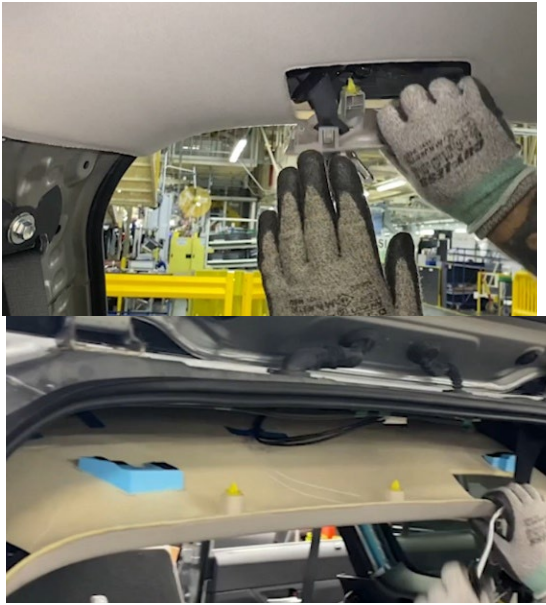
23. Rear Headliner clips and seatbelt

- a. Remove the 3rd row seatbelt trim from the headliner.
- b. Unfasten the rear headliner clips.
- c. Disconnect the rear headliner wire harness connections.

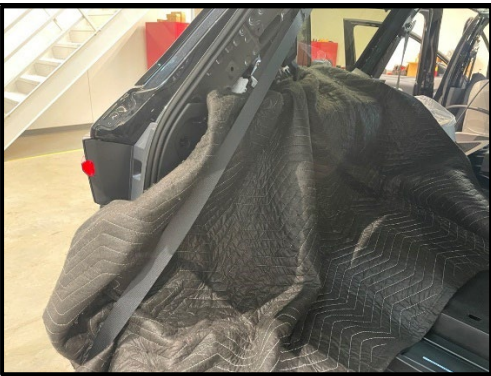
24. Mutilation prevention to D-pillar trim

- a. Place a protector/cover to the lower D-pillar trim to mitigate mutilation to the interior trims.

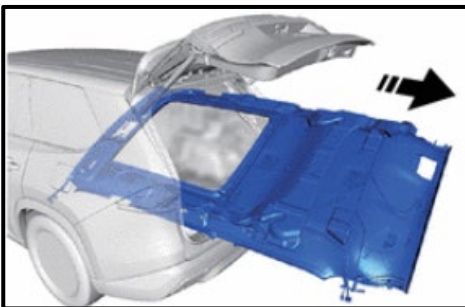
25. Headliner removal

- a. Pull down on the headliner to release it from roof.
- b. Store headliner in a manner to prevent mutilation and contaminants.

NOTE: Due to the length of the headliner it is best to use a minimum of 3 people to remove from the vehicle to prevent mutilation to the headliner.

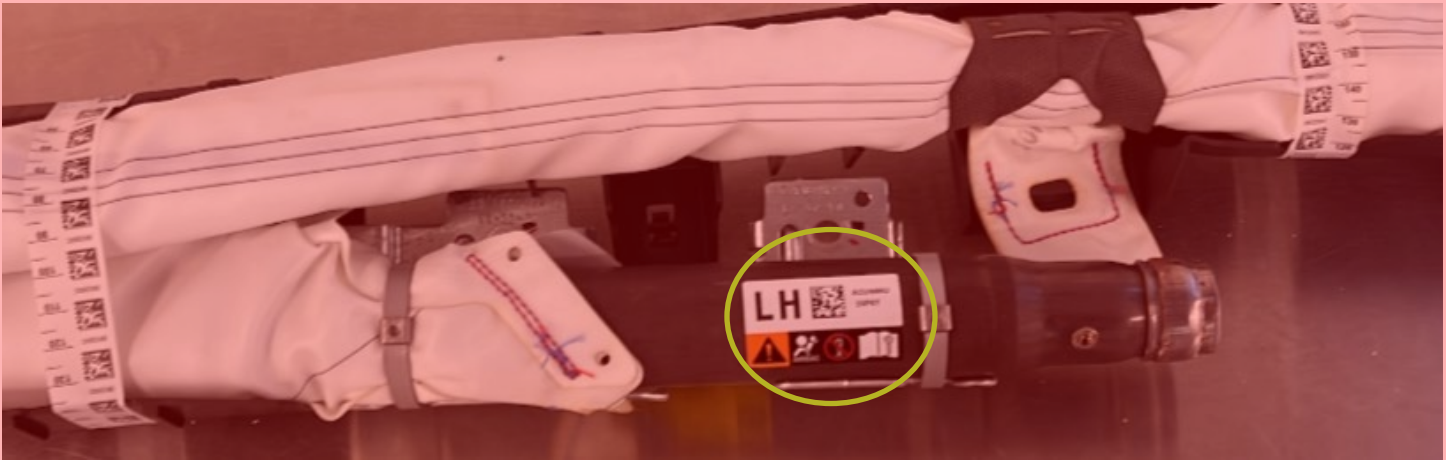
E) Scan the Old Airbag QR codes on the airbag inflator – **DO NOT SCAN ANY OTHER CODES**

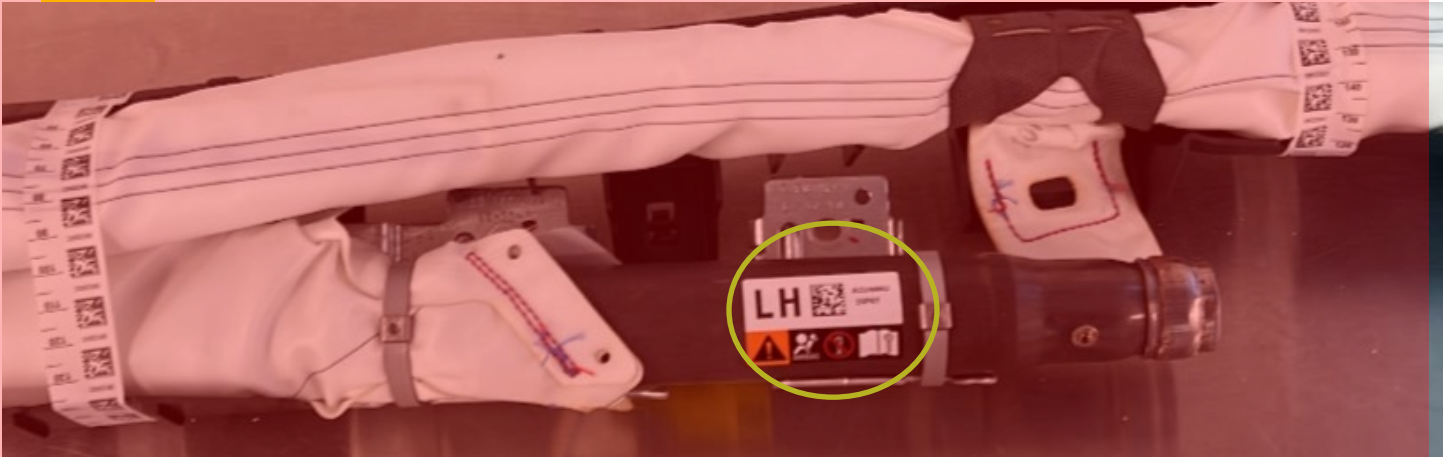
F) Scan the New Airbag QR codes on the airbag inflator – **DO NOT SCAN ANY OTHER CODES**

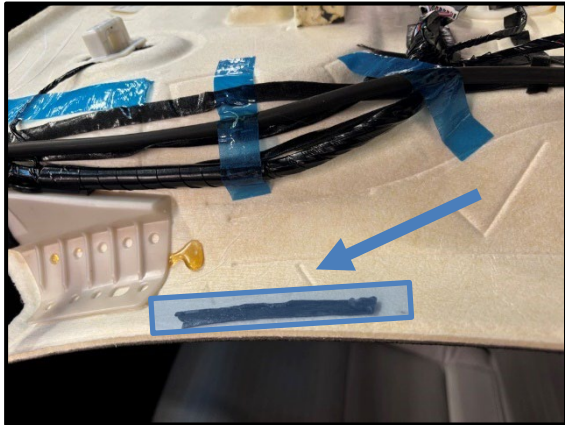
31. Covering the Butyl on the LH side

- a. If the Butyl tape is present, apply the blue Nitto tape on top of the Butyl tape, completely covering the Butyl tape.

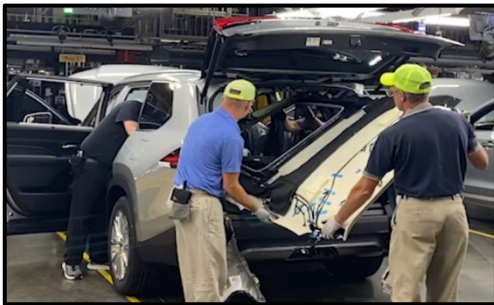
32. Reinstall the Headliner

- a. Install the headliner into the vehicle
- b. Refasten all headliner clips to the roof

NOTE: Due to the length of the headliner it is best to use a minimum of 3 people to install. This will prevent mutilation or cracking to the headliner.

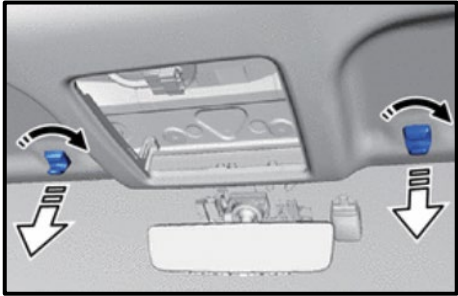
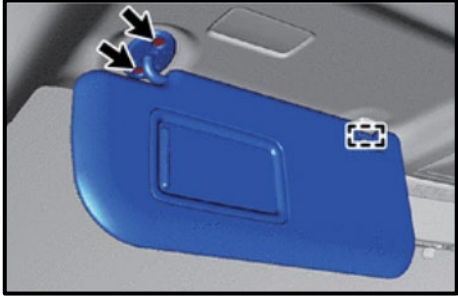
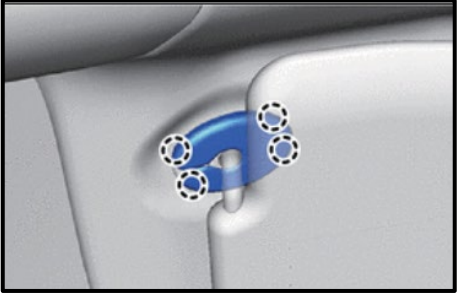
33. Reinstall the LH & RH sun visor and sun visor clips

- a. Install the sun visor clips into the body.
- b. Install the sunvisors
- c. Install the sun visor caps.

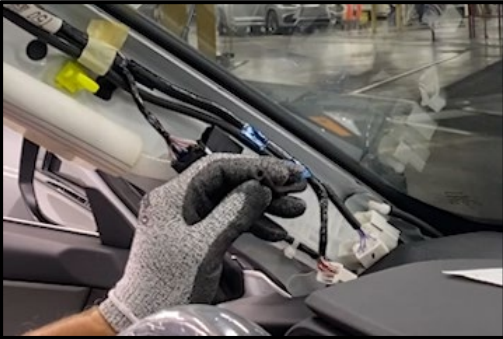
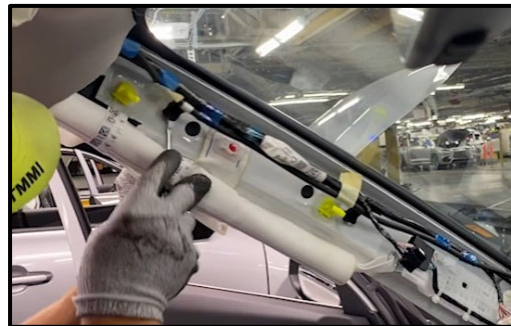
34. Wire harnesses, Washer fluid hose, and antenna Install (LH A-pillar)

- a. Connect the 2 Antenna wire harness clips to the body
- b. Connect the wire harness connection.
- c. Connect the washer hose.

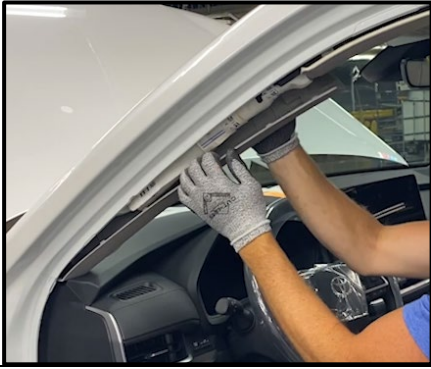
35. Reinstall the LH A-pillar garnish

- a. Install **NEW** tether clips to the A-pillar garnish.
- b. Install the speaker into the garnish (If applicable)
- c. Line up the A-pillar garnish and install

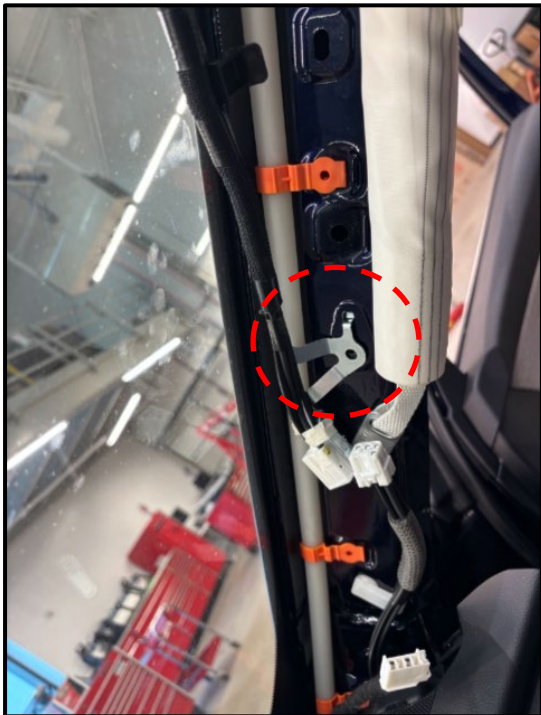
37. Reinstall the RH A-pillar garnish

- a. Install **NEW** tether clips to the the A-pillar garnish.
- b. Install the speaker into the garnish (If applicable)
- c. Line up the A-pillar garnish and install

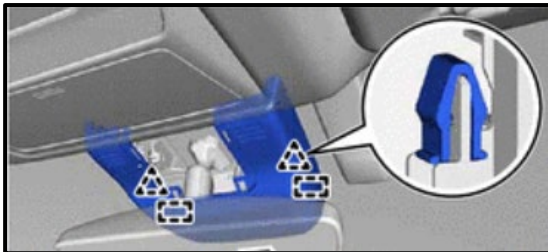
39. Reinstall the Rear view mirror covers and connections

- a. Connect all mirror connections.
- b. Reinstall all mirror covers.
- c. Connect Rain sensor (If Applicable)

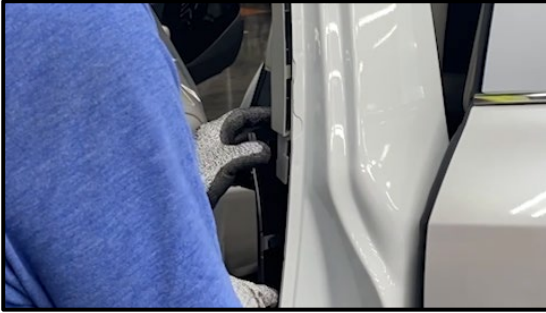
41. Reinstall the LH & RH Upper B-pillar garnish

- a. Clip in the upper B-pillar garnish
- b. Install the black clips on the lower portion

Note: Ensure the Seatbelt adjust is aligned correctly and it adjusts correctly before moving to the next step.

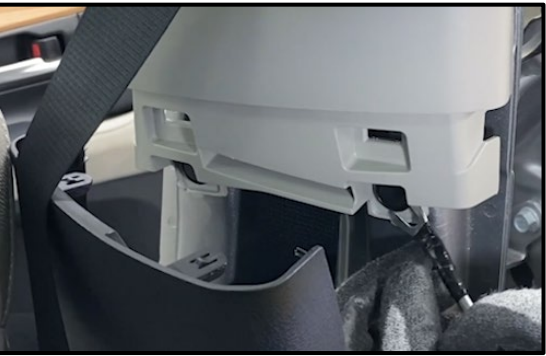
42. Reinstall the LH & RH lower B-pillar garnish

- a. Install the lower B-pillar garnish

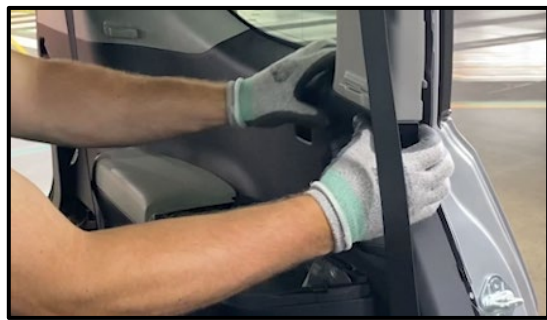
48. Install the LH & RH upper and lower C-pillar garnishes

- a. Install the upper C-pillar garnish
- b. Install the lower C-pillar garnish

NOTE: Ensure the seatbelts move freely.

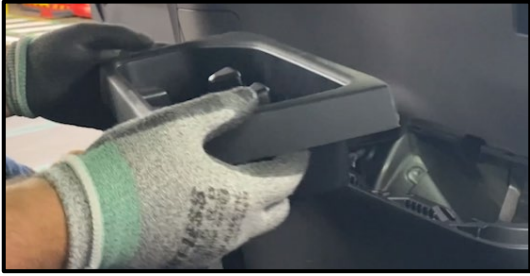
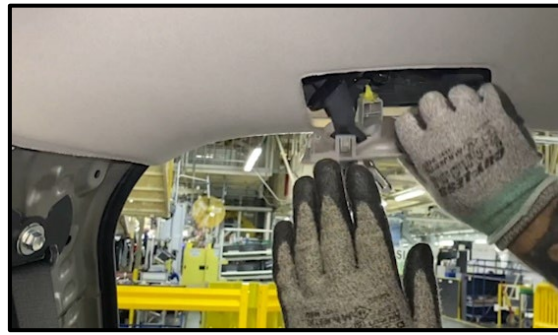
50. Install the 3rd row seatbelt trim

- a. Install the 3rd row seatbelt trim and confirm operability.

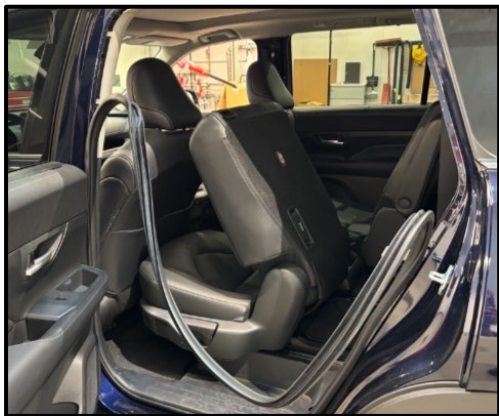
51. Install the LH & RH#2 door weather strips

- a. Install the door opening weatherstrips
